PCB ABATEMENT CLOSEOUT SUMMARY REPORT

SKY VALLEY EDUCATION CENTER
351 Short Columbia Street
Monroe, Washington

October 2016
PBS Project # 41373.000

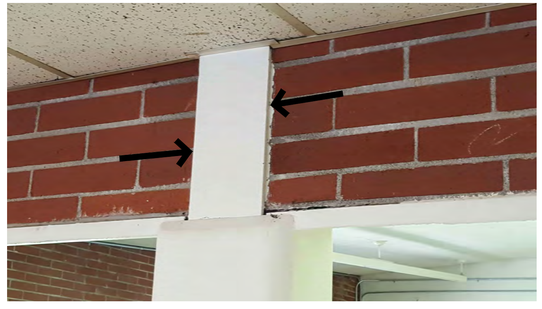
(8) REMOVE APPROX. 500 LF OF PCB-CONTAINING CAULKING LOCATED ON ALL VERTICAL STRUCTURAL METAL COLUMN TRANSITIONS THROUGHOUT THE EAST ELEVATION OF THE LARGE GYM AS SHOWN. THIS INCLUDES THE REMOVAL OF ALL CAULKING ON THE INTERIOR DEMISING WALL METAL BEAMS (VERTICAL AND HORIZONTAL) BETWEEN THE DAYCARE AND THE GATHERING PLACE/CAFETERIA AS SHOWN. THE CAULKING IS HEAVILY PAINTED THROUGHOUT THE WORK SCOPE AREA.

(9) REMOVE APPROX. 780 LF OF PCB-CONTAINING CAULKING LOCATED ON ALL EXTERIOR VERTICAL STRUCTURAL METAL COLUMN TRANSITIONS THROUGHOUT THE LOWER WEST AND SOUTH ELEVATIONS OF THE LARGE GYM BUILDING AS SHOWN.

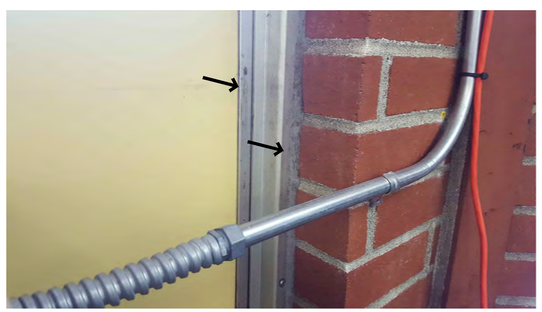
(1) PHOTO DETAIL

(1) REMOVE APPROX. 500 LF OF PCB-CONTAINING CAULKING LOCATED ON INTERIOR PERIMETER METAL WINDOW FRAME TO BRICK TRANSITION VERTICALS IN EACH OF CLASSROOMS 1-20 AS SHOWN.

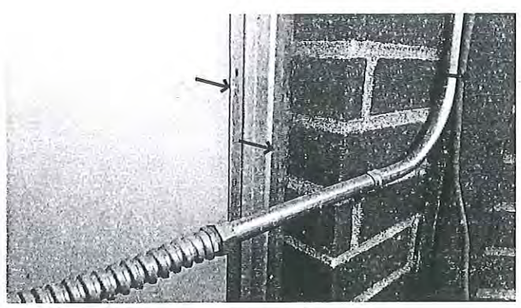
①PHOTO DETAIL

① REMOVE APPROX. 500 LF OF PCB-CONTAINING CAULKING LOCATED ON INTERIOR PERIMETER METAL WINDOW FRAME TO BRICK TRANSITION VERTICALS IN EACH OF CLASSROOMS 1-20 AS SHOWN.

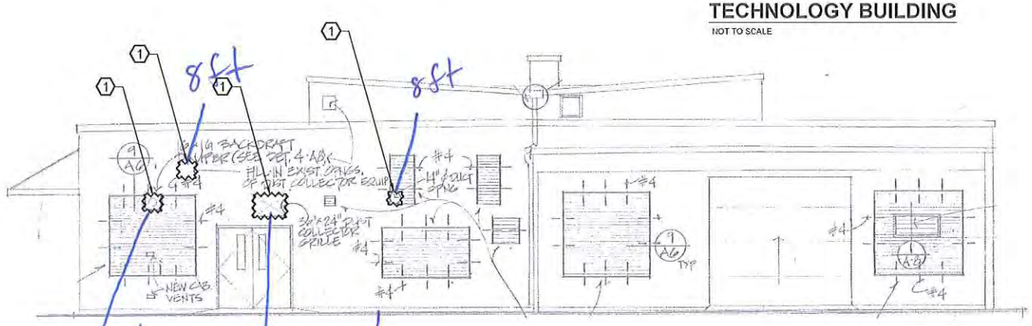
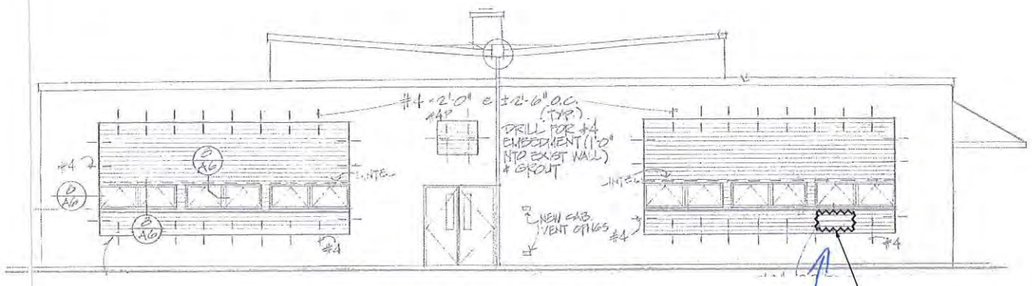
1 HM5 TECHNOLOGY BUILDING EAST
NOT TO SCALE

① REMOVE APPROX. 60 LF OF PCB-CONTAINING CAULKING LOCATED ON EXTERIOR LOUVERS, VENTS AND DUCTING ON METAL TRANSITIONS ON THE WEST AND EAST EXTERIOR ELEVATIONS OF THE TECHNOLOGY BUILDING AS SHOWN.

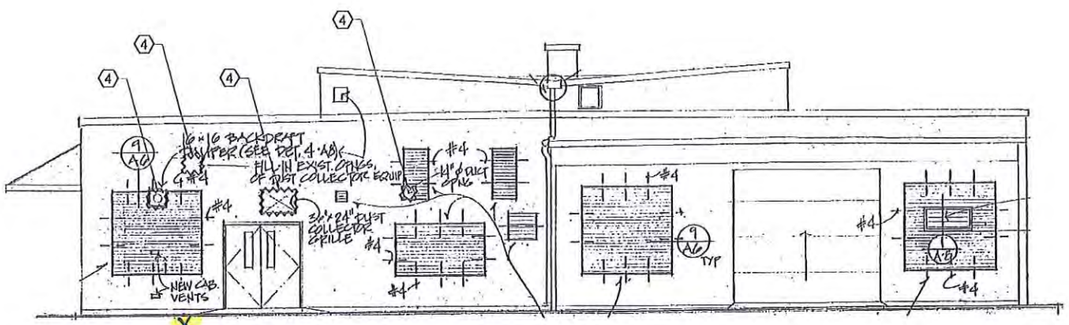
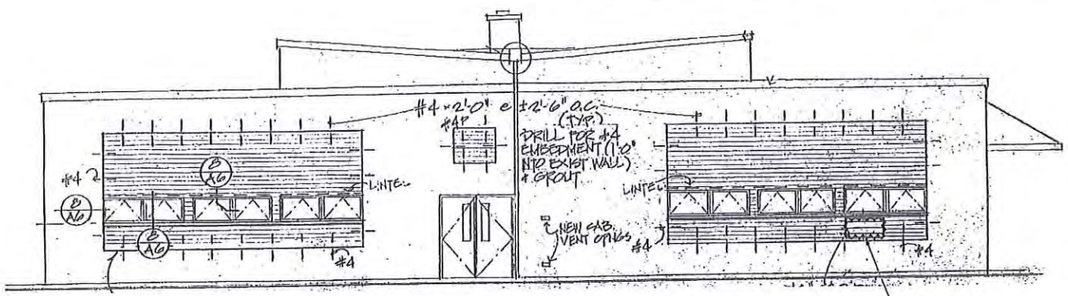
1 TECHNOLOGY BUILDING EAST
HM5 NOT TO SCALE

1. REMOVE APPROX. 60 LF OF PCB-CONTAINING SOFT GREY CAULKING LOCATED ON EXTERIOR LOUVERS, VENTS AND DUCTING ON METAL TO BRICK TRANSITIONS ON THE WEST AND EAST EXTERIOR ELEVATIONS OF THE TECHNOLOGY BUILDING AS SHOWN. SEE FLOOR PLAN CROSS-SECTIONS FOR APPROXIMATE LOCATIONS.
