March 23, 2017

RE: Air and Wipe Sampling in Select Areas – March 2017 – Update
Sky Valley Educational Center, 351 Short Columbia Street, Monroe, Washington

Attachment A

Site Photographs

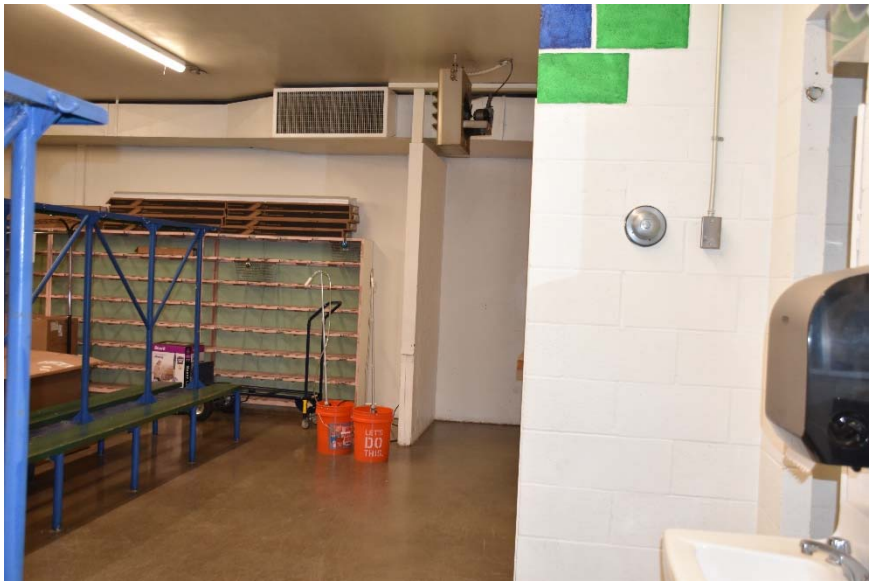
Sky Valley Education Center located at 351 Short Columbia Street in Monroe, Washington

View of the West Pod Mezzanine.

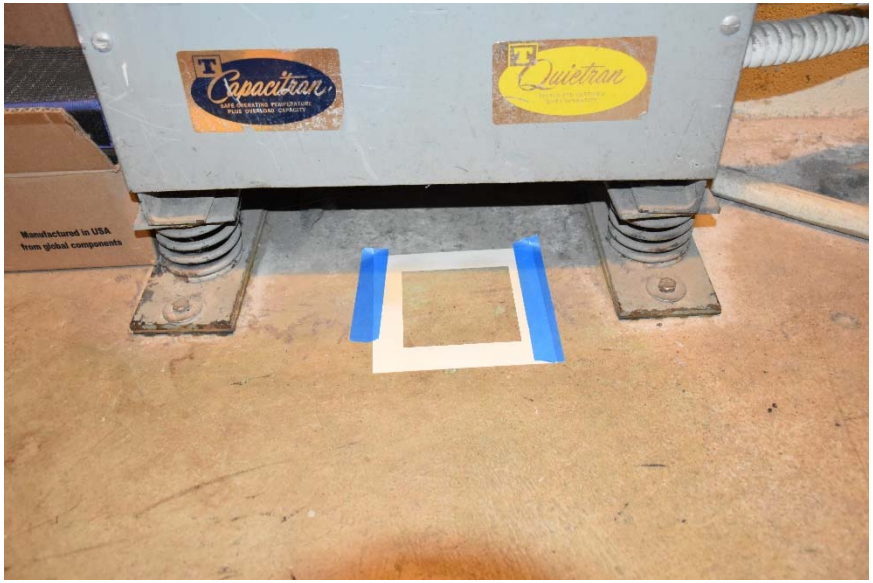
030617-11: Small Gym – Electrical Closet. Sample taken from side of transformer in an area where streaking was observed.

030617-12: Small Gym – Electrical Closet. Sample taken directly below transformer on electrical box.

030617-13: Large Gym – Electrical Closet. Sample taken from side of transformer in an area with discoloration.

030617-14: Large Gym – Electrical Closet. Sample taken directly beneath the transformer on the concrete floor. No staining was observed.

030617-15 & 030617-16: CTE Classroom – Electrical Room. Samples collected from the side of the transformer and directly below transformer on concrete floor.

030617-17: West Pod – Mezzanine. Sample collected on the wood flooring directly below the transformer. Slight staining was observed.

030617-18: West Pod – Mezzanine. Sample taken from side of transformer. No staining or streaking was observed.

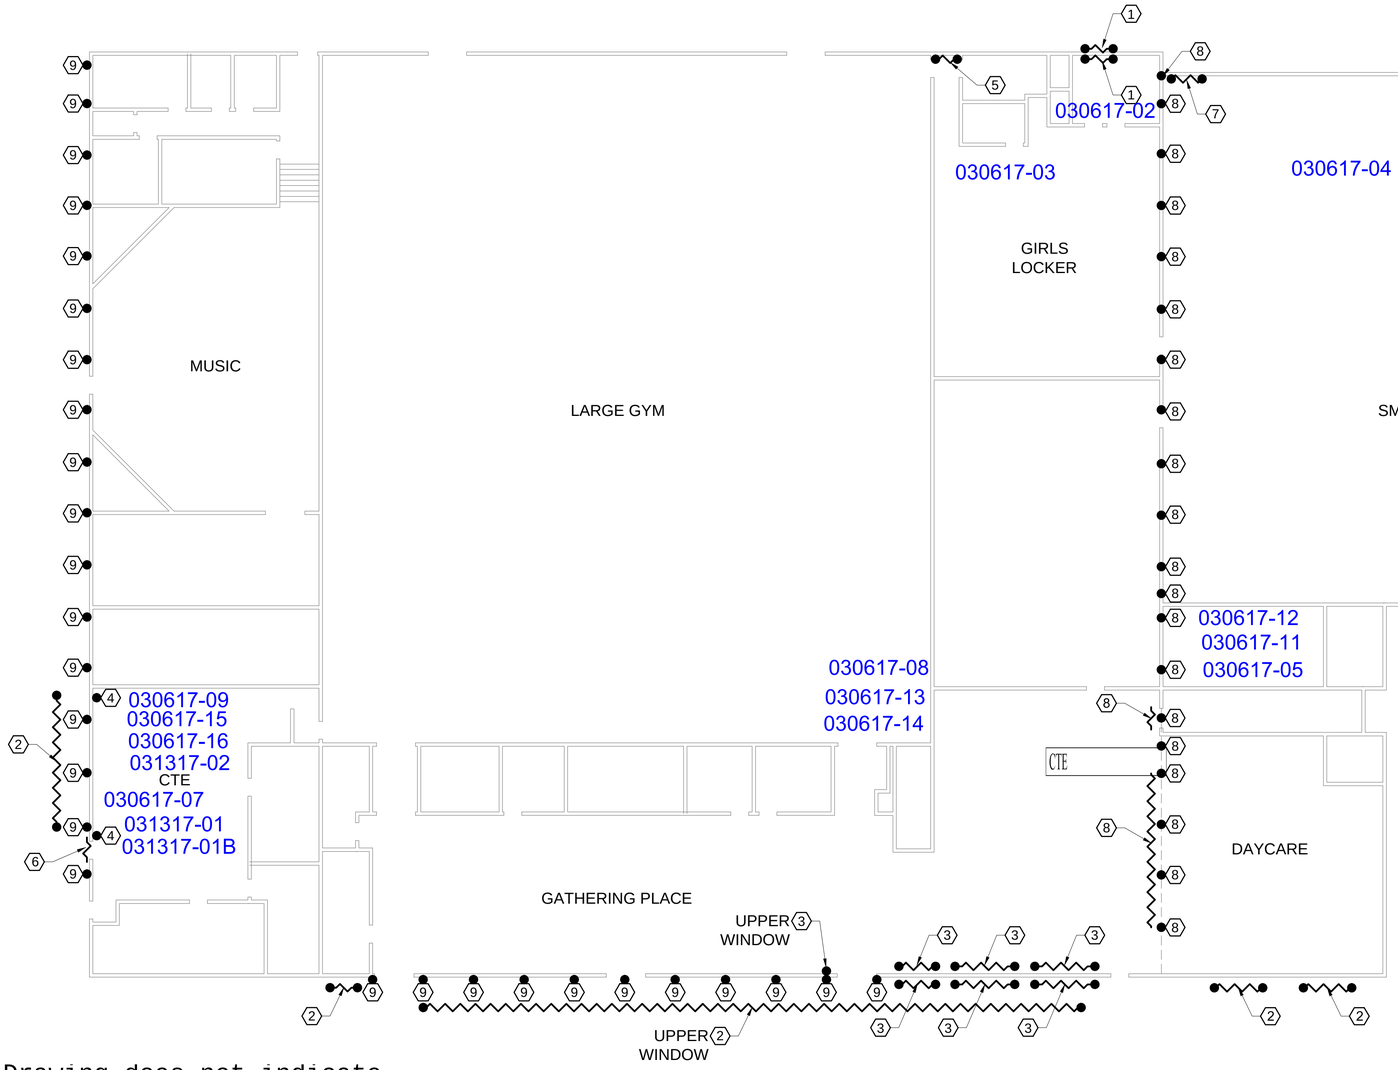
031317-02: CTE Classroom – Electrical Room.
