MERCURY SURVEILLANCE REPORT

Hunterdon Central Regional High School
11-12 Field House Gymnasium
9-10 Auxiliary Gymnasium
84 Route 31,
Flemington, New Jersey 08822

MONTROSE PROJECT NO. 1124-30

July 2023

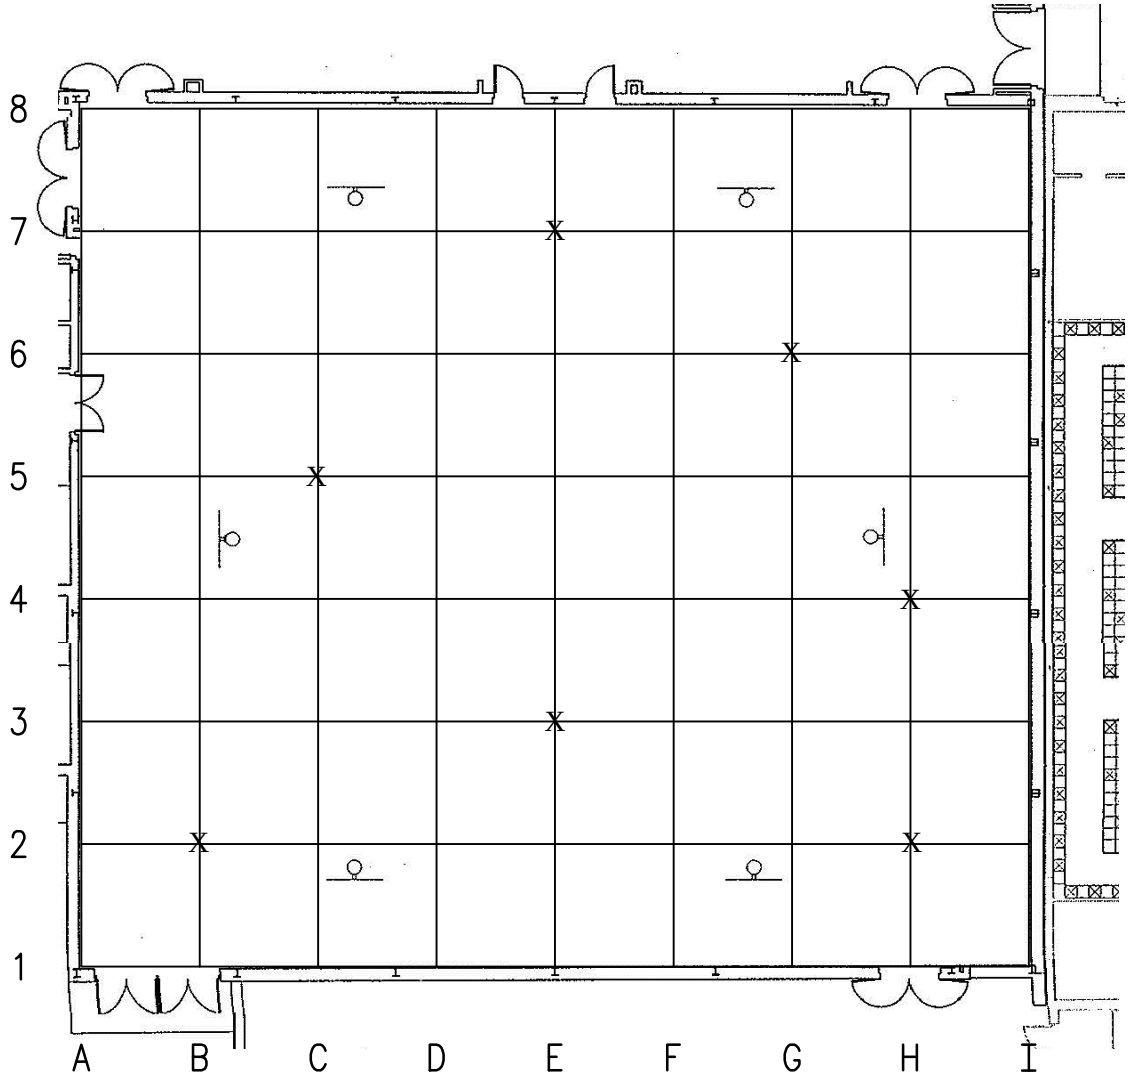
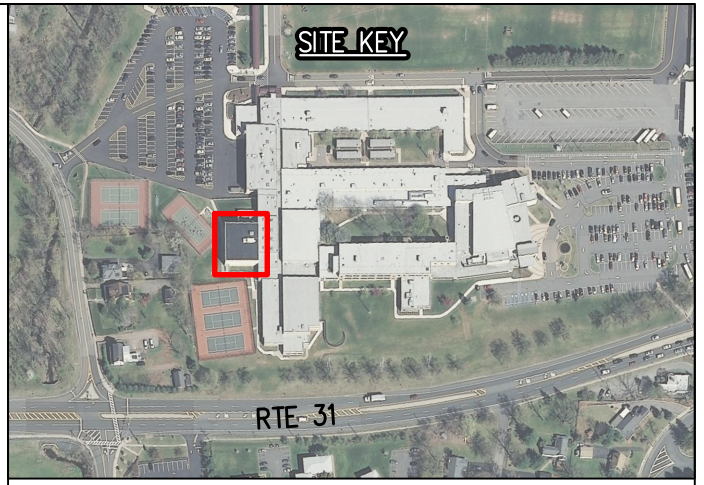
FIGURE 1
9-10 Auxiliary Gymnasium Sample Grid

9-10 Auxiliary Gymnasium				
6/23/2023	1	2B	0	0
6/23/2023	2	2H	0	0
6/23/2023	3	3E	0	0
6/23/2023	4	4H	0	0
6/23/2023	5	5C	0	0
6/23/2023	6	6G	100	0
6/23/2023	7	7E	100	100
	Average Reading		**28.57142857**	**14.28571429**
		Combined Average (Low & High Readings)		**21.42857143**

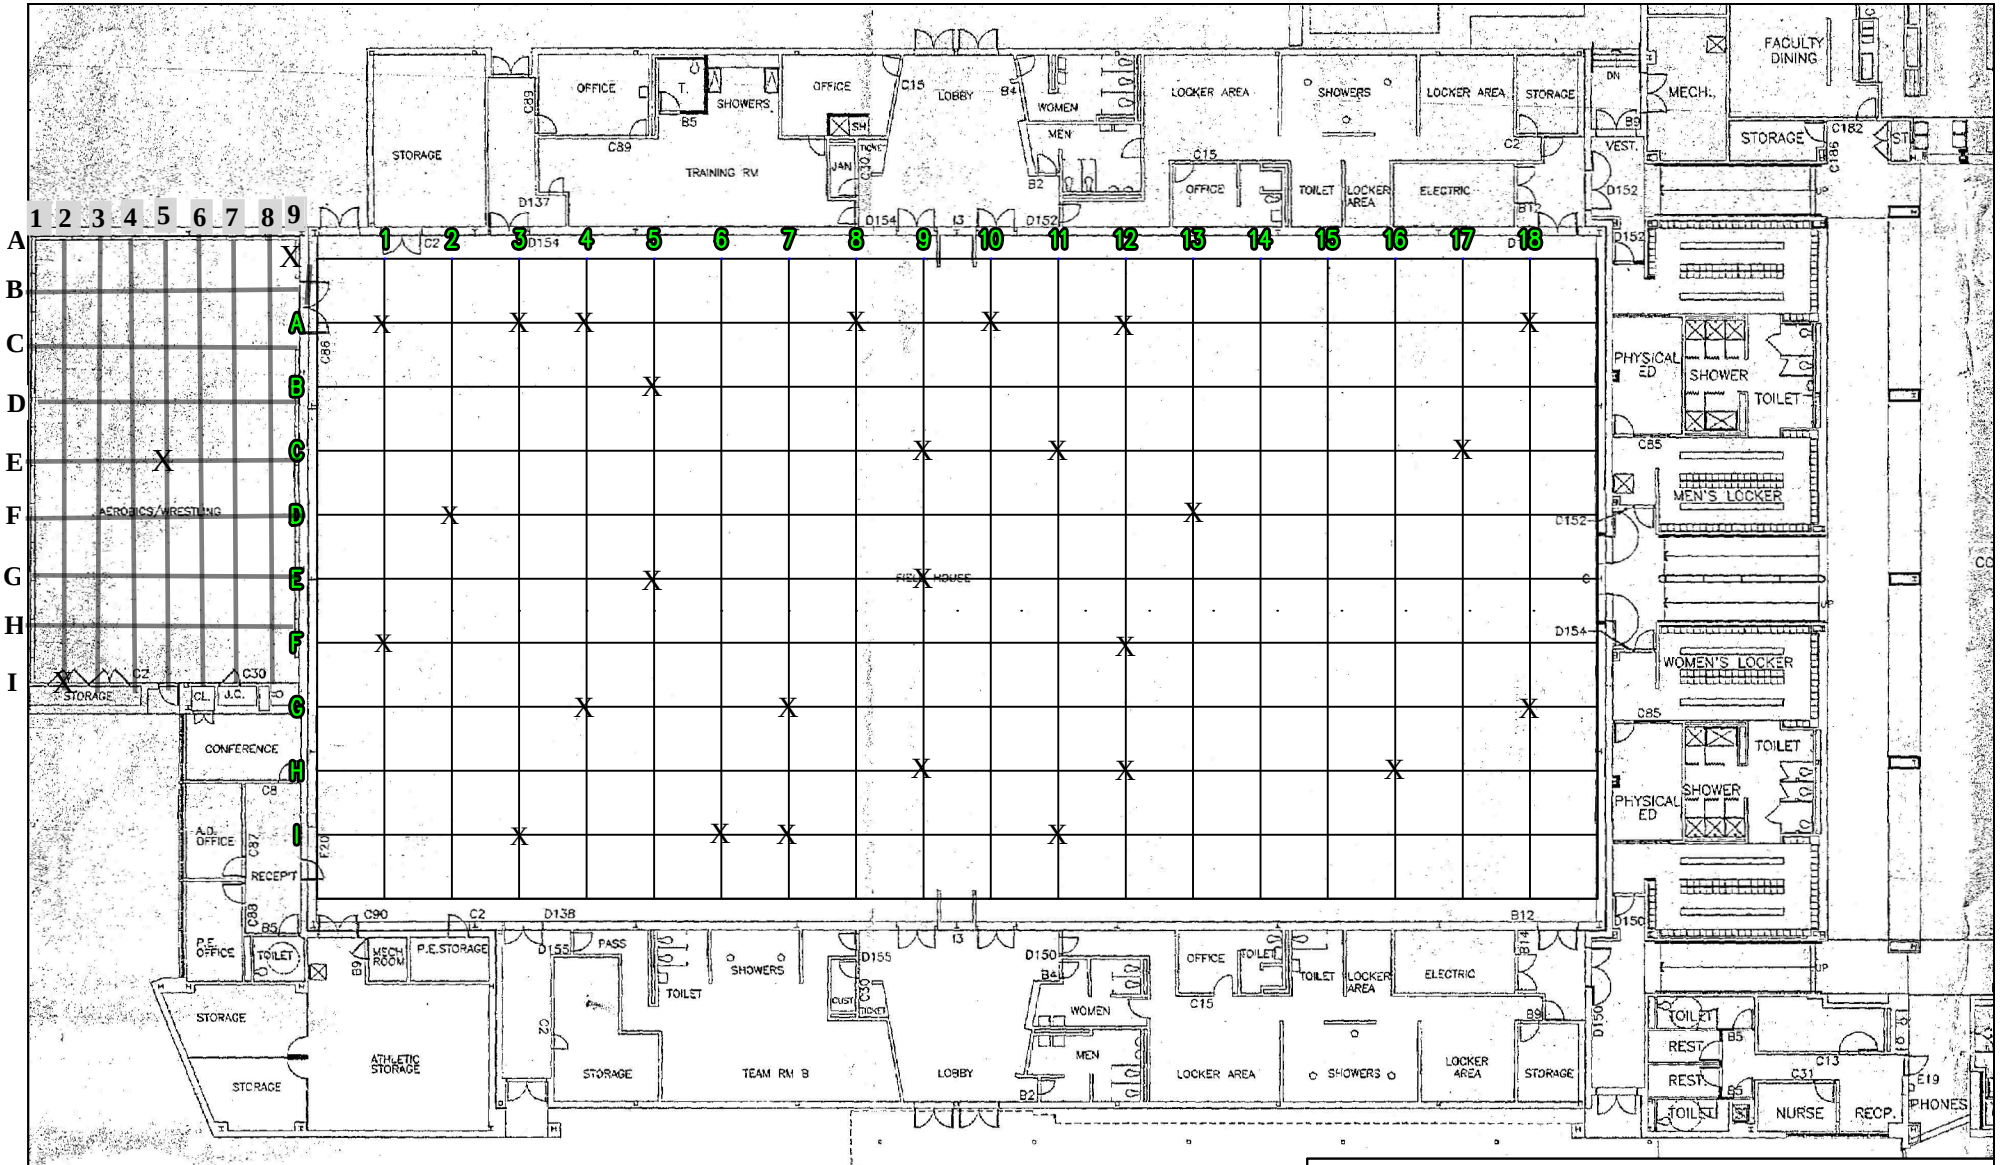
FIGURE 2
11-12 Field House Gymnasium Sample Grid

Date	Reading	Location on Grid	Low Reading (6" Off Floor)	High Reading (Waist Height)
11-12 Field House Gymnasium				
6/23/2023	1	1A	200	200
6/23/2023	2	1F	200	300
6/23/2023	3	2D	300	200
6/23/2023	4	3A	500	100
6/23/2023	5	3I	200	100
6/23/2023	6	4A	400	300
6/23/2023	7	4G	200	200
6/23/2023	8	5B	300	300
6/23/2023	9	5E	100	200
6/23/2023	10	6A	300	200
6/23/2023	11	7G	300	200
6/23/2023	12	7I	500	200
6/23/2023	13	8A	200	300
6/23/2023	14	9C	200	200
6/23/2023	15	9E	200	200
6/23/2023	16	9H	200	200
6/23/2023	17	10A	300	200
6/23/2023	18	11C	200	200
6/23/2023	19	11I	200	200
6/23/2023	20	12A	200	200
6/23/2023	21	12F	200	200
6/23/2023	22	12H	200	200
6/23/2023	23	13D	200	200
6/23/2023	24	16H	100	200
6/23/2023	25	17C	200	100
6/23/2023	26	18A	200	200
6/23/2023	27	18G	200	100
6/23/2023	28	Wrestling 2I	0	0
6/23/2023	29	Wrestling 5E	0	0
6/23/2023	30	Wrestling 9A	0	0
	Average Reading		**216.6666667**	**180**
		Combined Average (Low & High Readings)		**198.3333333**
