MERCURY SURVEILLANCE REPORT

Hunterdon Central Regional High School
11-12 Field House Gymnasium
9-10 Auxiliary Gymnasium
84 Route 31,
Flemington, New Jersey 08822

MONTROSE PROJECT NO. 1124-37

August 2024

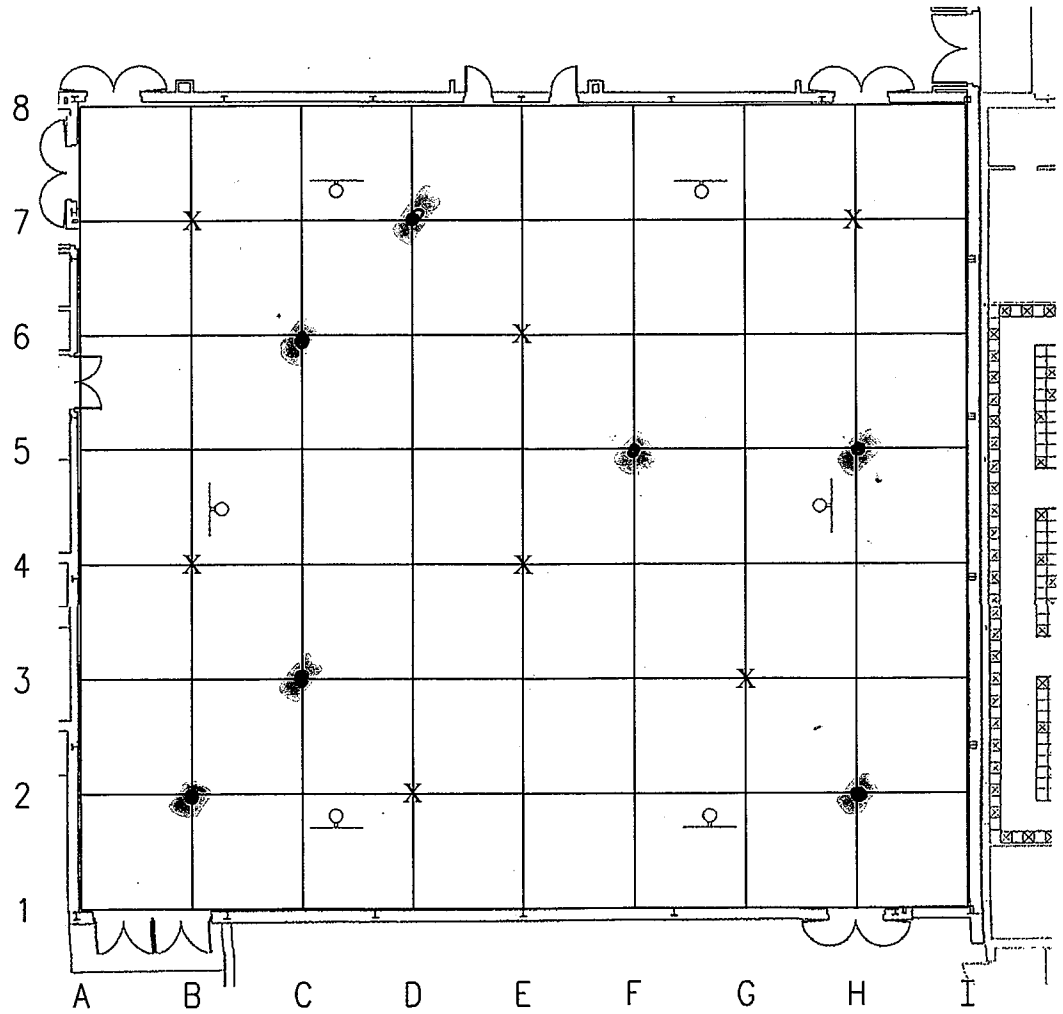
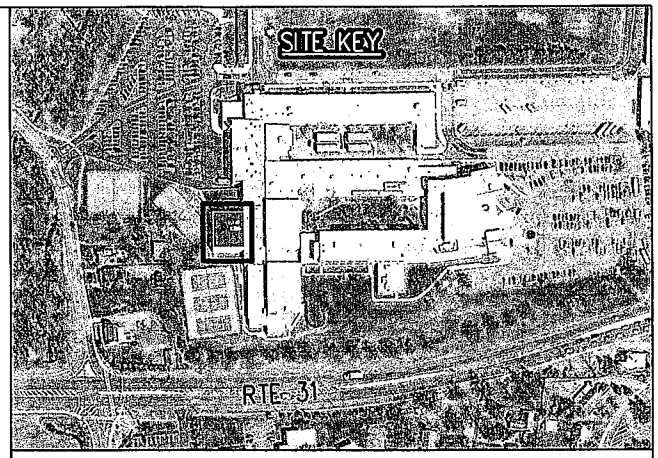
FIGURE 1
9-10 Auxiliary Gymnasium Sample Grid

9-10 Auxiliary Gymnasium				
8/16/2024	1	2B	0	0
8/16/2024	2	2H	0	0
8/16/2024	3	3C	0	30
8/16/2024	4	5F	0	30
8/16/2024	5	5H	20	0
8/16/2024	6	6C	0	0
8/16/2024	7	7D	0	0
	Average Reading		**2.857142857**	**8.571428571**
			Combined Average (Low & High Readings)	**5.714285714**

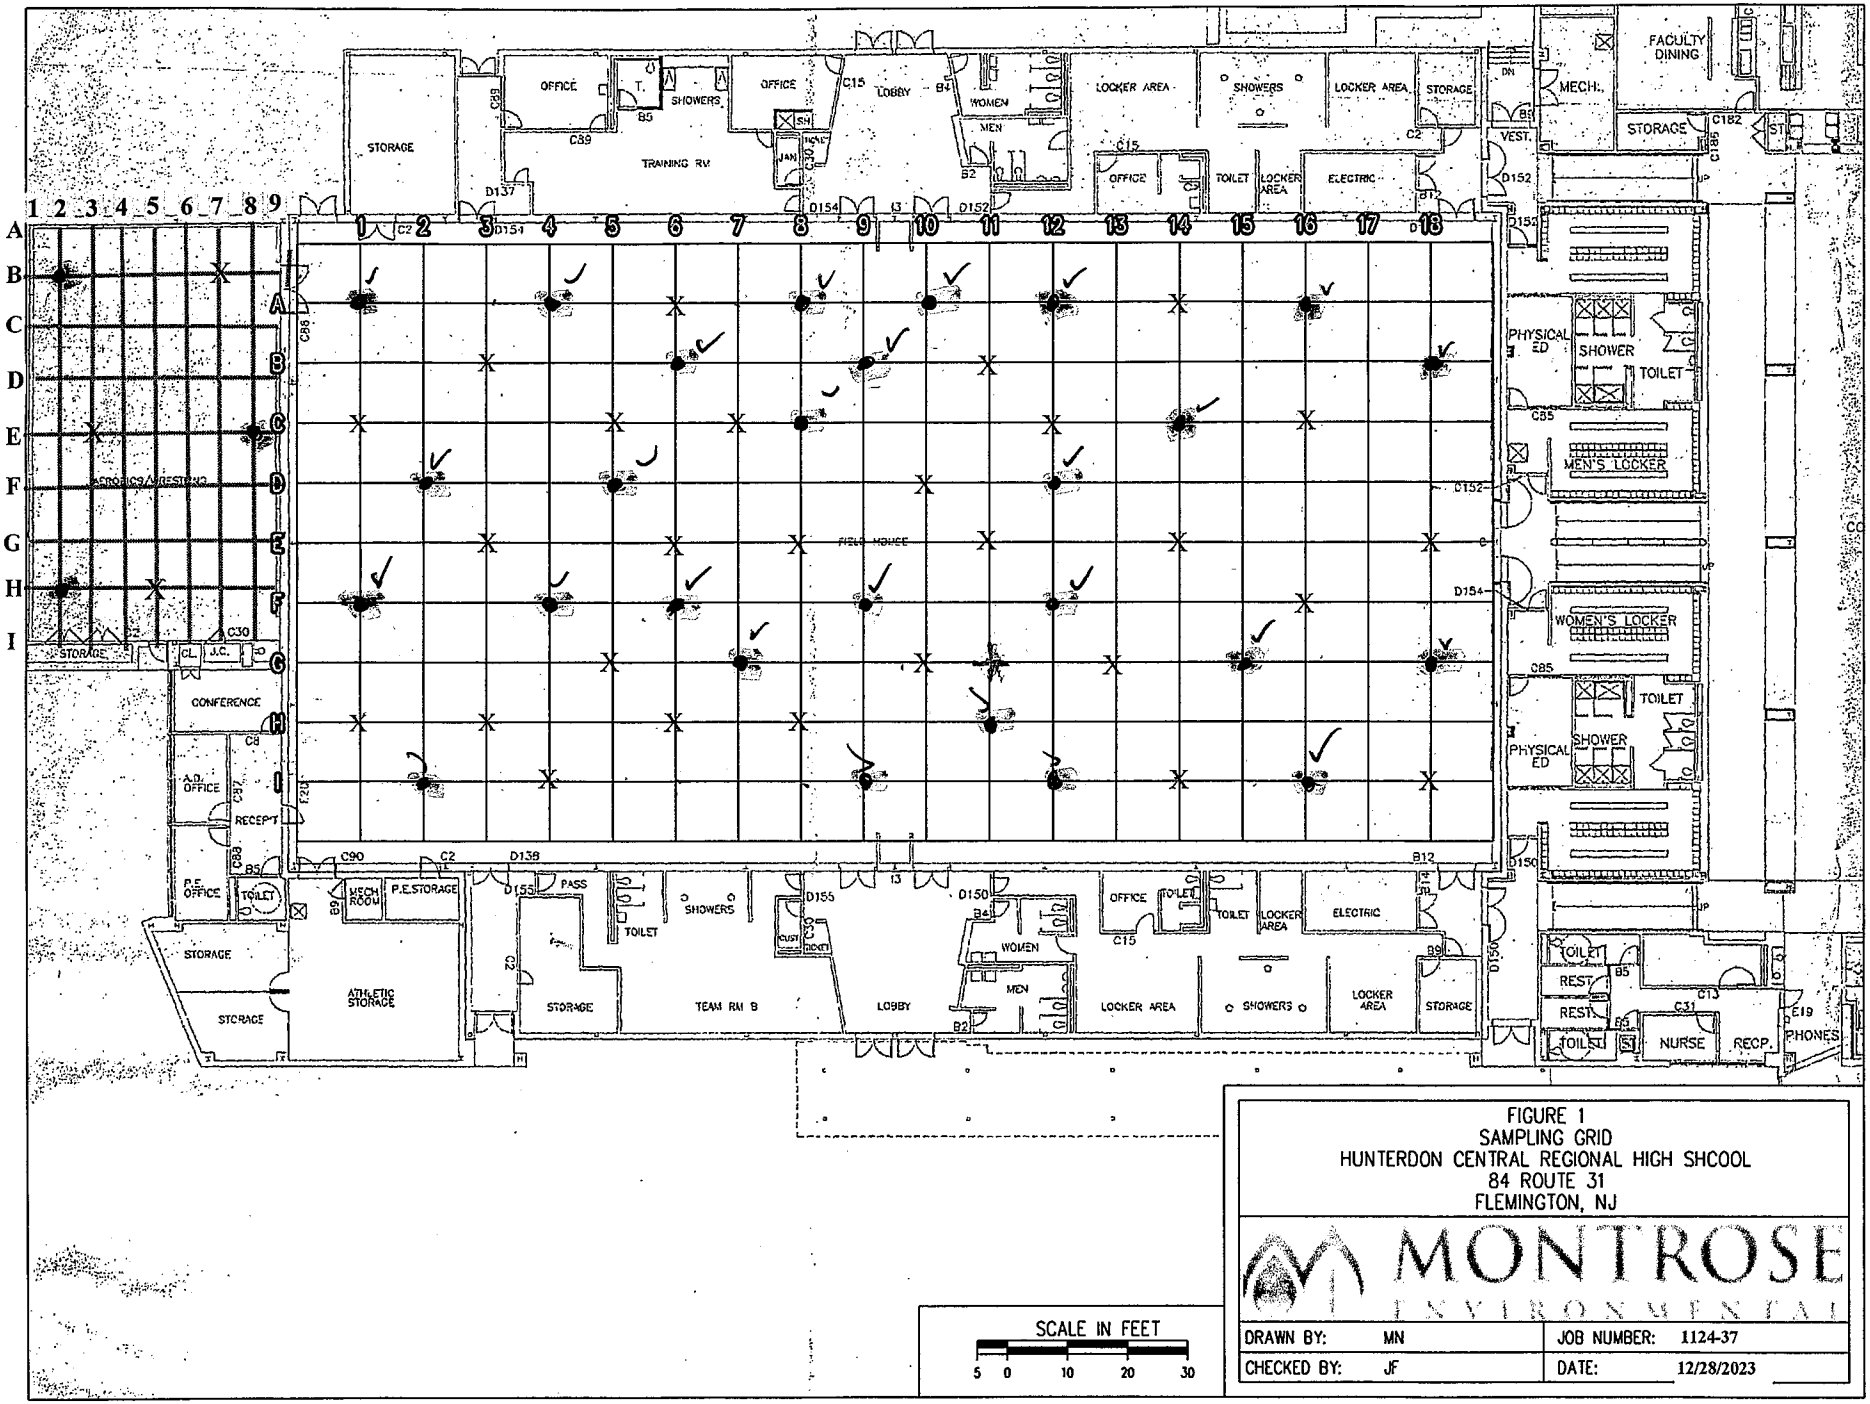
FIGURE 2
11-12 Field House Gymnasium Sample Grid

Date	Reading	Location on Grid	Low Reading (6" Off Floor)	High Reading (Waist Height)
11-12 Field House Gymnasium				
8/16/2024	1	1A	0	100
8/16/2024	2	1F	200	100
8/16/2024	3	2D	100	200
8/16/2024	4	2I	100	200
8/16/2024	5	4A	200	0
8/16/2024	6	4F	200	100
8/16/2024	7	5D	500	200
8/16/2024	8	6B	200	100
8/16/2024	9	6F	300	0
8/16/2024	10	7G	100	100
8/16/2024	11	8A	200	100
8/16/2024	12	8C	200	200
8/16/2024	13	9B	400	200
8/16/2024	14	9F	100	100
8/16/2024	15	9i	100	200
8/16/2024	16	10A	100	100
8/16/2024	17	11H	200	200
8/16/2024	18	12A	200	100
8/16/2024	19	12D	100	200
8/16/2024	20	12F	100	200
8/16/2024	21	12i	200	200
8/16/2024	22	14C	0	200
8/16/2024	23	15G	100	200
8/16/2024	24	16A	100	200
8/16/2024	25	18B	200	100
8/16/2024	26	18G	200	100
8/16/2024	27	16i	300	100
8/16/2024	28	Wrestling 2B	0	0
8/16/2024	29	Wrestling 2H	0	0
8/16/2024	30	Wrestling 8E	0	0
	Average Reading		**156.6666667**	**126.6666667**
			Combined Average (Low & High Readings)	**141.667**
