July 2, 2024

North Kansas City School District
2000 Northeast 46th Street
Kansas City, Missouri 64116

Project: Limited Lead in Drinking Water Testing
Address: 3000 Northeast 108th Street, Kansas City, Missouri 64156

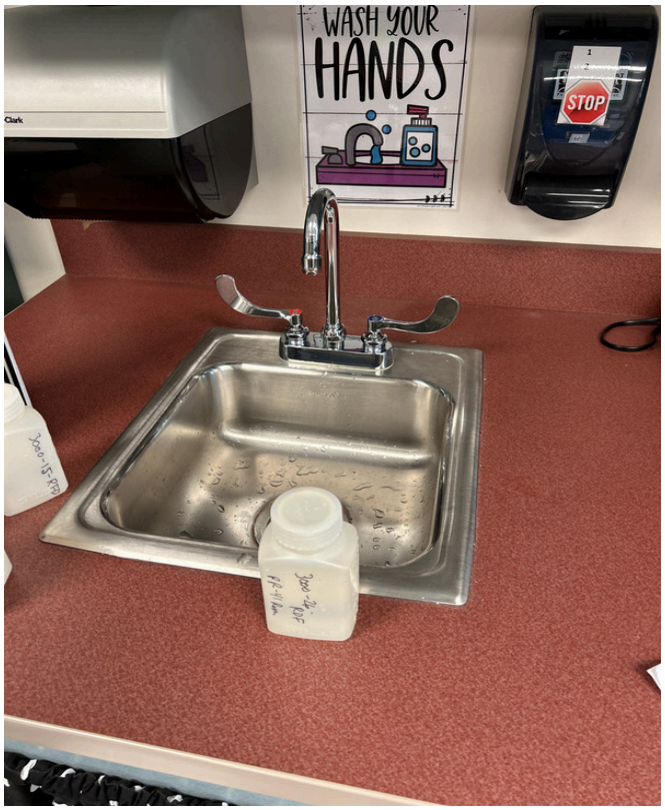
5/29/2024 - 3000-26 - Bell Prairie Elementary School - PR41

Sample #	Location	Source Under Test	Test Type	Lead Result (ppb)
3000-26-RDF	Bell Prairie Elementary School - PR41	Sink Tap	Retest - First Draw	1.4
3000-25-RDF	Bell Prairie Elementary School - PR40	Sink Tap	Retest - First Draw	7.9
3000-15-RDF	Bell Prairie Elementary School - PR28	Sink Tap	Retest - First Draw	5.3
3000-49-RDF	Bell Prairie Elementary School - IN98	Sink Tap	Retest - First Draw	0.8
3000-30-RDF	Bell Prairie Elementary School - IN76	Sink Tap	Retest - First Draw	22.2

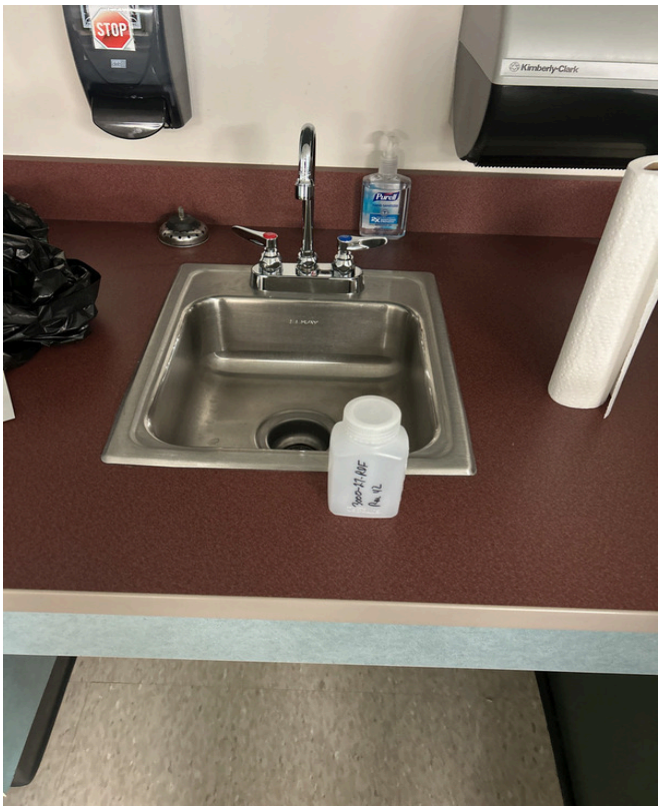
5/30/2024 - 3000-27 - Belle Prairie Elementary - Classroom 42

Sample #	Location	Source Under Test	Test Type	Lead Result (ppb)
3000-27-RDF	Belle Prairie Elementary - Classroom 42	Sink Tap	Retest - First Draw	<0.4

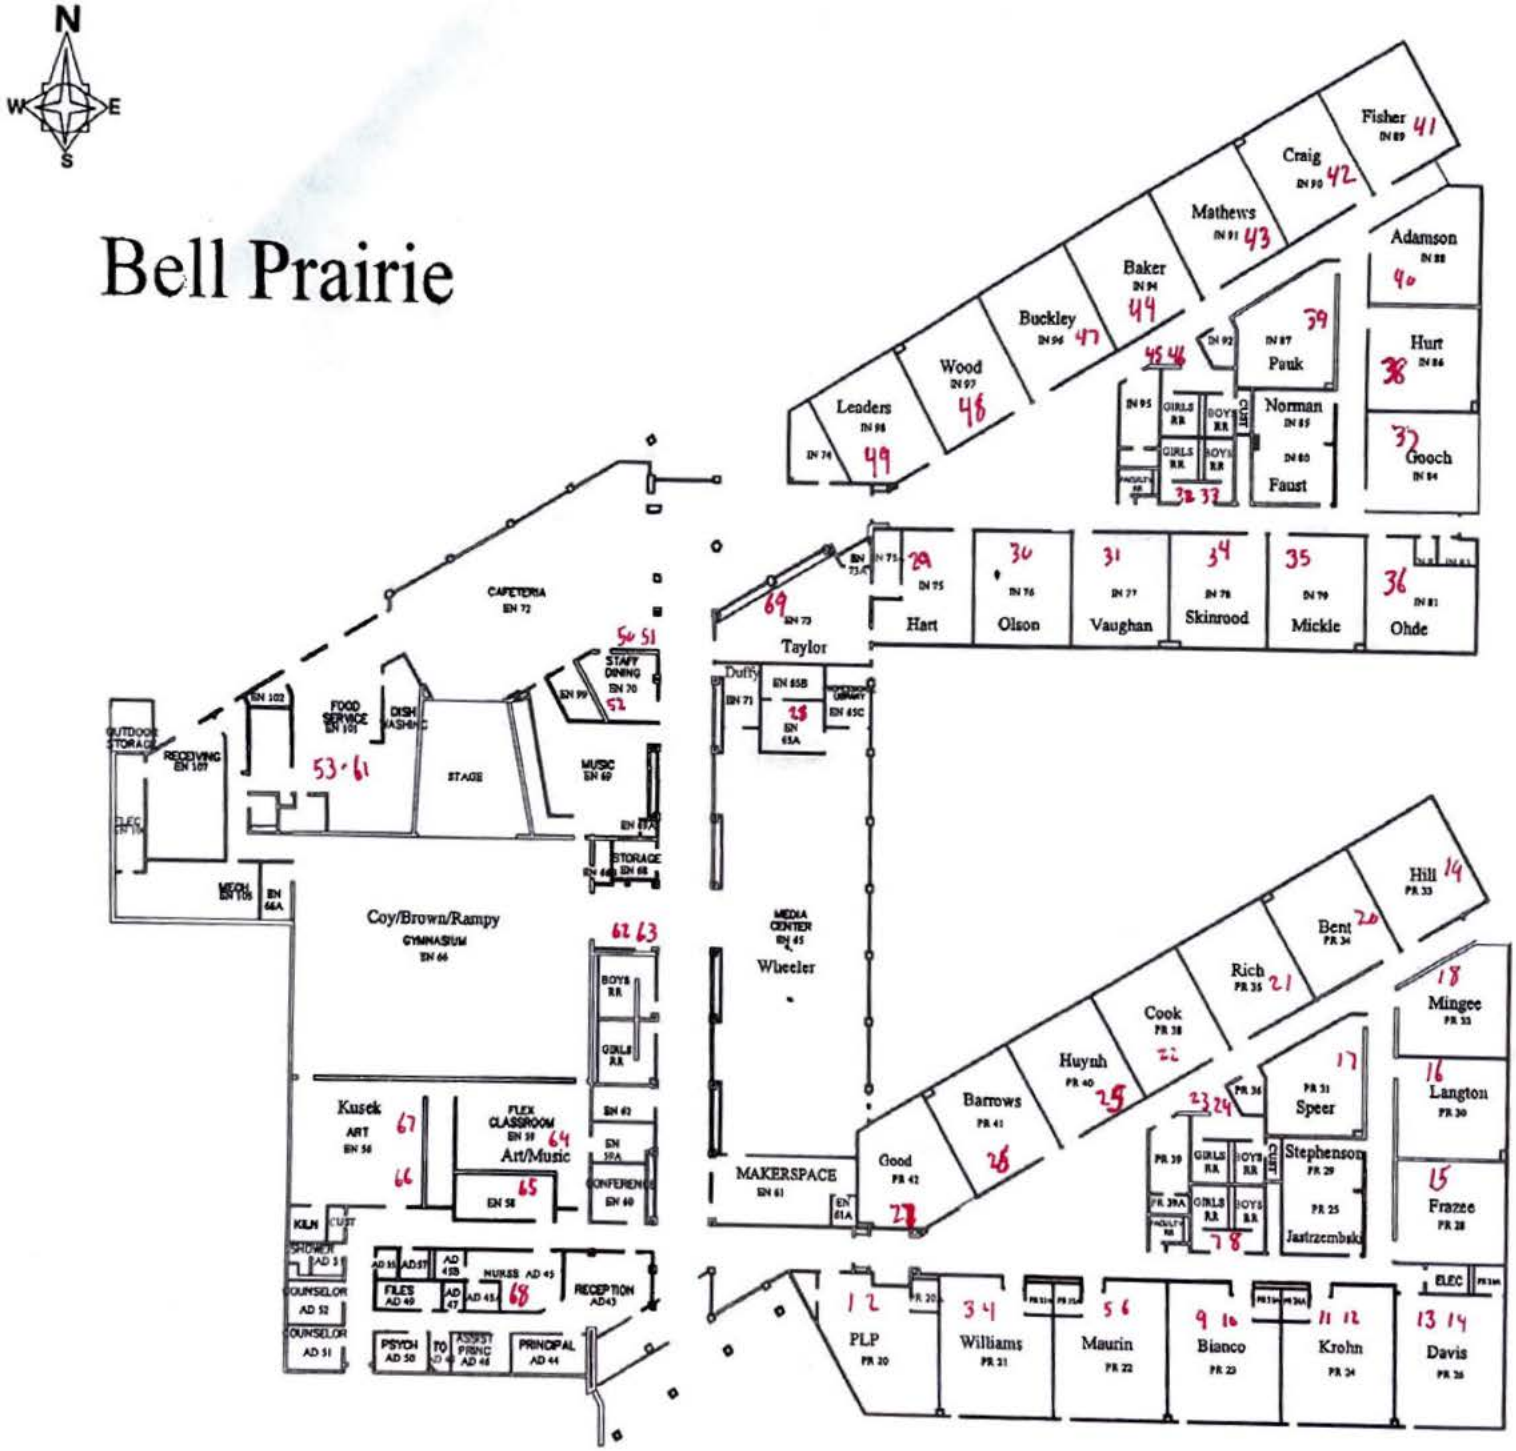
Appendix E
Source Identification Diagram

ASP was provided sample locations by
North Kansas City School District
