July 3, 2024

North Kansas City School District
2000 Northeast 46th Street
Kansas City, Missouri 64116

Project: Limited Lead in Drinking Water Testing
Address: 8100 North Troost Avenue, Kansas City, Missouri 64118

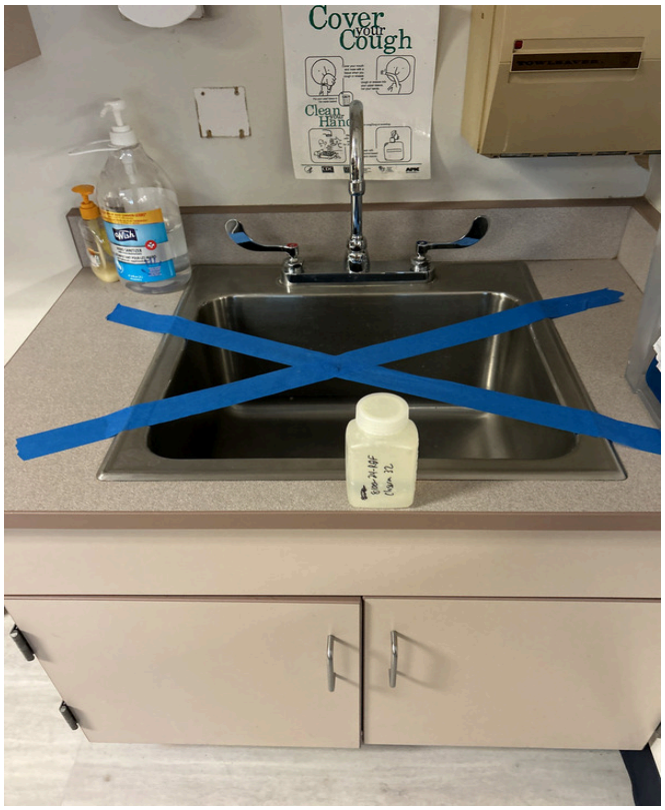
5/29/2024 - 8100-21 - Clardy Elementary - Classroom 35

Sample #	Location	Source Under Test	Test Type	Lead Result (ppb)
8100-41-RDF	Clardy Elementary - Kitchen	Pot Filler	Retest - First Draw	24.8
8100-20-RDF	Clardy Elementary - Classroom 30	Sink Tap	Retest - First Draw	0.7
8100-21-RDF	Clardy Elementary - Classroom 35	Sink Tap	Retest - First Draw	1.2
8100-24-RDF	Clardy Elementary - Classroom 32	Sink Tap	Retest - First Draw	2.1
8100-25-RDF	Clardy Elementary - Classroom 33	Sink Tap	Retest - First Draw	0.8
