August 29, 2024

North Kansas City School District
2000 Northeast 46th Street
Kansas City, Missouri 64116

Project: Limited Lead in Drinking Water Testing
Address: 3100 Northeast 46th Street, Kansas City, Missouri 64117

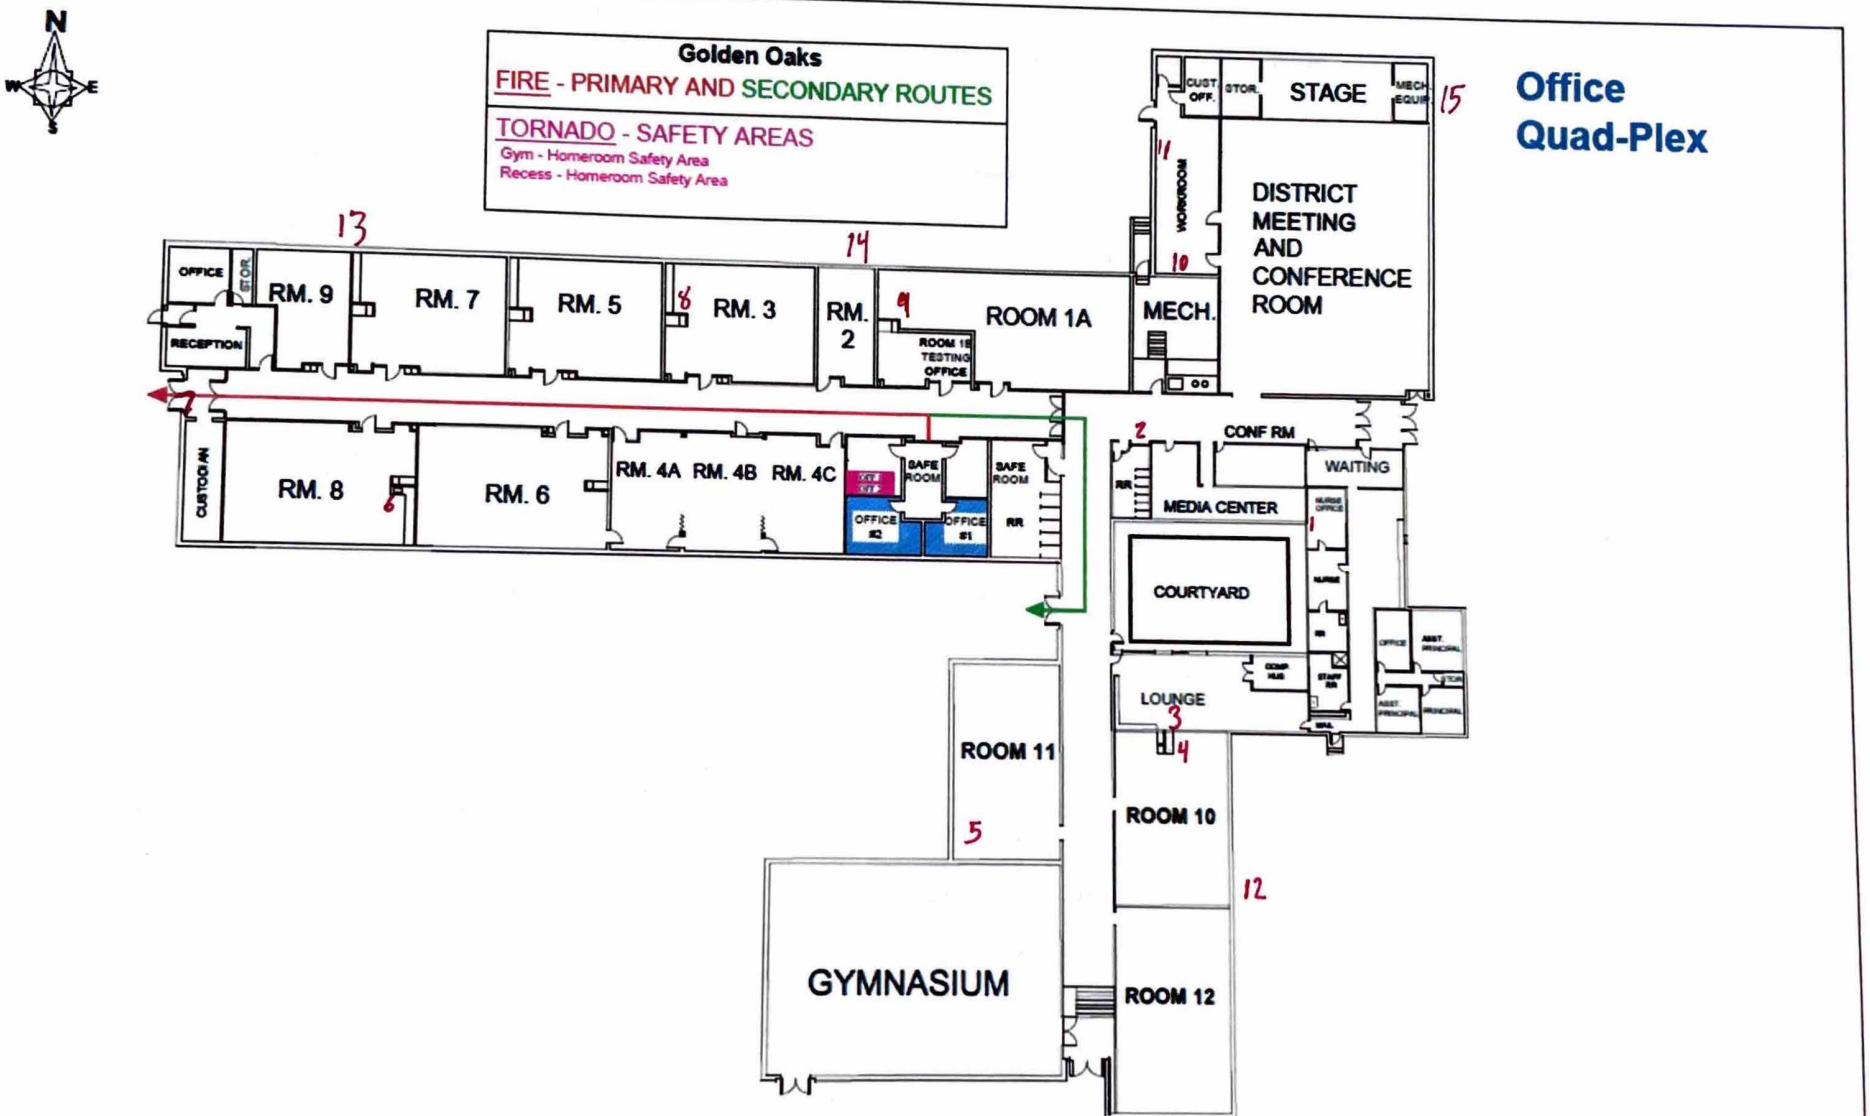
Appendix E
Source Identification Diagram

ASP was provided sample locations by
North Kansas City School District
