July 18, 2024

Project: Limited Lead in Drinking Water Testing
Address: 620 East 23rd Avenue, North Kansas City, Missouri 64116

May 30, 2024 Water Sampling Results:

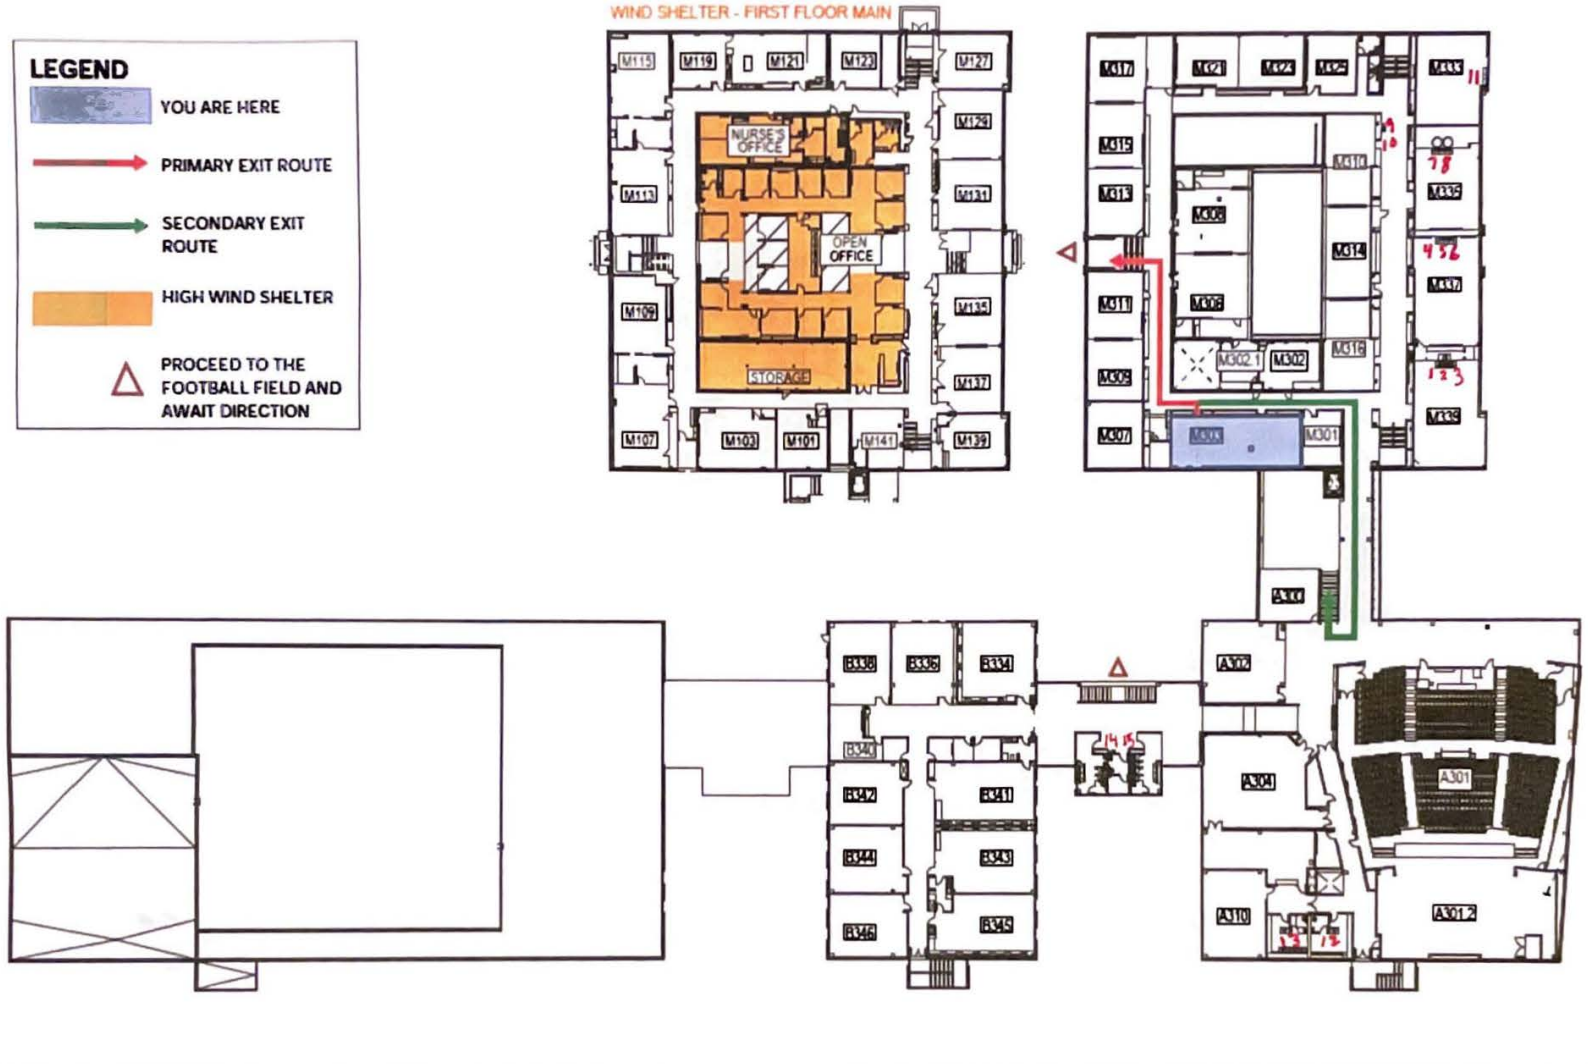
NKCSD	NORTH KANSAS CITY SCHOOLS BUILDING PLAN	M303	
		Architect bnim	By bnim

ASP was provided sample locations by
North Kansas City School District
