January 17, 2025

Project: Limited Lead in Drinking Water Testing
Address: 2601 Howell Street, North Kansas City, Missouri 64116

Appendix D
Photo Log

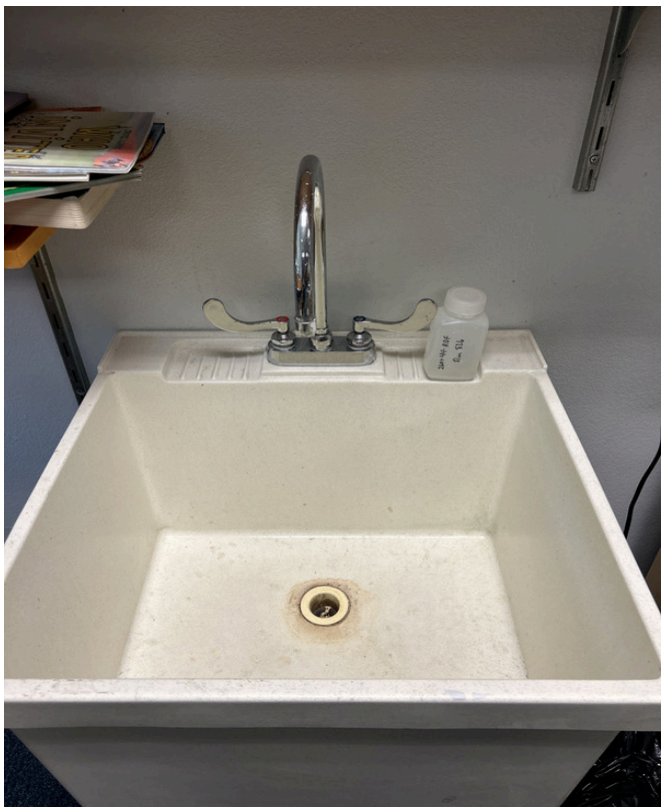
5/30/2024 - 2601-40 - Norclay Building - Room 828 - North Sink

Sample #	Location	Source Under Test	Test Type	Lead Result (ppb)
2601-39-RDF	Norclay Building - Room 828 - Southwest Sink	Sink Tap	Retest - First Draw	14.2
2601-40-RDF	Norclay Building - Room 828 - North Sink	Sink Tap	Retest - First Draw	9.8
2601-44-RDF	Norclay Building - Room 826	Sink Tap	Retest - First Draw	12.2

Sample #	Location	Source Under Test	Test Type	Lead Result (ppb)
2601-39-RDF	Norclay Building - Room 828-Southwest Sink	Sink Tap	Retest - First Draw	16.8
2601-40-RDF	Norclay Building - Room 828-North Sink	Sink Tap	Retest - First Draw	2.6
2601-44-RDF	Norclay Building - Room 826	Sink Tap	Retest - First Draw	63.9

- Per the State of Missouri Senate Bills Nos. 681 & 662, a remediation plan should be developed and executed.
- Take immediate steps to prevent use from the failed source(s).

- Shut-off problem outlets
- Post “Not for Drinking/Cooking” at Problem Outlets. If initial sample results from an outlet(s) exceed the remediation trigger level, but are not routinely used for human ingestion (e.g., handwashing), clear signage can be posted to notify people that the outlet is not to be used for drinking or cooking until the problem is resolved.

- Consider performing follow-up flush testing in order to attempt to identify what component within the system is the source of the elevated lead concentration. This testing will assist to pinpoint where lead is getting into drinking water (i.e., fixtures versus interior plumbing) so that appropriate corrective measures can be taken.

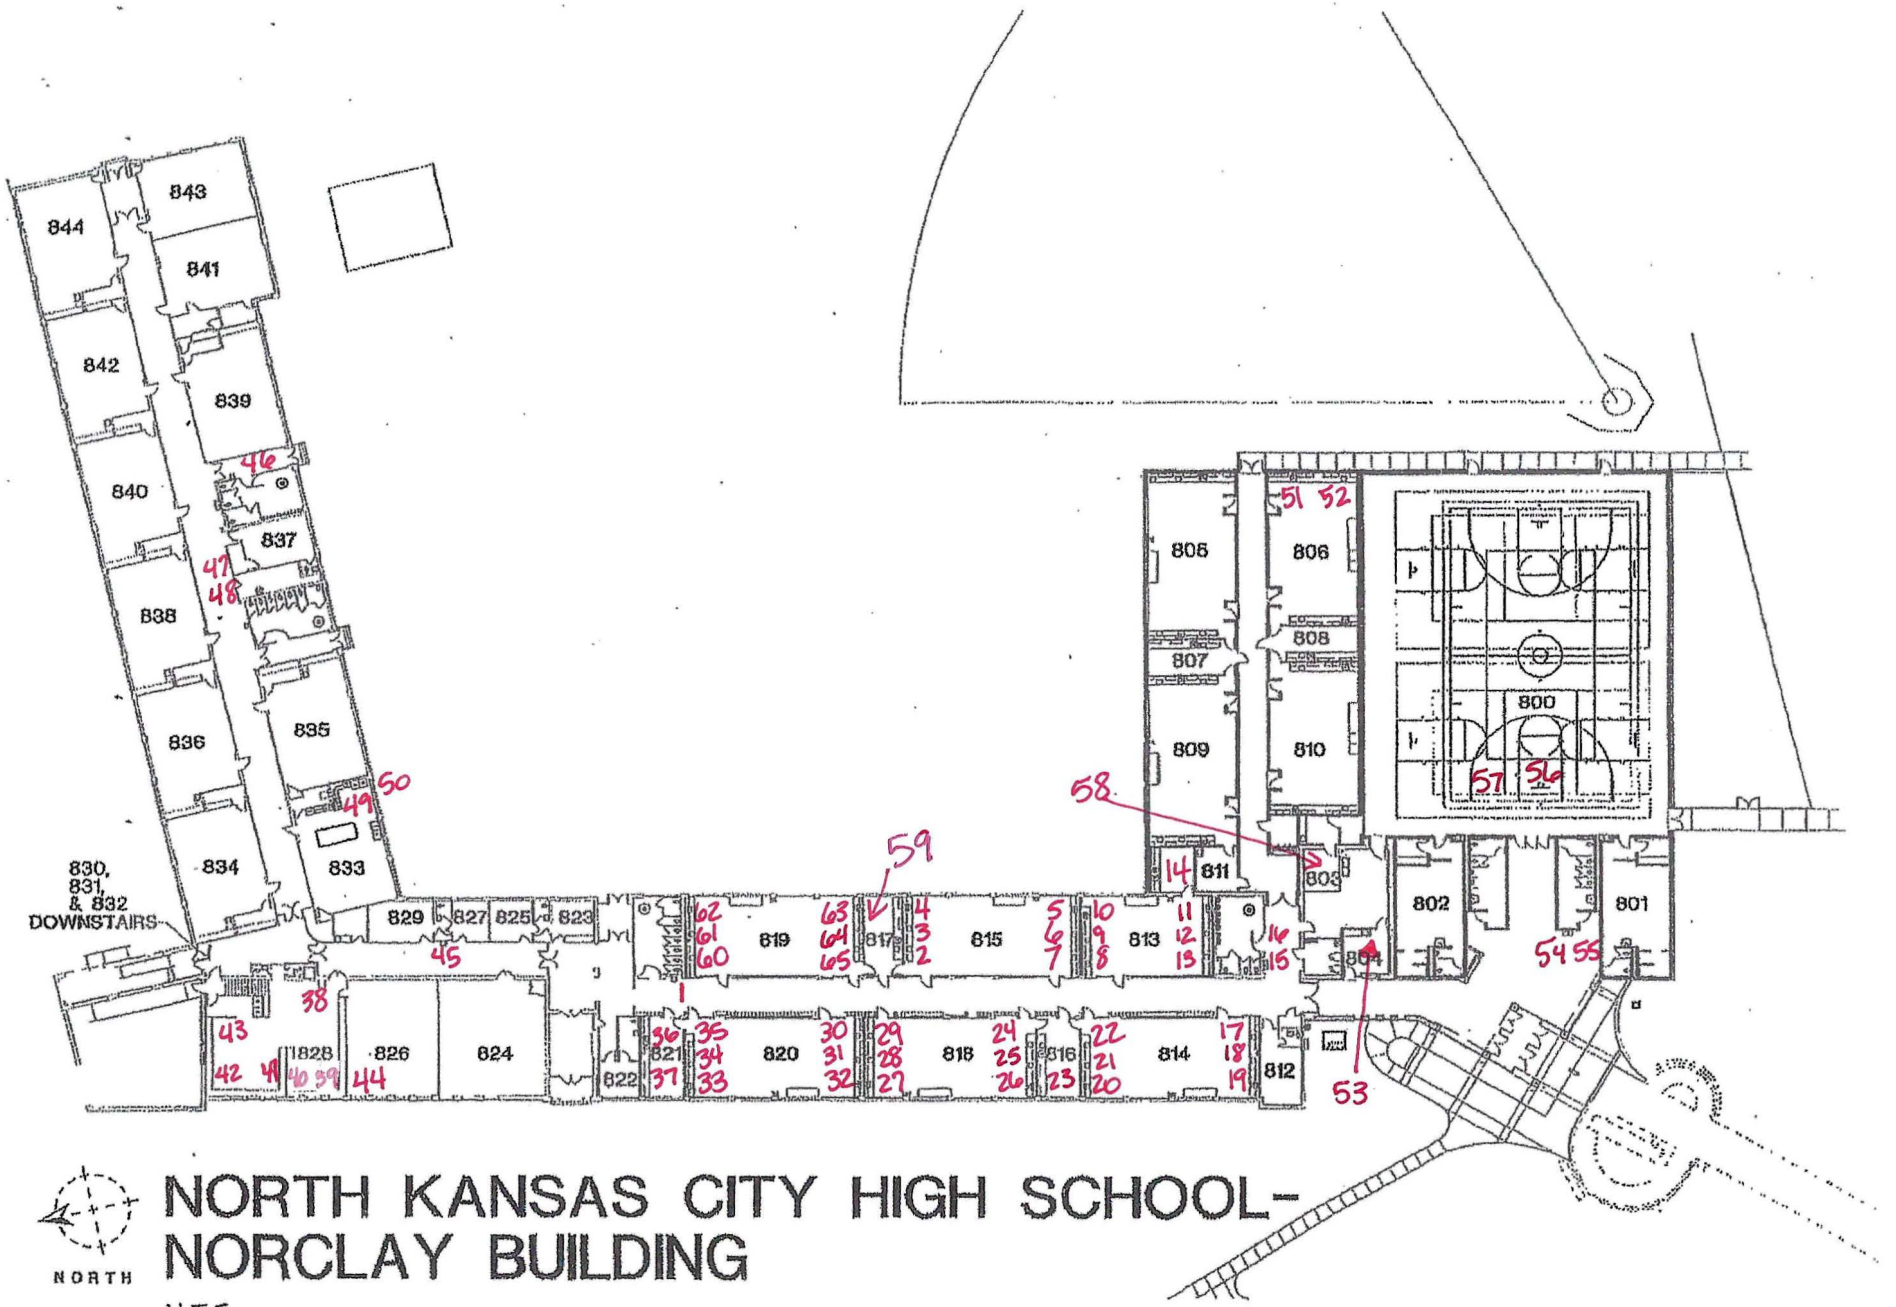
NORTH KANSAS CITY HIGH SCHOOL-
NORCLAY BUILDING

Appendix E
Source Identification Diagram

ASP was provided sample locations by
North Kansas City School District
