August 14, 2024

Project: Limited Lead in Drinking Water Testing
Address: 10601 East 59th Street, Kansas City, Missouri 64133

July 8, 2024 Water Sampling Results:

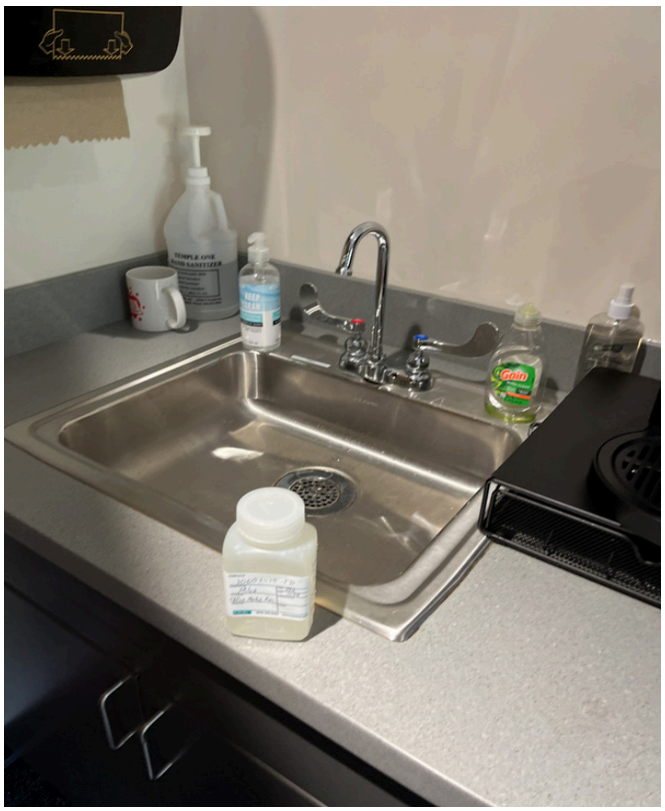
7/8/2024 - 10601-15 - Raytown Central Middle - Office Meeting Room

Determination of Total Metals	Result	RL	Units	DF	Note	Prepared	Analyzed	Analyst
200.8								
Lead, total	**1.0**	0.4	ppb	2		08/05/24 1620	08/06/24 1439	RVV

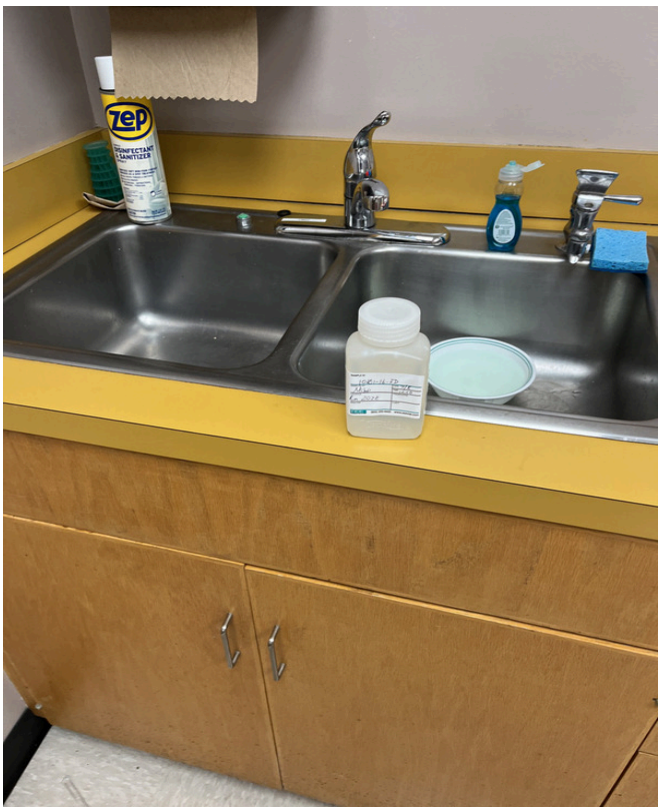
7/8/2024 - 10601-16 - Raytown Central Middle - Room 202E

Determination of Total Metals	Result	RL	Units	DF	Note	Prepared	Analyzed	Analyst
200.8								
Lead, total	**2.8**	0.4	ppb	2		08/05/24 1620	08/06/24 1442	RVV

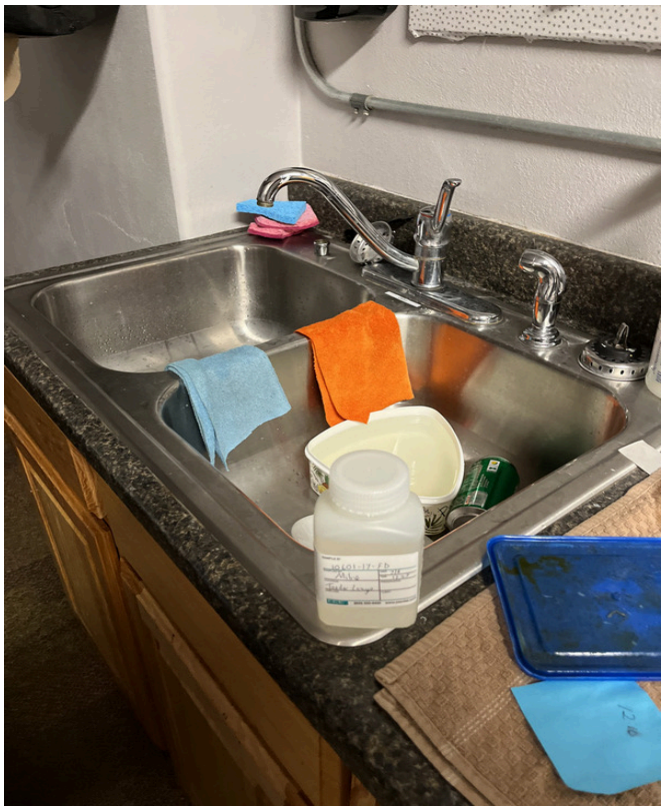
7/8/2024 - 10601-17 - Raytown Central Middle - Teacher's Lounge

Determination of Total Metals	Result	RL	Units	DF	Note	Prepared	Analyzed	Analyst
200.8								
Lead, total	**0.6**	0.4	ppb	2		08/05/24 1620	08/06/24 1445	RVV
