May 31, 2024

Project: Limited Lead in Drinking Water Testing
Address: 1138 Southview Drive, Liberty, Missouri 64068

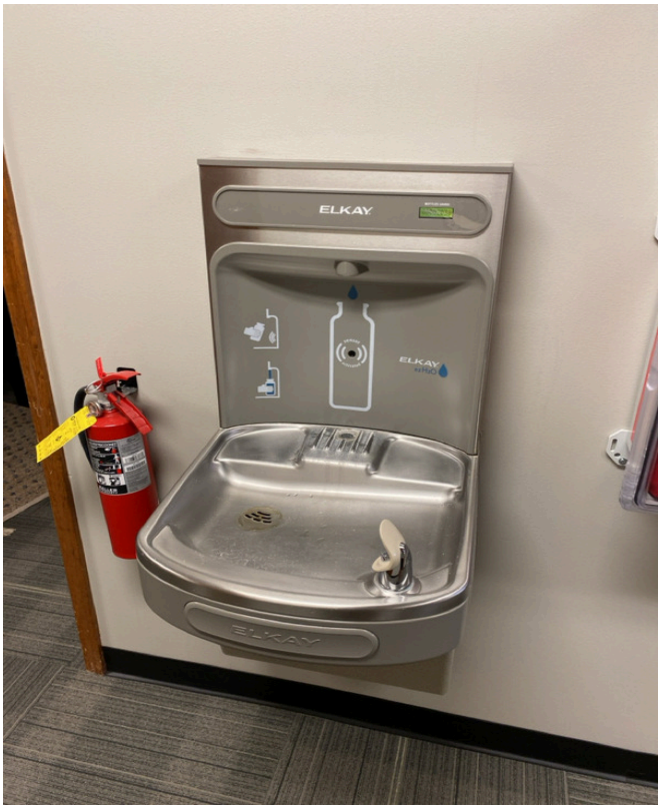
4/9/2024 - 1138-1 - Facilities Center - 004072B- Main Lobby

Sample #	Location	Source Under Test	Test Type	Lead Result (ppb)
1138-1-FD	Facilities Center - 004072B-Main Lobby	Drinking Fountain	First Draw	<0.4
1138-2-FD	Facilities Center - 004072F-Main Lobby	Bottle Filler	First Draw	<0.4
1138-3-FD	Facilities Center - 004070-Main Lobby- Boys Restroom	Sink Tap	First Draw	<0.4
1138-4-FD	Facilities Center - 004071-Main Lobby-Girls Restroom	Sink Tap	First Draw	<0.4
1138-5-FD	Facilities Center - 004069-Conference Room-Restroom	Sink Tap	First Draw	<0.4
1138-6-FD	Facilities Center - 000947-L-Break Room	Ice Machine	First Draw	<0.4
1138-7-FD	Facilities Center - 004068-Break Room	Sink Tap	First Draw	<0.4
