MEMORANDUM

DATE	March 17, 2025
TO	Shawn Woodward, Superintendent, Monroe School District Adam Denney, Director of Facilities, Monroe School District
FROM	Tarell Manjarrez, Fulcrum Environmental Consulting, Inc. Ryan K. Mathews, CIH, CHMM, Fulcrum Environmental Consulting, Inc.
RE	Sky Valley Education Center, 351 Short Columbia Street, Monroe, Washington EPA ID: WAH000051422
SUBJECT	**Localized Epoxy Repairs – March 2025**

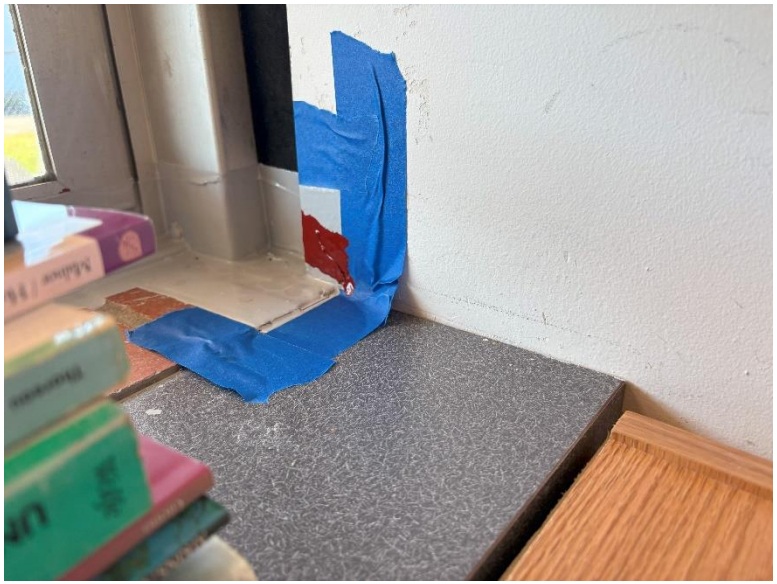
Annex E East

A 2-inch crack and a 1-inch crack were coated with the Sikaguard 62 red epoxy base layer.

After allowing sufficient time for the red base layer to dry, a second layer of Sikaguard 62 gray epoxy covering layer was applied.

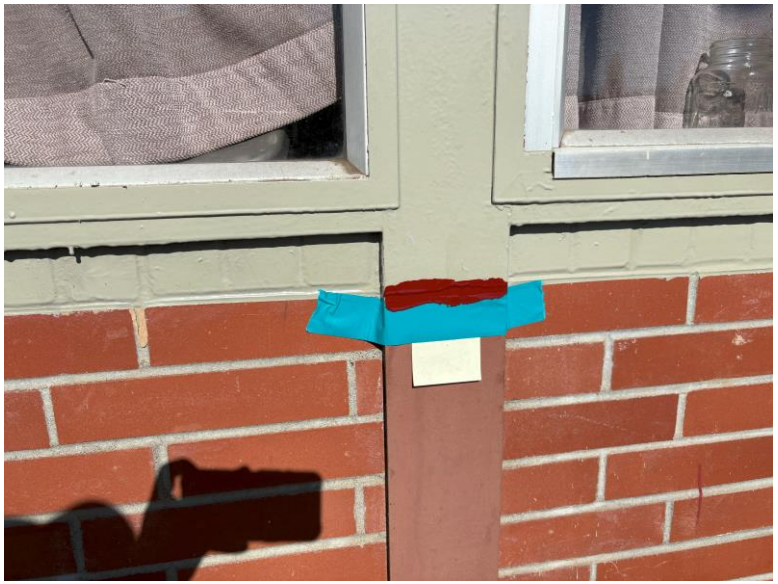
Annex E South Exterior

Two ½-inch cracks were coated with the Sikaguard 62 red epoxy base layer.

After allowing sufficient time for the red base layer to dry, a second layer of Sikaguard 62 gray epoxy covering layer was applied.

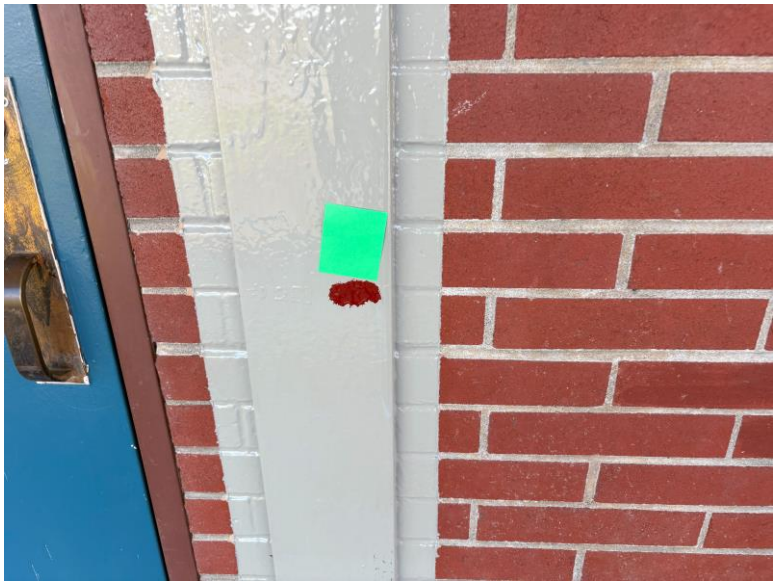
Annex Girl's Restroom South Exterior

A ½-inch crack was coated with the Sikaguard 62 red epoxy base layer.

After allowing sufficient time for the red base layer to dry, a second layer of Sikaguard 62 gray epoxy covering layer was applied.

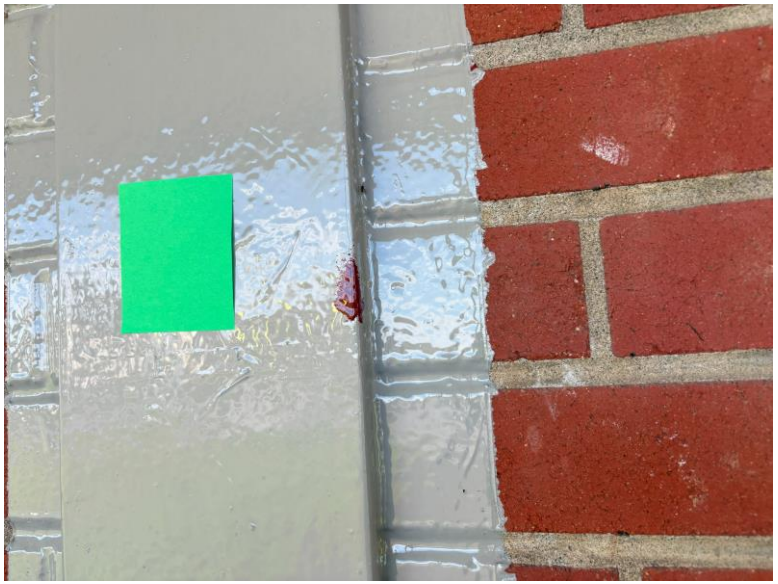
Gym CTE Classroom West Exterior

A ¼-inch chip was coated with the Sikaguard 62 red epoxy base layer.

After allowing sufficient time for the red base layer to dry, a second layer of Sikaguard 62 gray epoxy covering layer was applied.

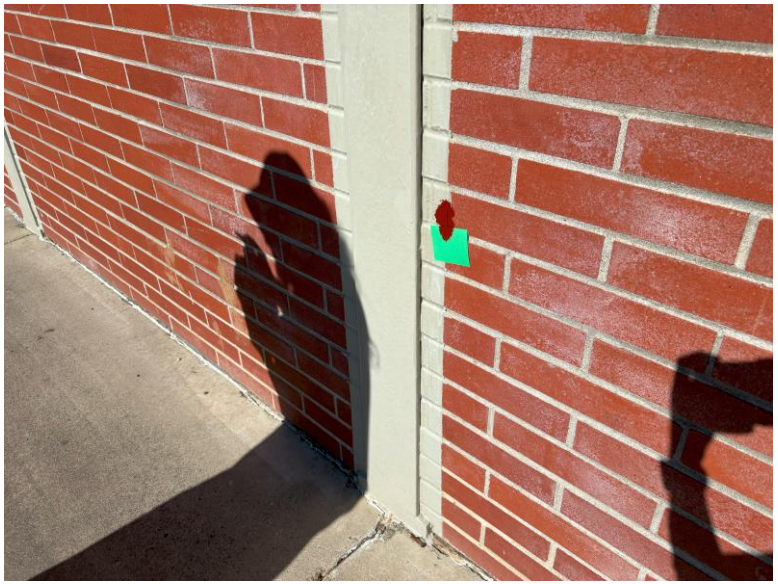
Gym Gathering Room South Exterior

A 1-inch crack was coated with the Sikaguard 62 red epoxy base layer.

After allowing sufficient time for the red base layer to dry, a second layer of Sikaguard 62 gray epoxy covering layer was applied.

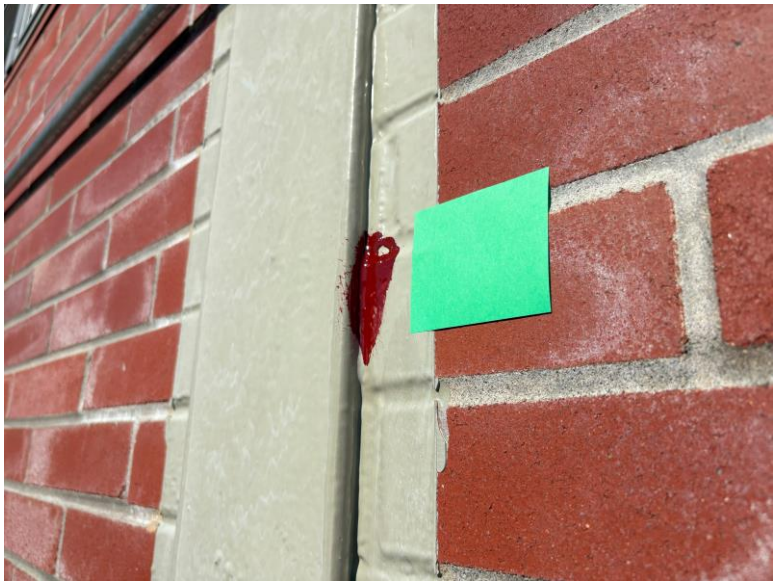
Gym Gathering Room South Exterior

A ½-inch crack was coated with the Sikaguard 62 red epoxy base layer.

After allowing sufficient time for the red base layer to dry, a second layer of Sikaguard 62 gray epoxy covering layer was applied.

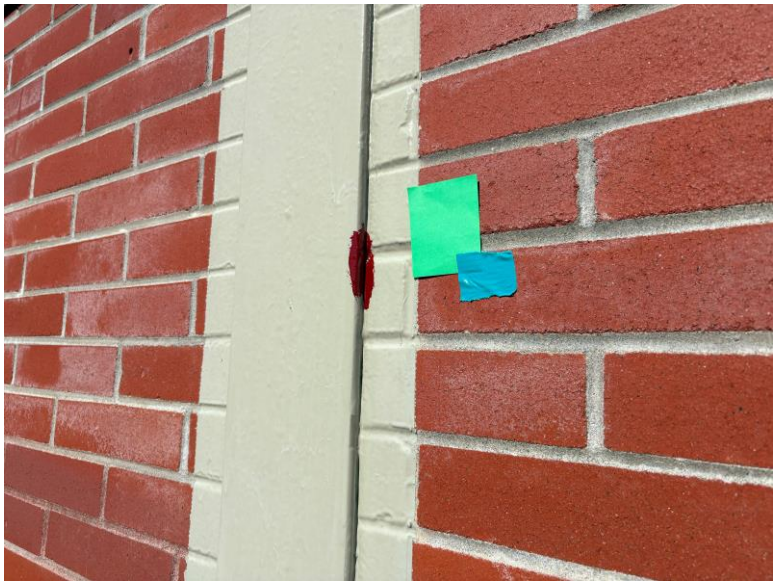
Gym Gathering Room South Exterior

A ½-inch crack was coated with the Sikaguard 62 red epoxy base layer.

After allowing sufficient time for the red base layer to dry, a second layer of Sikaguard 62 gray epoxy covering layer was applied.

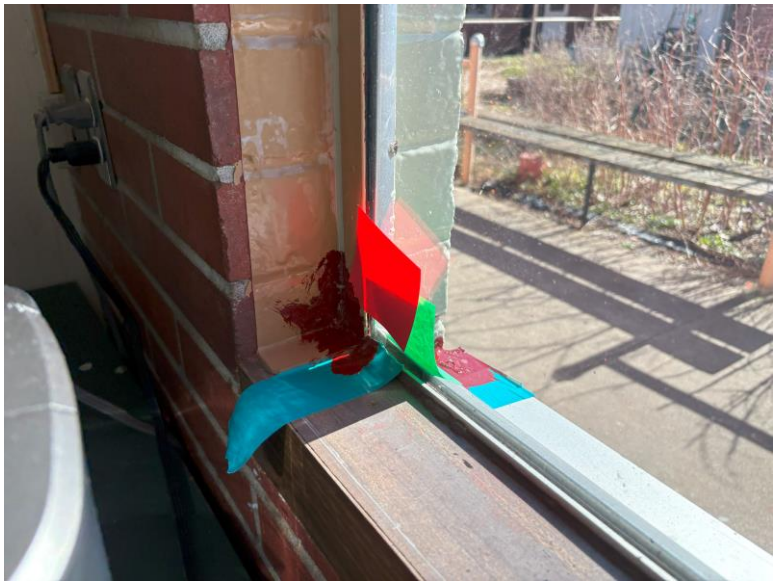
Gym Southeast Gathering Room

Three cracks, each about 1-inch in length, were coated with the Sikaguard 62 red epoxy base layer.

After allowing sufficient time for the red base layer to dry, a second layer of Sikaguard 62 gray epoxy covering layer was applied.

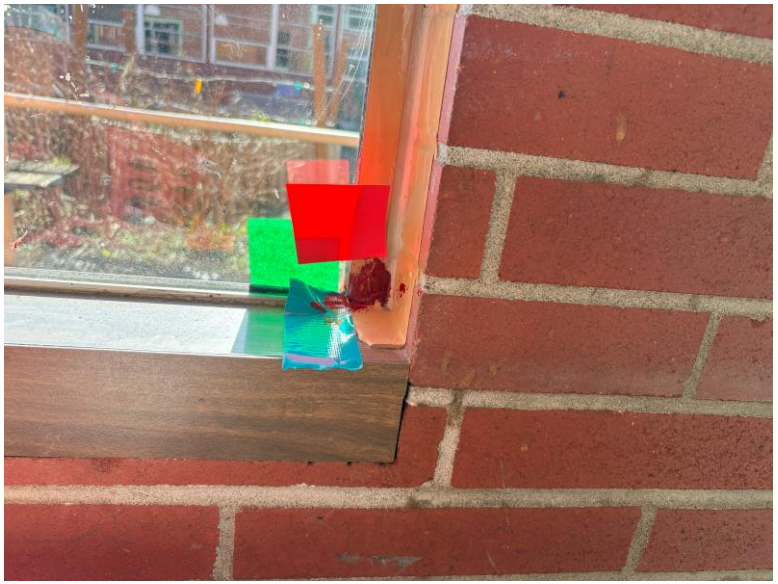
Gym Southeast Gathering Room

A ½-inch crack was coated with the Sikaguard 62 red epoxy base layer.

After allowing sufficient time for the red base layer to dry, a second layer of Sikaguard 62 gray epoxy covering layer was applied.

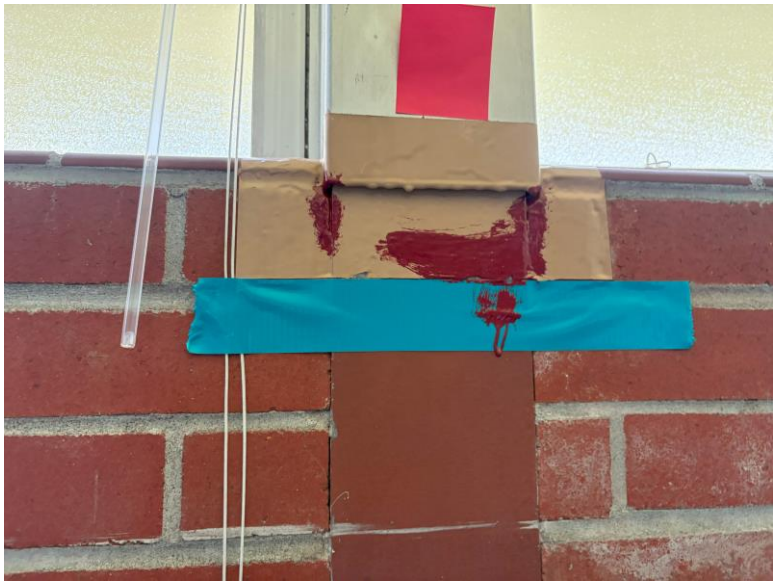
Gym CTE Classroom

Two cracks and a chip, each less than 1-inch in length, were coated with the Sikaguard 62 red epoxy base layer.

After allowing sufficient time for the red base layer to dry, a second layer of Sikaguard 62 gray epoxy covering layer was applied.

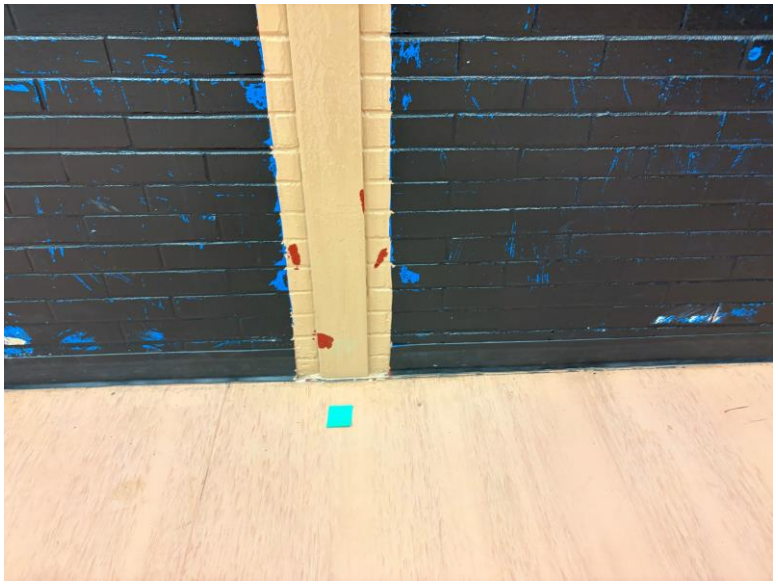
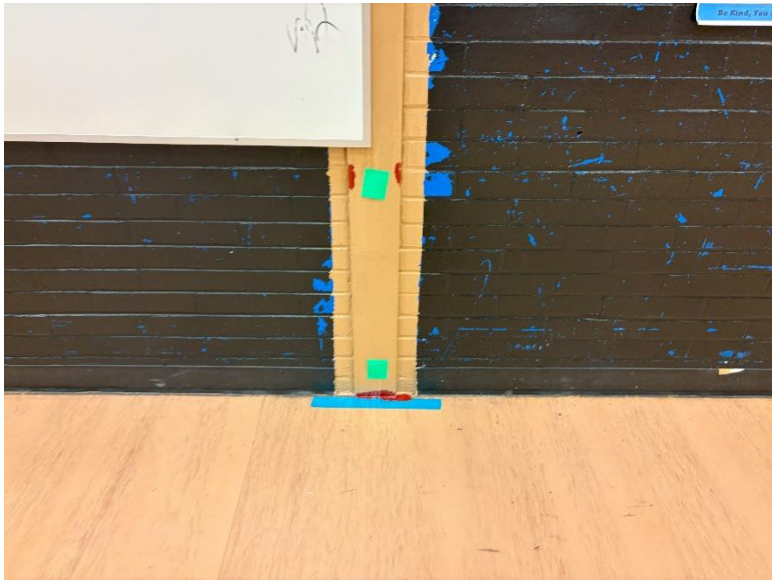
Northwest 1980 Gym

Four chips, each less than 1-inches square, were coated with the Sikaguard 62 red epoxy base layer.

After allowing sufficient time for the red base layer to dry, a second layer of Sikaguard 62 gray epoxy covering layer was applied.

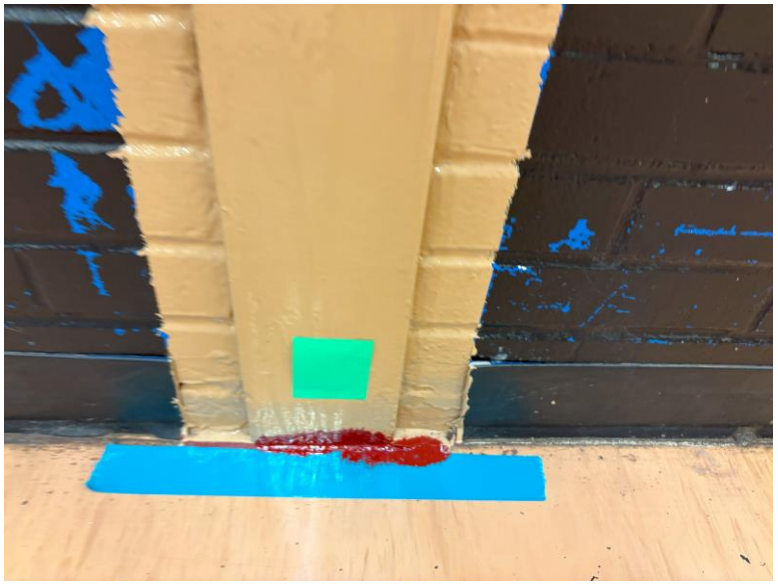
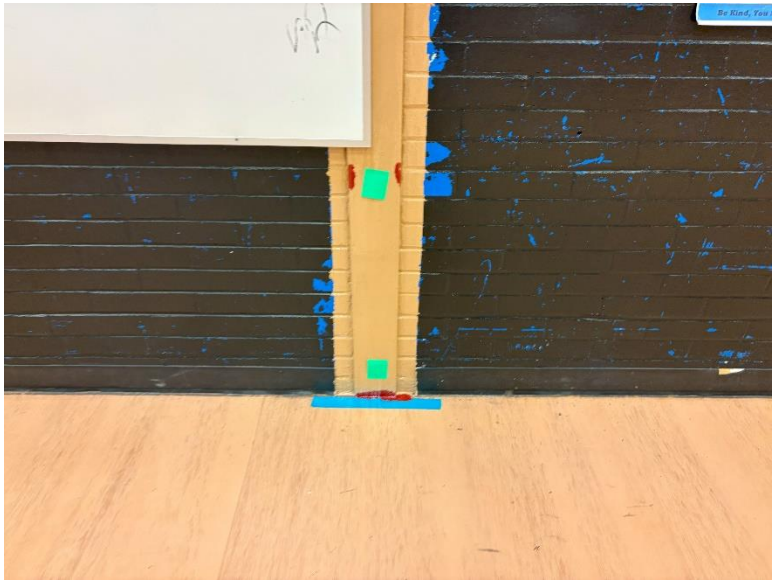
West 1980 Gym

A ½-inch crack was coated with the Sikaguard 62 red epoxy base layer.

After allowing sufficient time for the red base layer to dry, a second layer of Sikaguard 62 gray epoxy covering layer was applied.

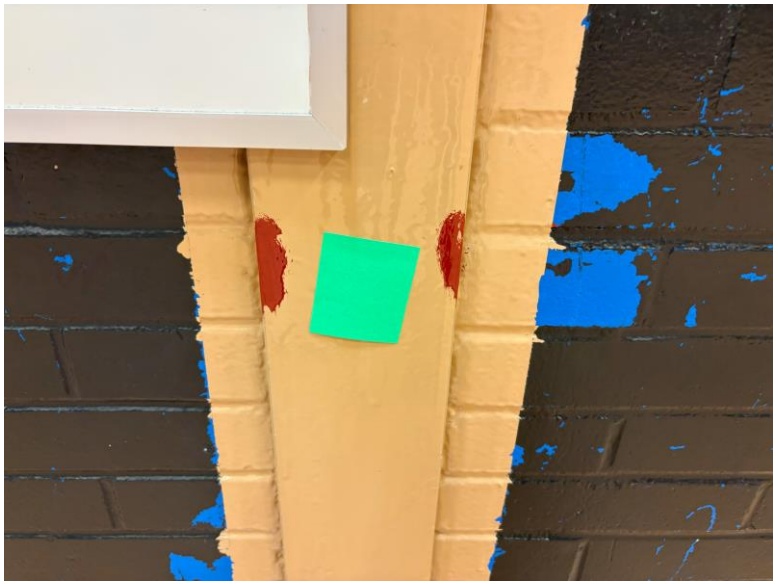
West 1980 Gym

Two ¼-inch chips were coated with the Sikaguard 62 red epoxy base layer.

After allowing sufficient time for the red base layer to dry, a second layer of Sikaguard 62 gray epoxy covering layer was applied.

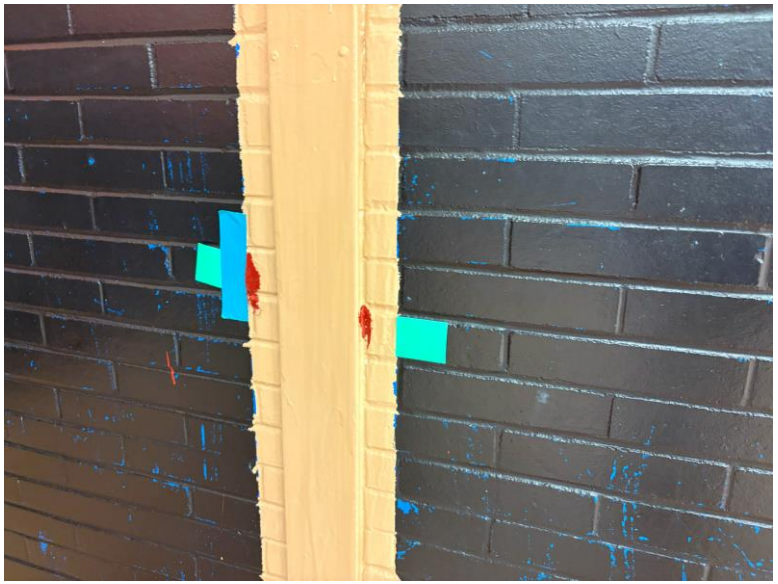
West 1980 Gym

Two ¼-inch chips were coated with the Sikaguard 62 red epoxy base layer.

After allowing sufficient time for the red base layer to dry, a second layer of Sikaguard 62 gray epoxy covering layer was applied.

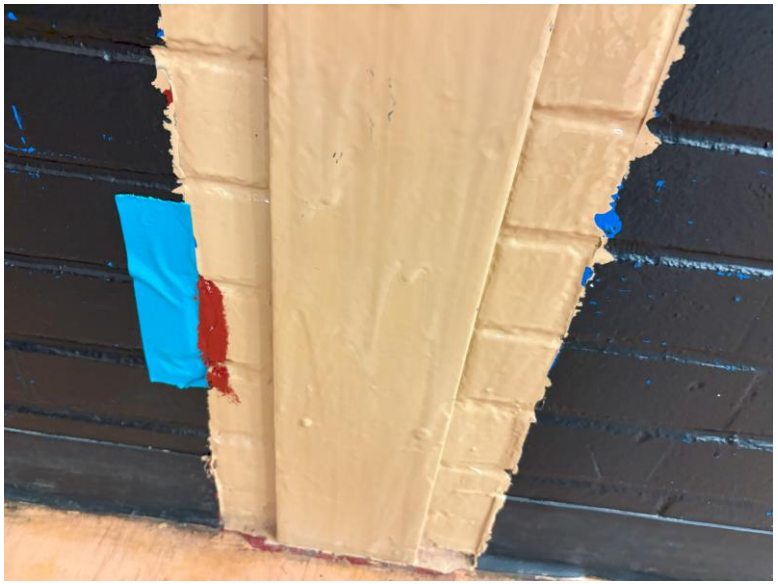
Southwest 1980 Gym

Two ¼-inch chips were coated with the Sikaguard 62 red epoxy base layer.

After allowing sufficient time for the red base layer to dry, a second layer of Sikaguard 62 gray epoxy covering layer was applied.

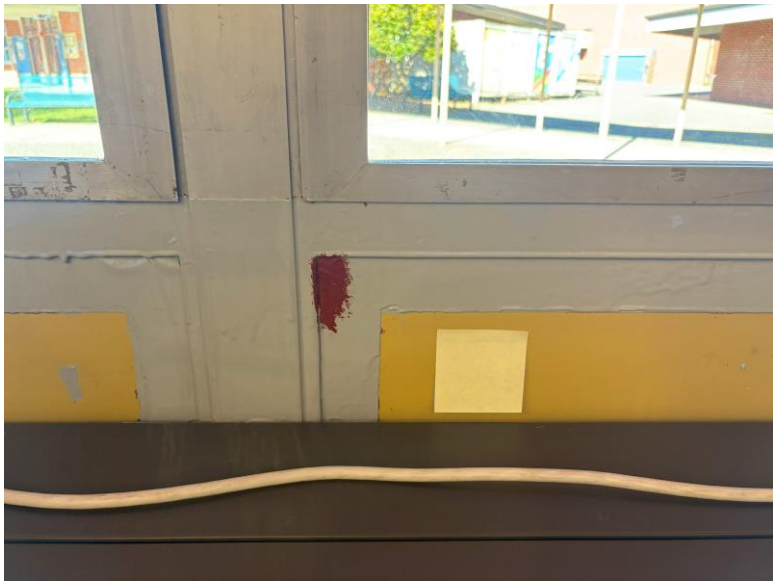
Pod Room 1

A ¼-inch crack was coated with the Sikaguard 62 red epoxy base layer.

After allowing sufficient time for the red base layer to dry, a second layer of Sikaguard 62 gray epoxy covering layer was applied.

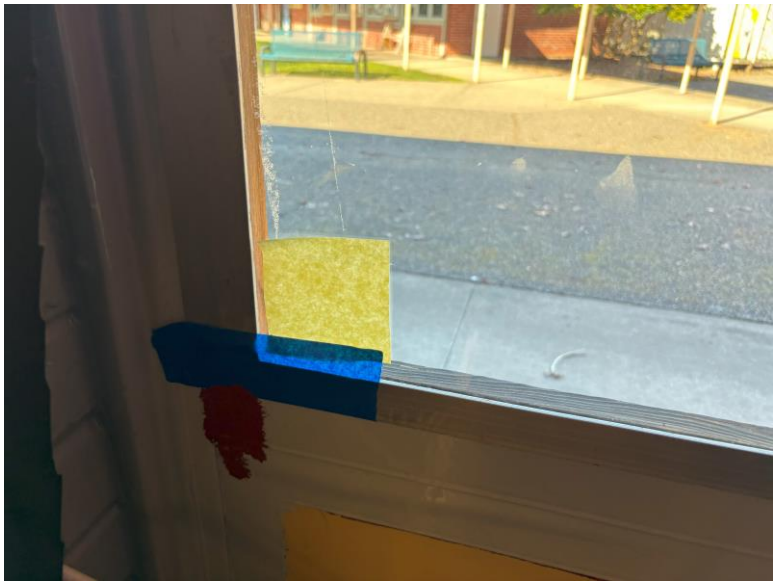
Pod Room 1

A ½-inch crack was coated with the Sikaguard 62 red epoxy base layer.

After allowing sufficient time for the red base layer to dry, a second layer of Sikaguard 62 gray epoxy covering layer was applied.

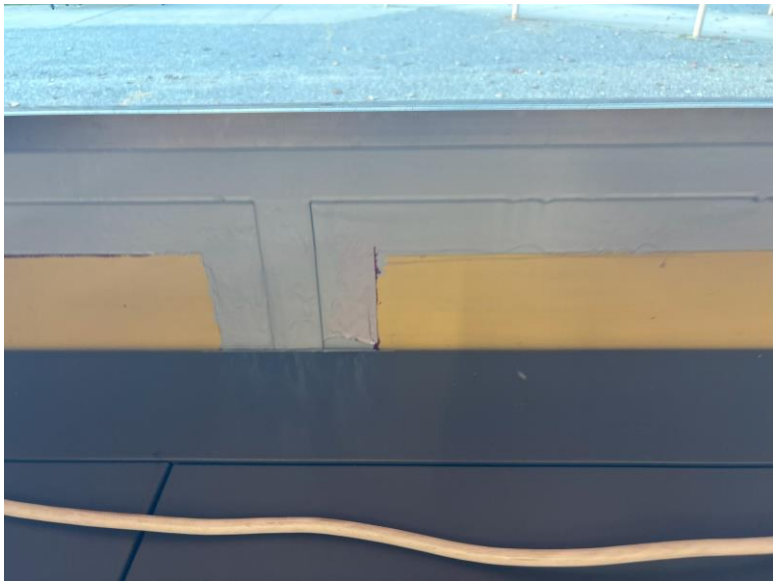
Pod Room 1

A ½-half inch chip was coated with the Sikaguard 62 red epoxy base layer.

After allowing sufficient time for the red base layer to dry, a second layer of Sikaguard 62 gray epoxy covering layer was applied.

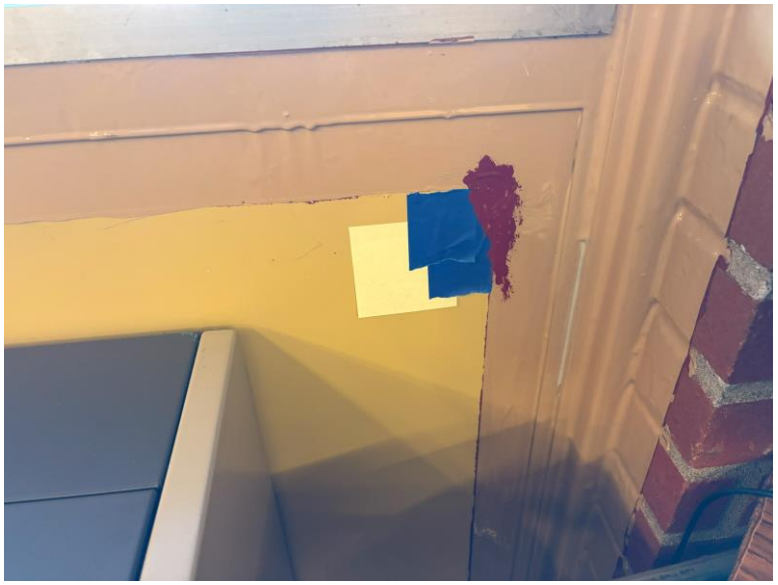
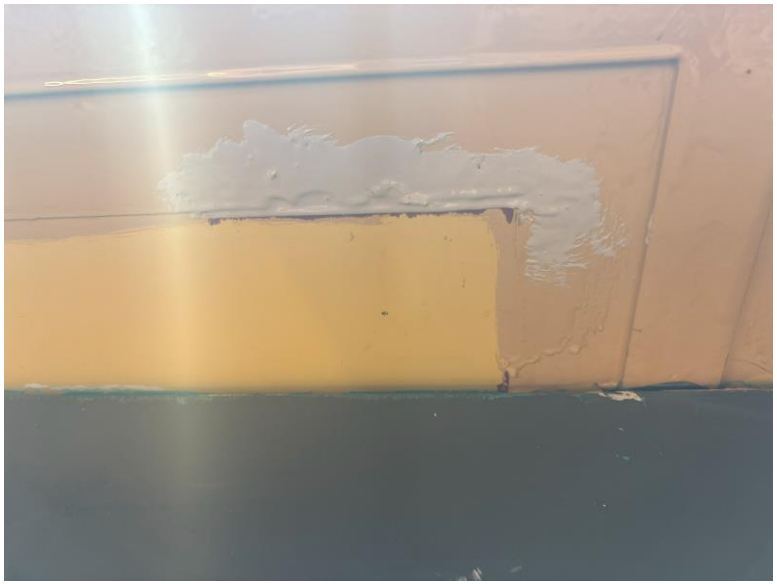
Pod Room 2

A ½-inch chip was coated with the Sikaguard 62 red epoxy base layer.

After allowing sufficient time for the red base layer to dry, a second layer of Sikaguard 62 gray epoxy covering layer was applied.

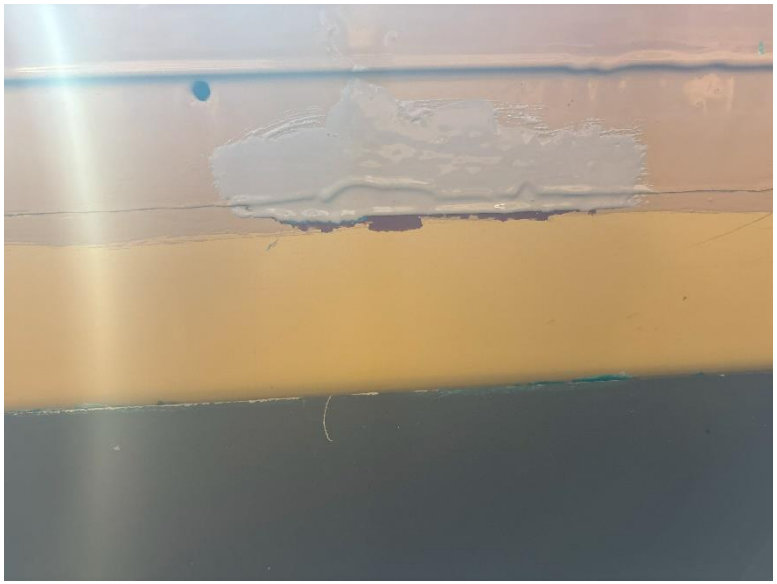
Pod Room 2

A ¼-inch chip was coated with the Sikaguard 62 red epoxy base layer.

After allowing sufficient time for the red base layer to dry, a second layer of Sikaguard 62 gray epoxy covering layer was applied.

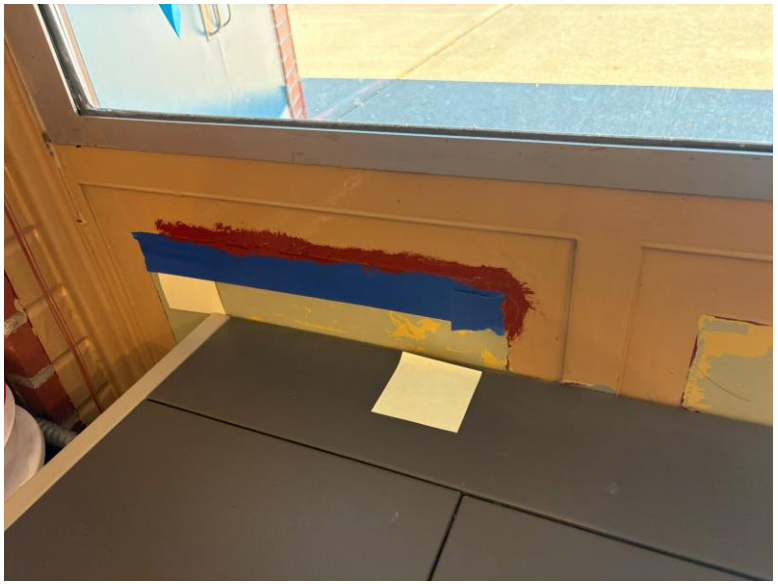
Pod Room 3

A 2-inch chip was coated with the Sikaguard 62 red epoxy base layer.

After allowing sufficient time for the red base layer to dry, a second layer of Sikaguard 62 gray epoxy covering layer was applied.

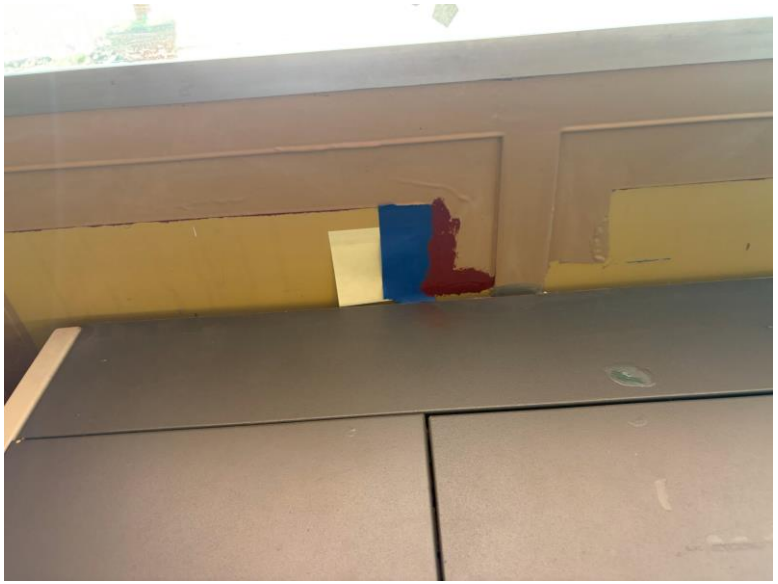
Pod Room 4

Four ¼-inch chips were coated with the Sikaguard 62 red epoxy base layer.

After allowing sufficient time for the red base layer to dry, a second layer of Sikaguard 62 gray epoxy covering layer was applied.

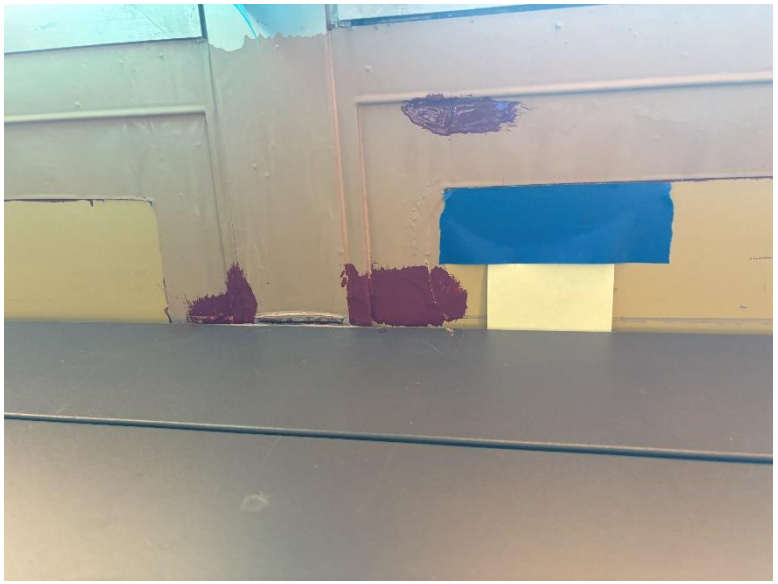
Pod Room 4

A ½-inch crack was coated with the Sikaguard 62 red epoxy base layer.

After allowing sufficient time for the red base layer to dry, a second layer of Sikaguard 62 gray epoxy covering layer was applied.

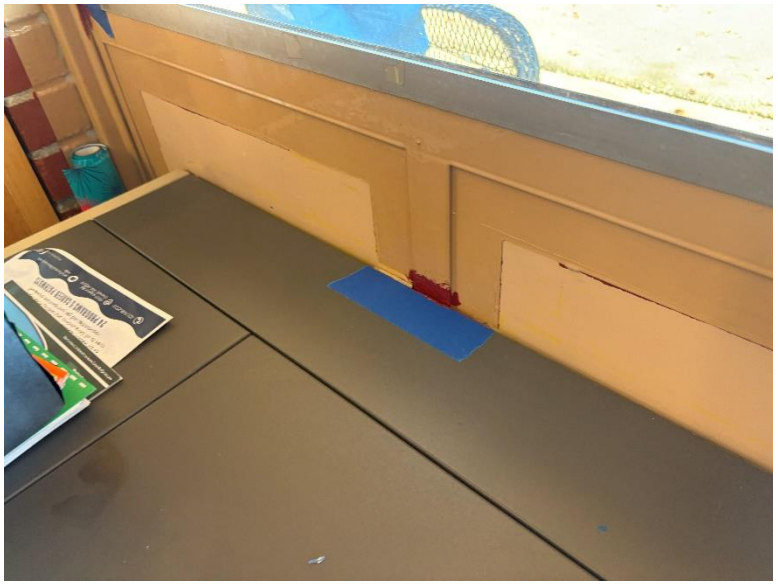
Pod Room 6

A ½-inch crack was coated with the Sikaguard 62 red epoxy base layer.

After allowing sufficient time for the red base layer to dry, a second layer of Sikaguard 62 gray epoxy covering layer was applied.

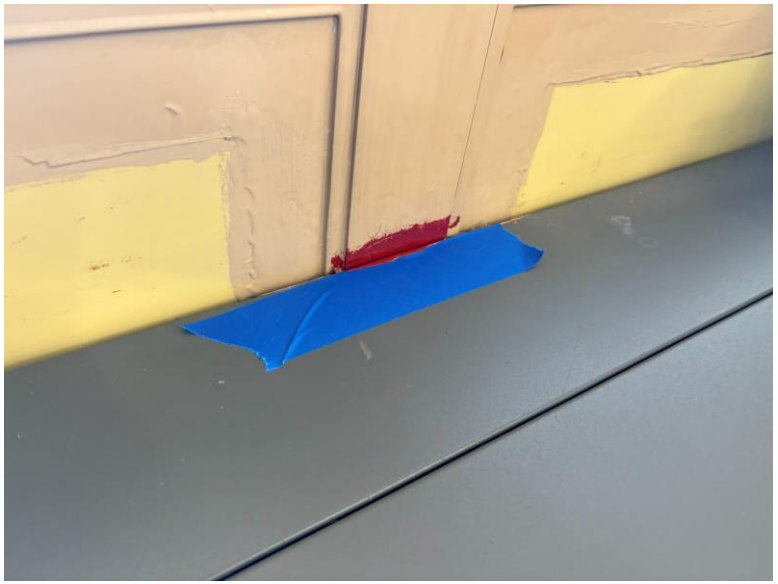
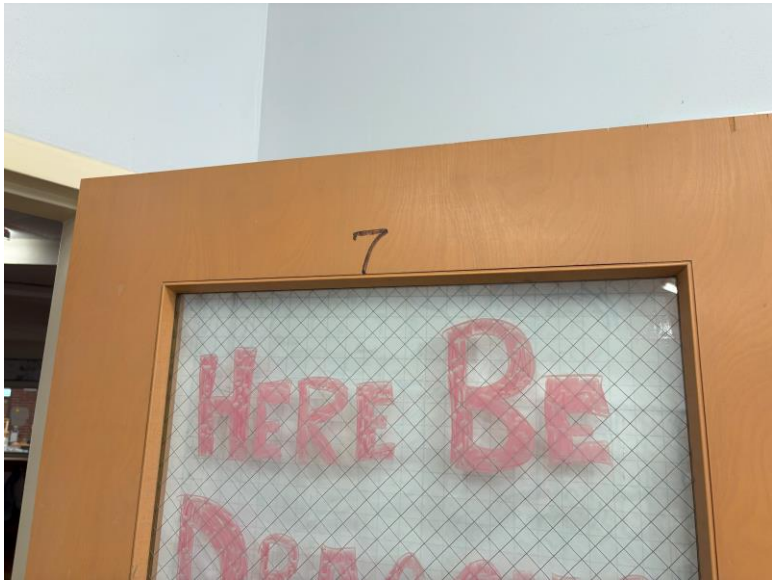
Pod Room 7

A ¼-inch chip was coated with the Sikaguard 62 red epoxy base layer.

After allowing sufficient time for the red base layer to dry, a second layer of Sikaguard 62 gray epoxy covering layer was applied.

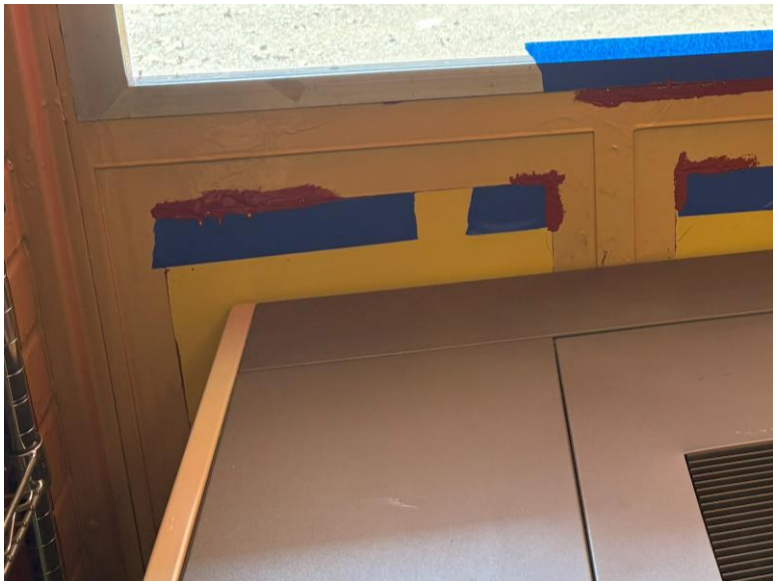
Pod Room 7

A ½-inch crack was coated with the Sikaguard 62 red epoxy base layer.

After allowing sufficient time for the red base layer to dry, a second layer of Sikaguard 62 gray epoxy covering layer was applied.

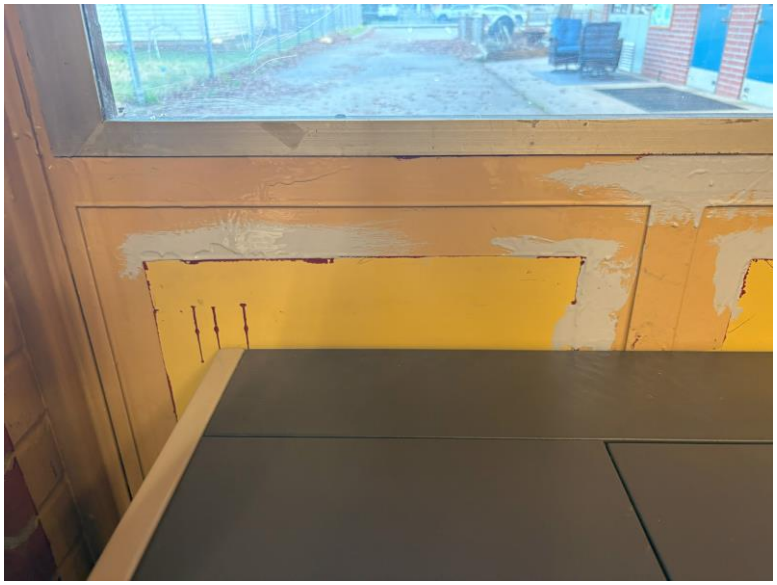
Pod Room 8

Multiple cracks and chips, ranging in size from ¼-inch to ½-inch were coated with the Sikaguard 62 red epoxy base layer.

After allowing sufficient time for the red base layer to dry, a second layer of Sikaguard 62 gray epoxy covering layer was applied.

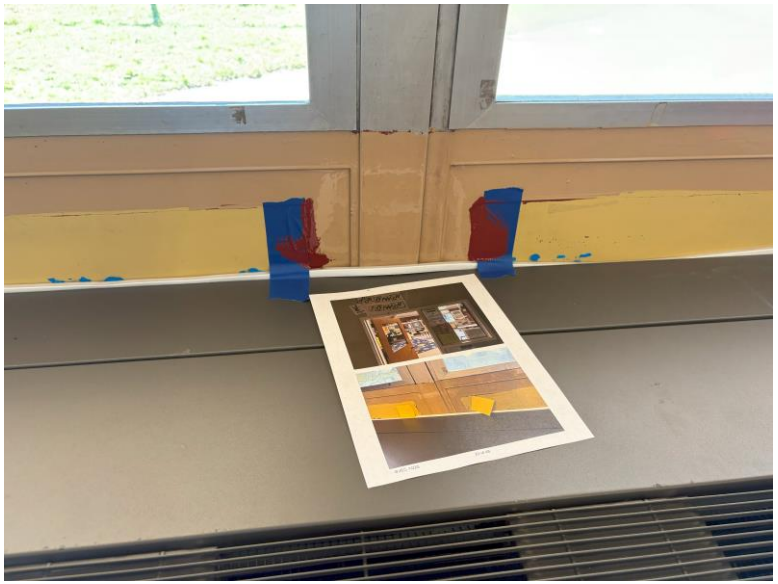
Pod Room 8

A ½-inch chip and 1-inch crack were coated with the Sikaguard 62 red epoxy base layer.

After allowing sufficient time for the red base layer to dry, a second layer of Sikaguard 62 gray epoxy covering layer was applied.

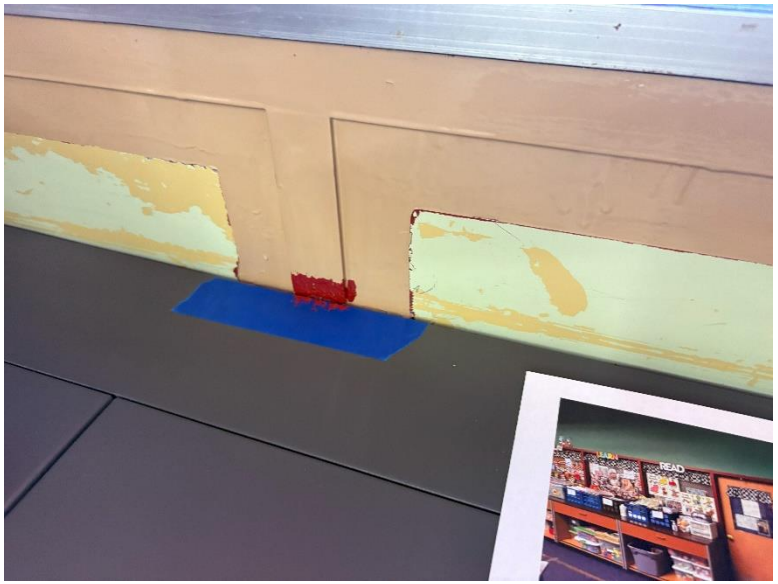
Pod Room 15

A ½-inch crack and a ¼-inch chip were coated with the Sikaguard 62 red epoxy base layer.

After allowing sufficient time for the red base layer to dry, a second layer of Sikaguard 62 gray epoxy covering layer was applied.

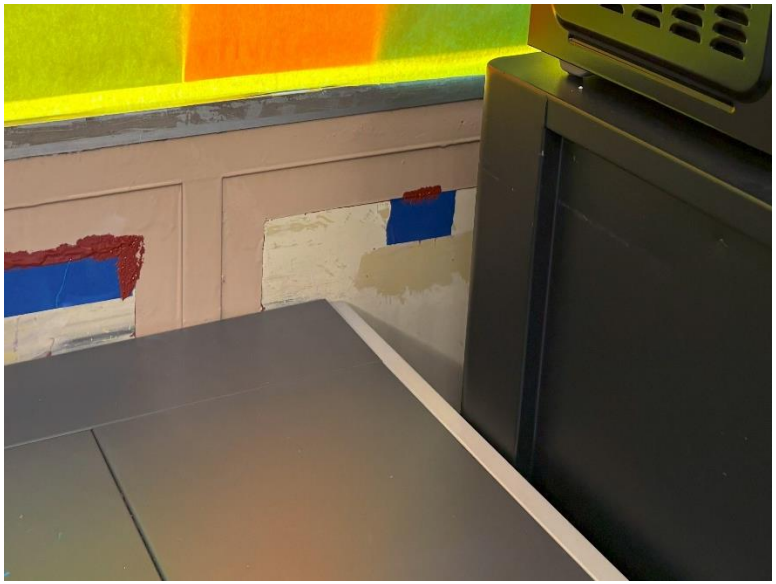
Pod Room 17

Multiple cracks, totaling about 3-inches, were coated with the Sikaguard 62 red epoxy base layer.

After allowing sufficient time for the red base layer to dry, a second layer of Sikaguard 62 gray epoxy covering layer was applied.

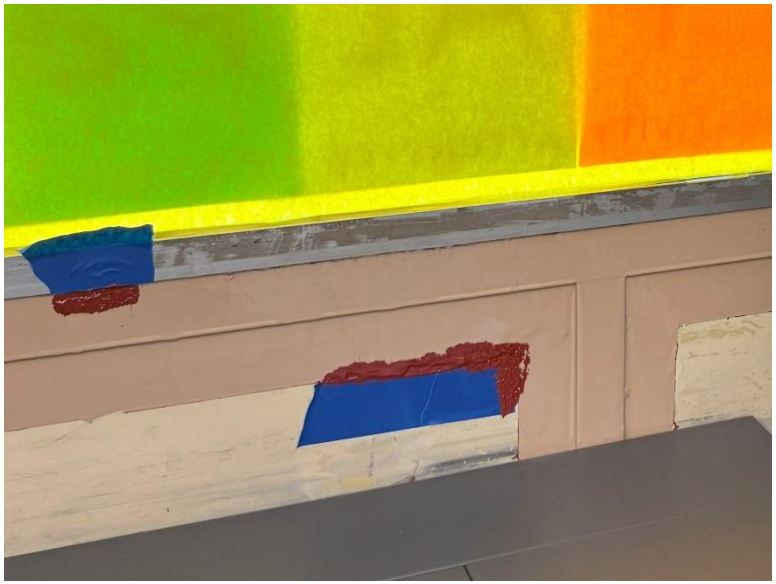
Pod Room 18

A ¼-inch chip was coated with the Sikaguard 62 red epoxy base layer.

After allowing sufficient time for the red base layer to dry, a second layer of Sikaguard 62 gray epoxy covering layer was applied.

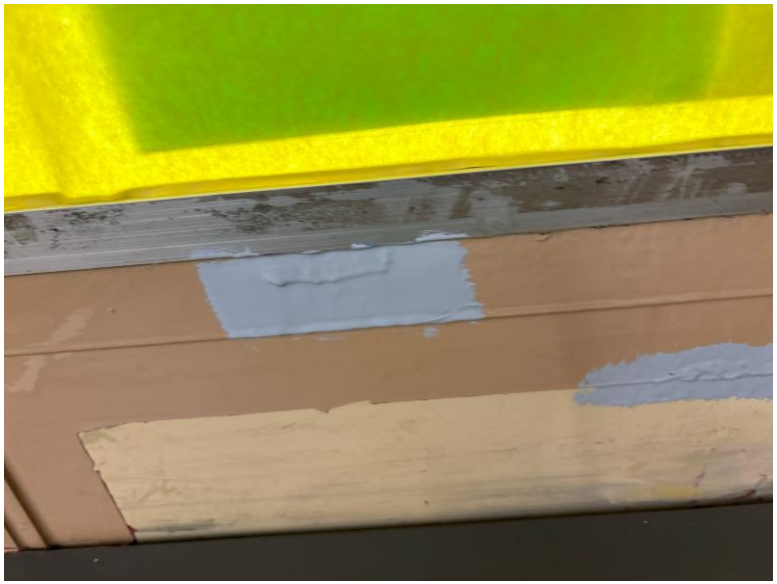
Pod Room 18

A ½-inch chip and three ¼-inch chips were coated with the Sikaguard 62 red epoxy base layer.

After allowing sufficient time for the red base layer to dry, a second layer of Sikaguard 62 gray epoxy covering layer was applied.

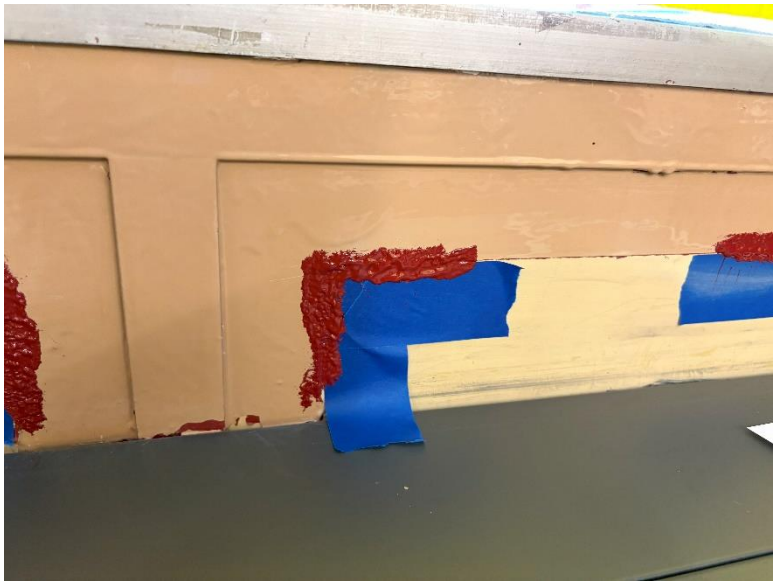
Pod Room 18

A ½-inch crack was coated with the Sikaguard 62 red epoxy base layer.

After allowing sufficient time for the red base layer to dry, a second layer of Sikaguard 62 gray epoxy covering layer was applied.

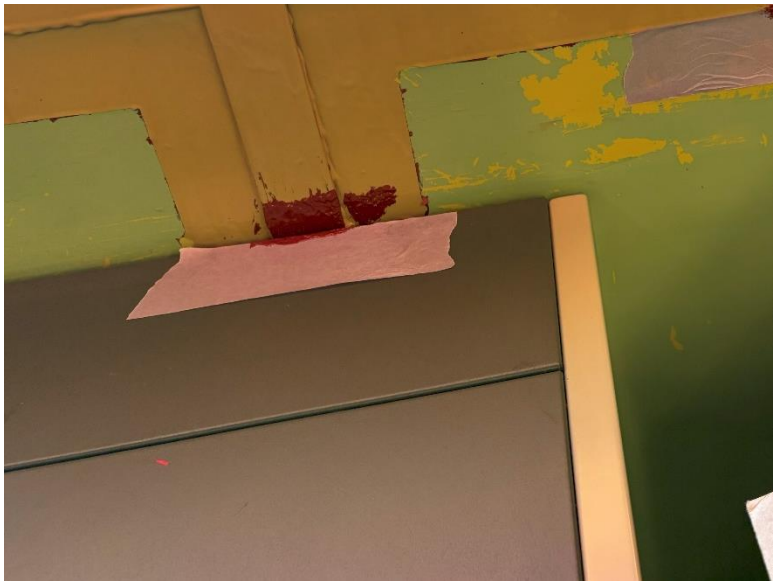
Pod Room 20

Three ¼-inch chips were coated with the Sikaguard 62 red epoxy base layer.

After allowing sufficient time for the red base layer to dry, a second layer of Sikaguard 62 gray epoxy covering layer was applied.

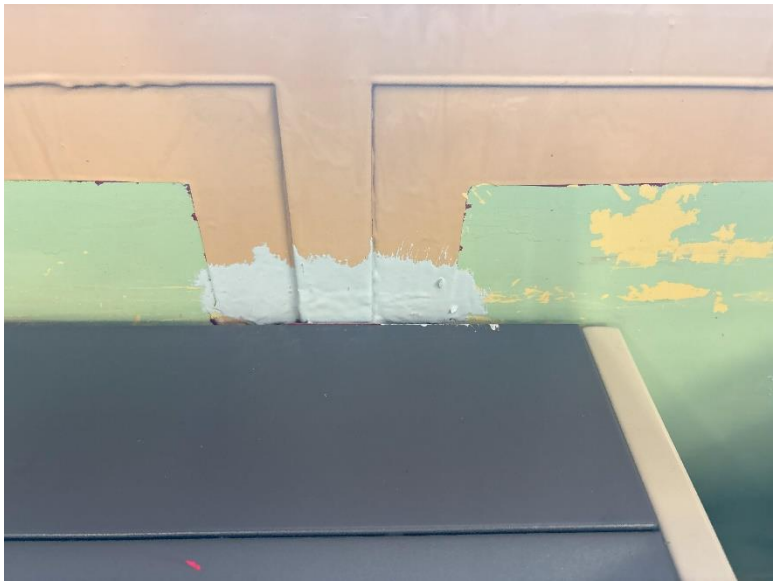
Pod Room 20

A ½-inch crack was coated with the Sikaguard 62 red epoxy base layer.

After allowing sufficient time for the red base layer to dry, a second layer of Sikaguard 62 gray epoxy covering layer was applied.

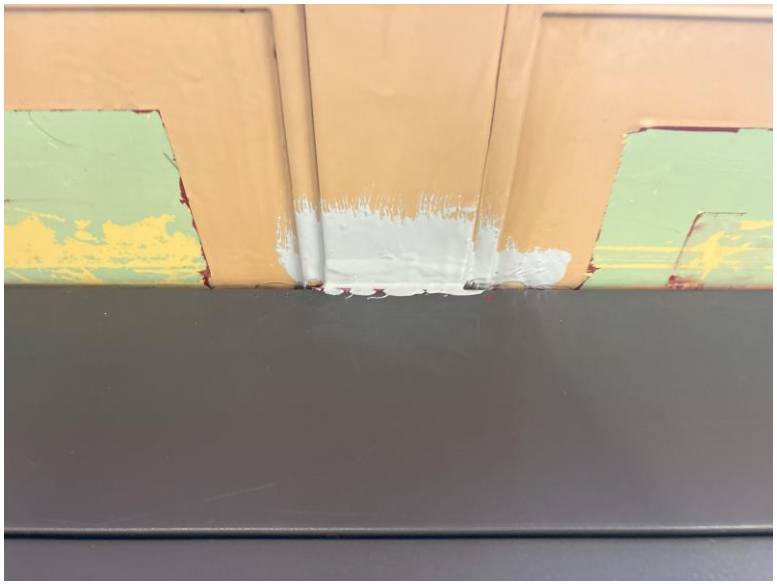
Pod Room 20

A ½-inch crack was coated with the Sikaguard 62 red epoxy base layer.

After allowing sufficient time for the red base layer to dry, a second layer of Sikaguard 62 gray epoxy covering layer was applied.

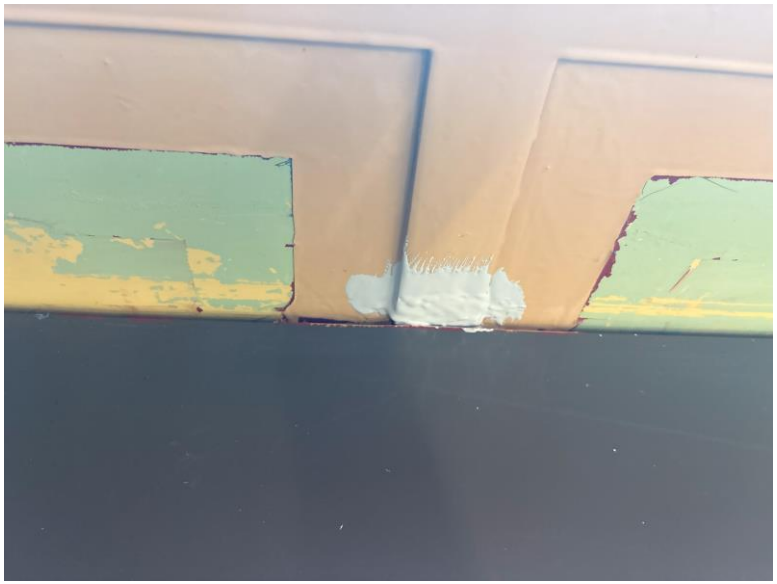
Pod Room 20

A ½-inch crack was coated with the Sikaguard 62 red epoxy base layer.

After allowing sufficient time for the red base layer to dry, a second layer of Sikaguard 62 gray epoxy covering layer was applied.

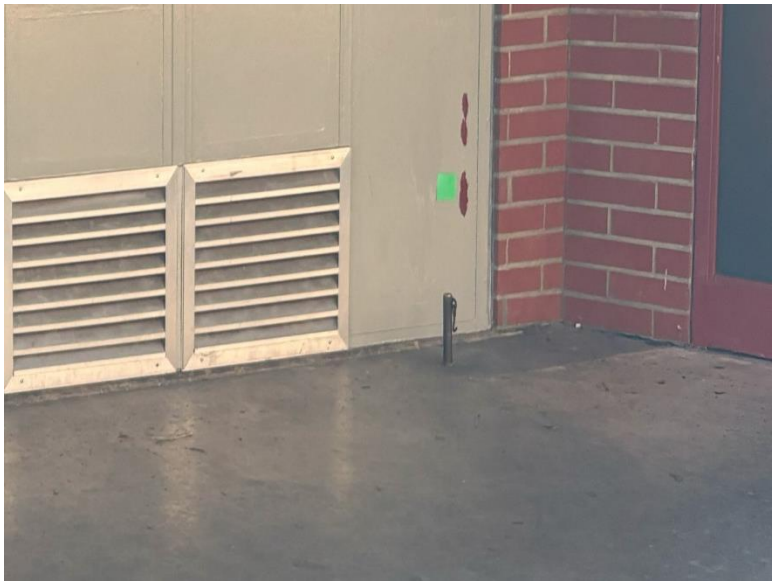
Pod Exterior Room 15

Two ¼-inch cracks were coated with the Sikaguard 62 red epoxy base layer.

After allowing sufficient time for the red base layer to dry, a second layer of Sikaguard 62 gray epoxy covering layer was applied.
