LEAD IN DRINKING WATER REPORT

Performed At:
Schools of South Orange- Maplewood

Performed For:
South Orange/Maplewood Board of Education
25 West Parker Ave, Maplewood, NJ, 07040

Inspection Date: 11/24/2024
Project Number: 2320

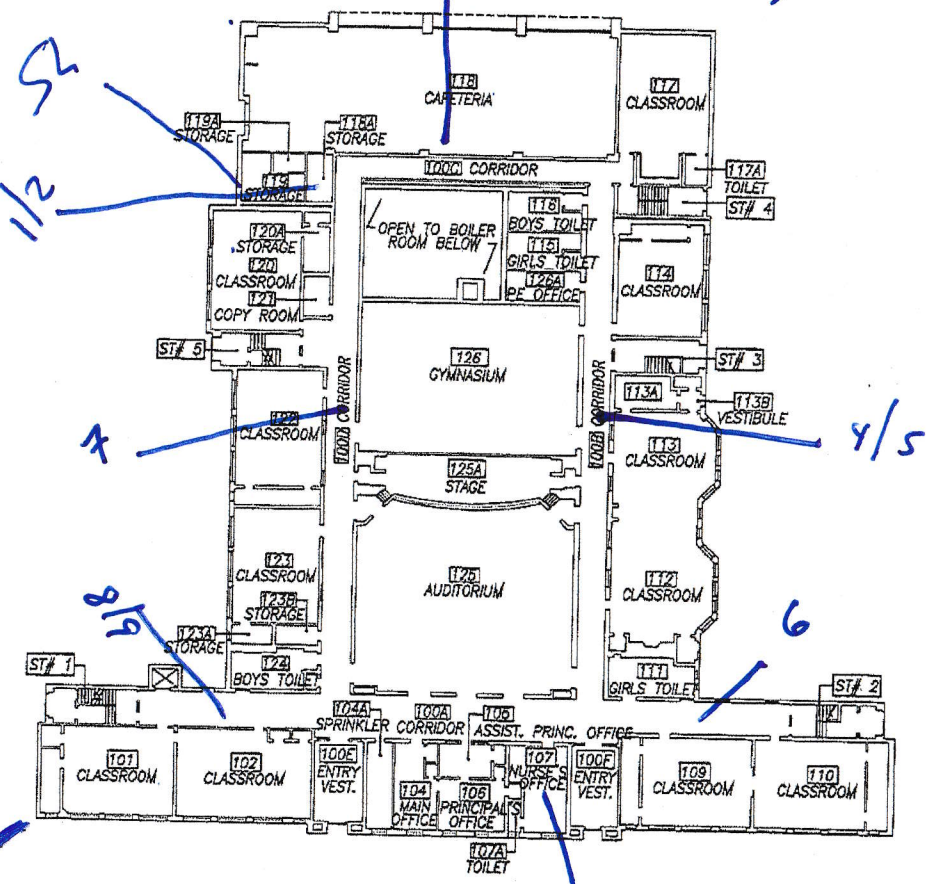
Room #s wrong.

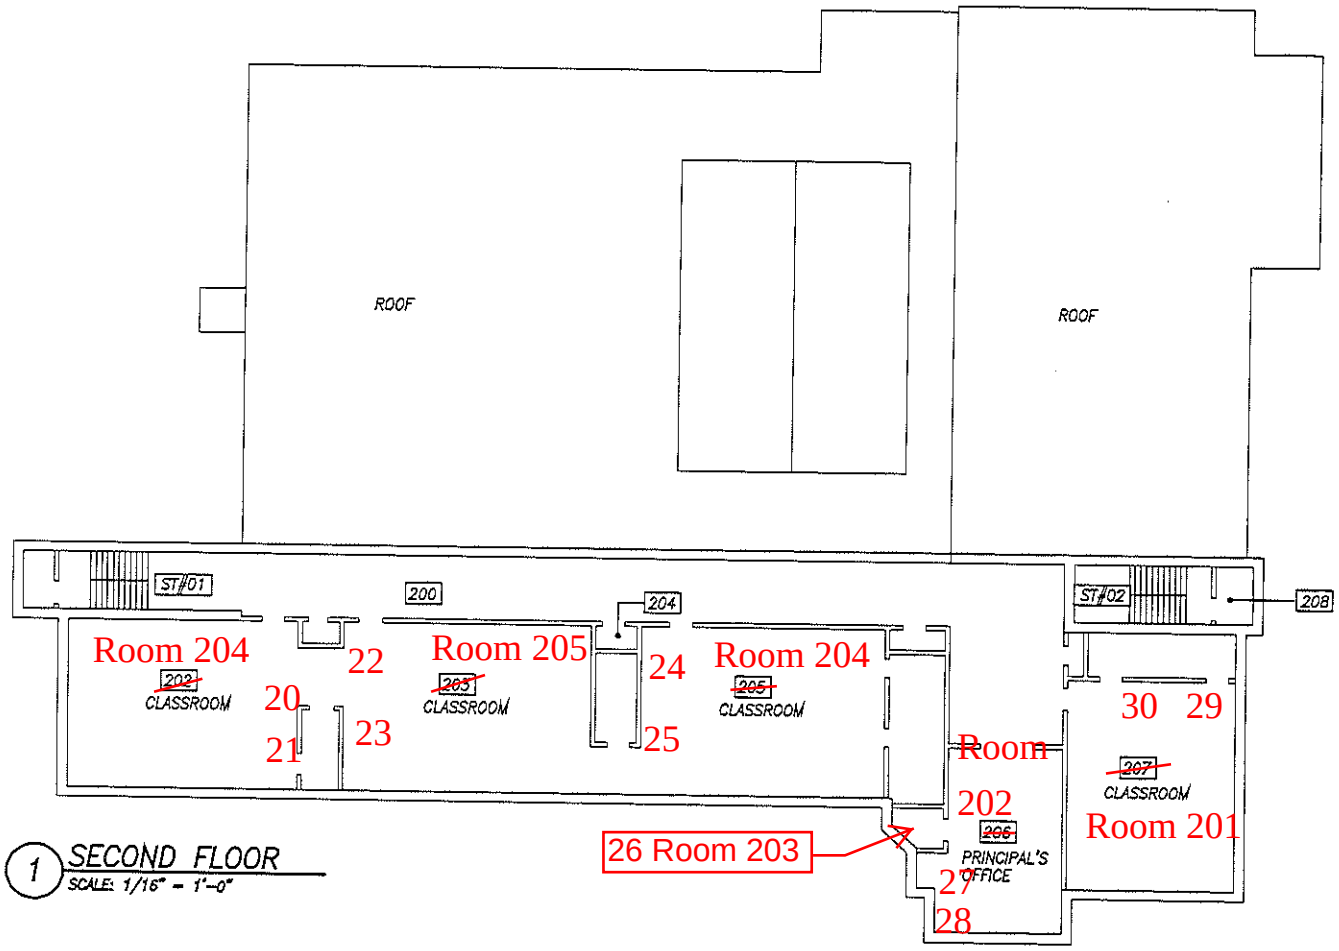
A-28

Layout of the rooms is not accurate

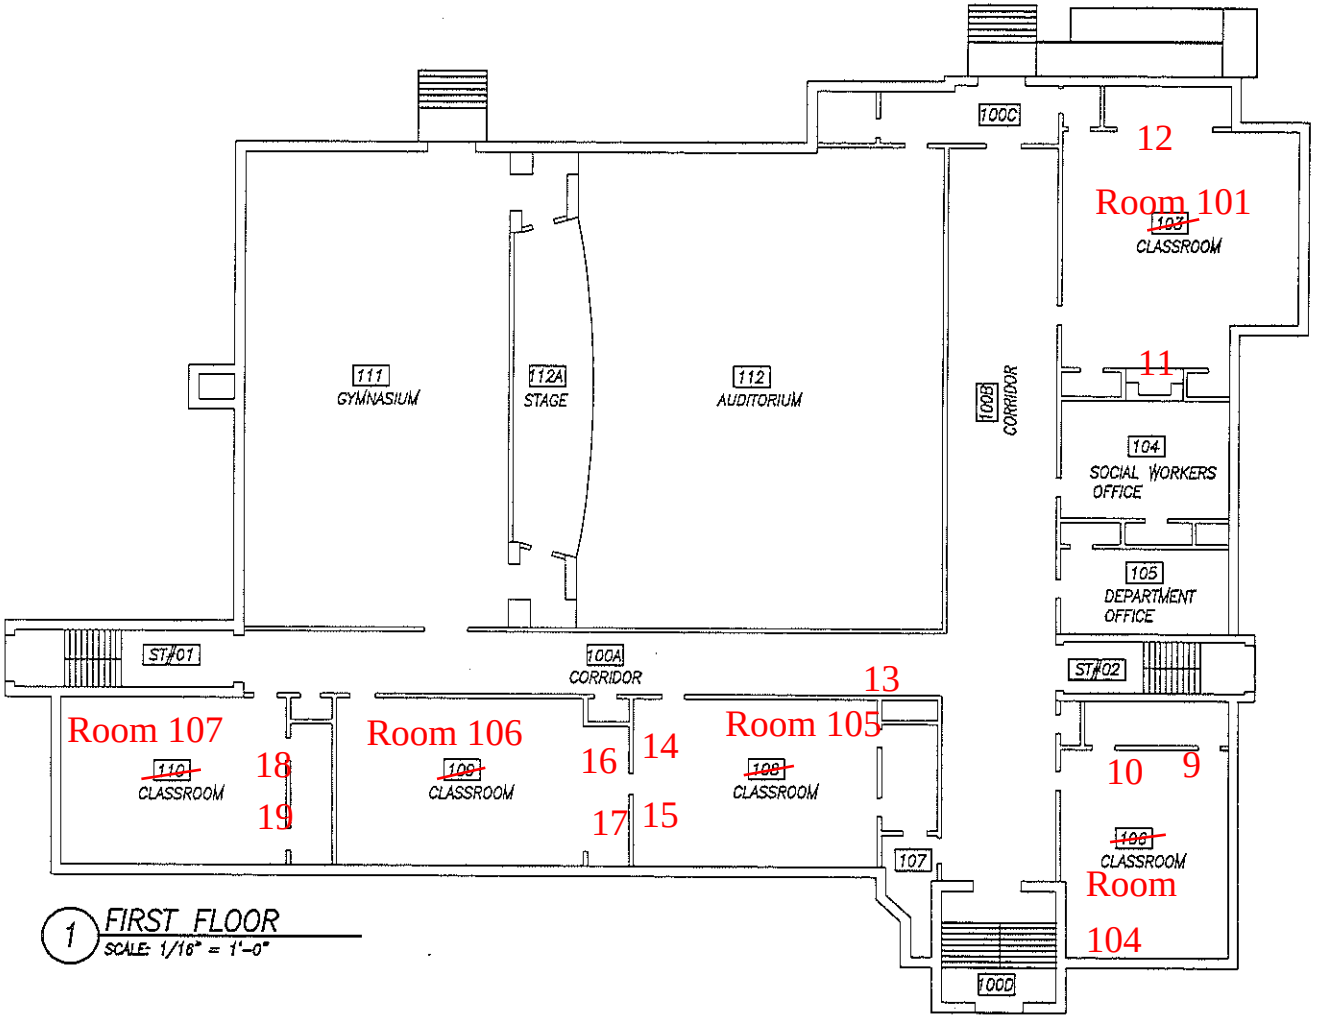
Layout of the rooms is not accurate

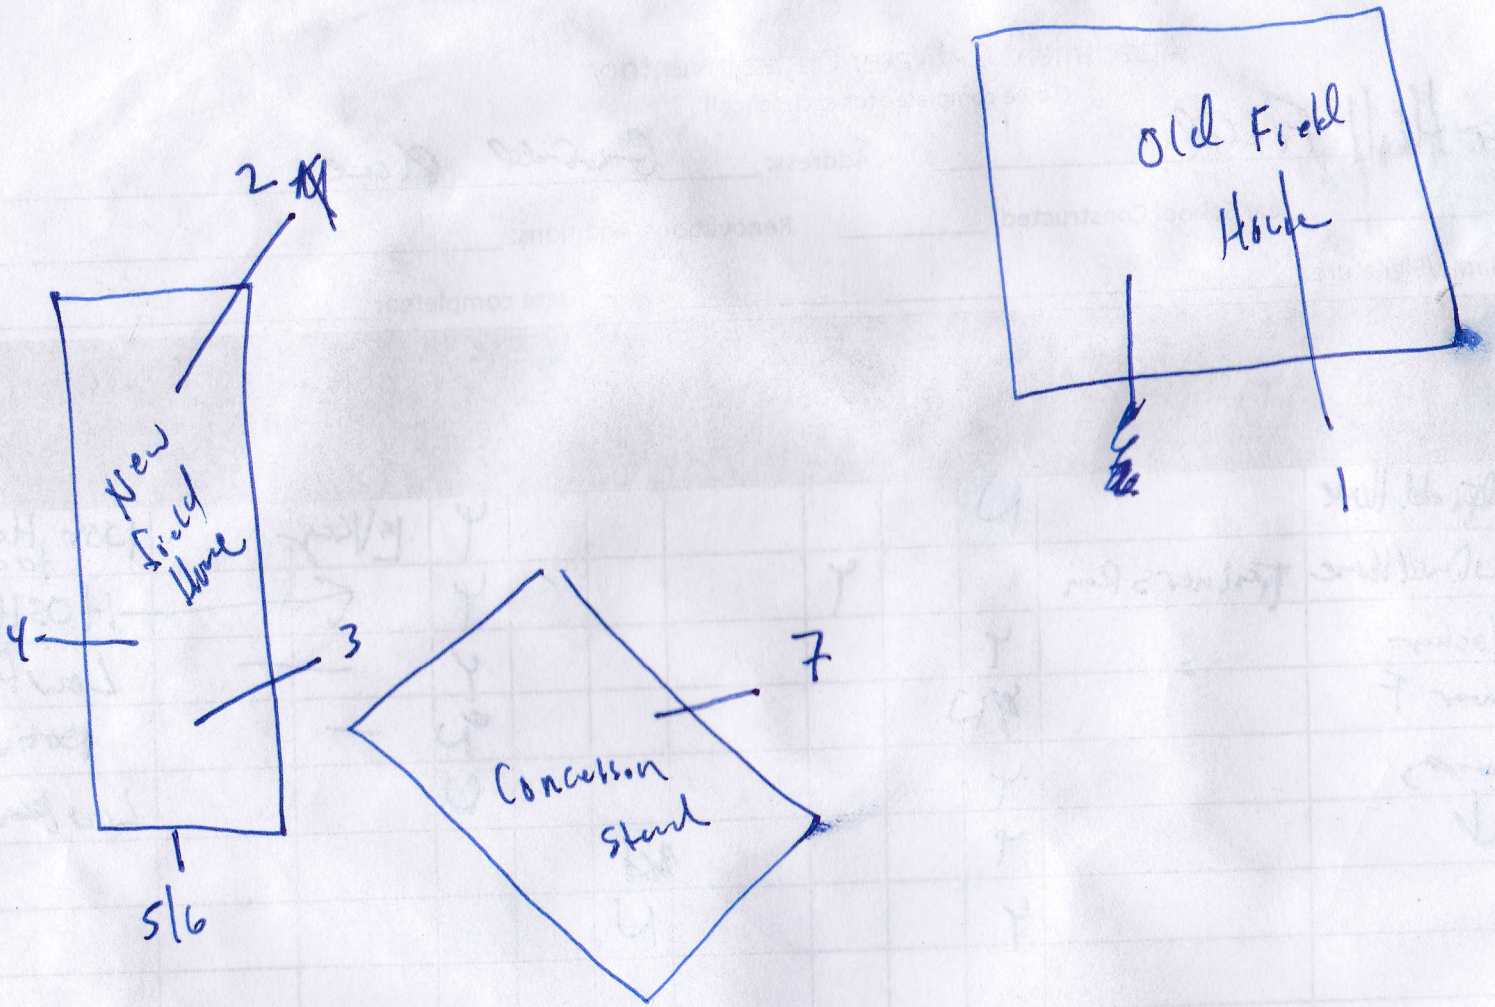
Building	DateCollected	AnalysisDate	Sample ID	Sample Description	Concentration (ppb)
Underhill Field	12/15/2024	12/27/2024	8	TRAINERS ROOM	260

Building	Location	Remediation Recommendation
Underhill Field	TRAINERS ROOM	Discontinue use and perform second draw sampling
