DeKalb County School District/Middle Schools

Chapel Hill Middle

School Assessment Report

May 20, 2016

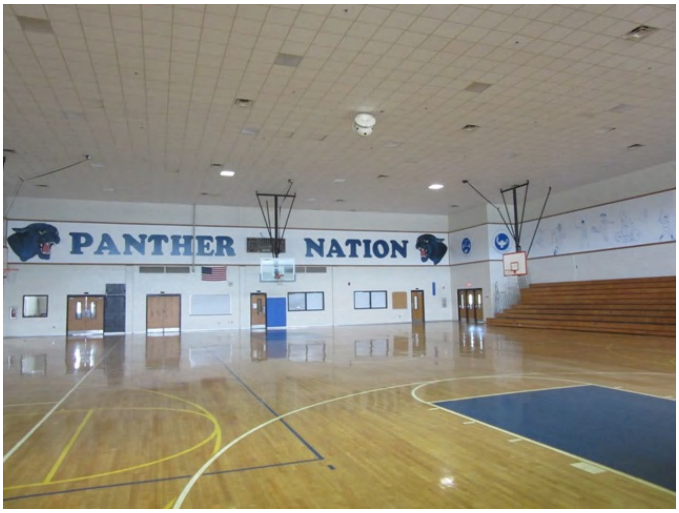
System: D3040 - Distribution Systems & Exhaust Systems

Location: Throughout Building
Distress: Inadequate
Category: Building Code Compliance
Priority: 2 Priority
Correction: Renew System
Qty: 154,881.00
Unit of Measure: S.F.
Estimate: $938,734.00
Assessor Name: Ben Nixon
Date Created: 06/19/2015

Notes: The exhaust system is inadequate and in poor condition, and does not meet current building code. The system should be scheduled for replacement.

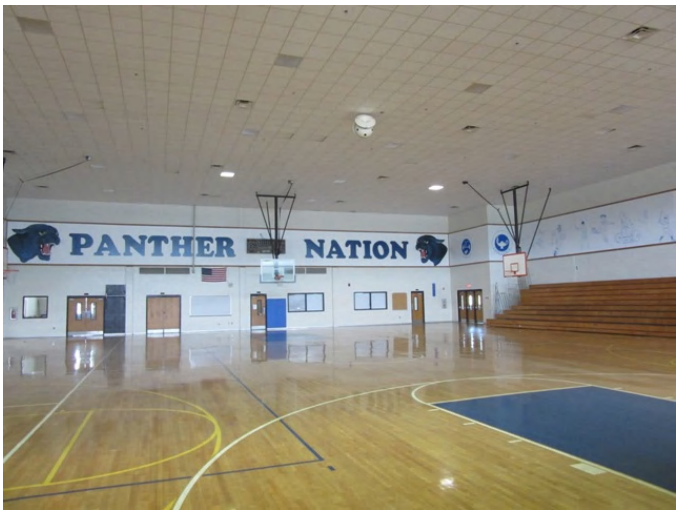
Notes: Building controls and instrumentation are beyond their expected service life, in poor condition, and should be scheduled for replacement.

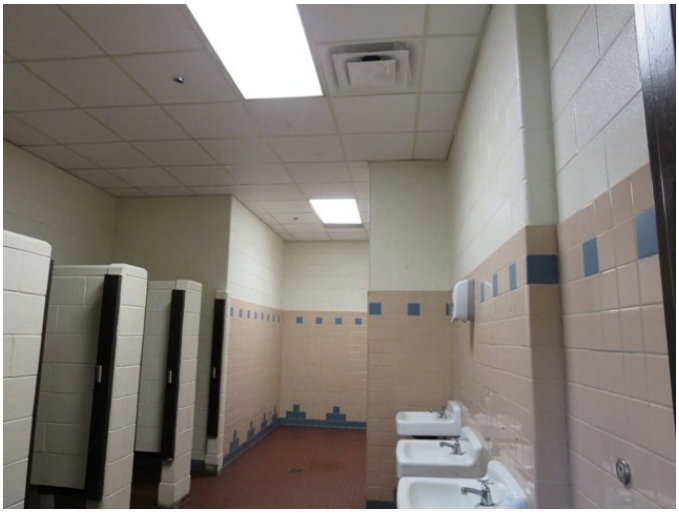
Notes: The facility fire alarm system is inadequate. There are no audible or visual alarms in the restrooms.
