DeKalb County School District/Elementary Schools

Wadsworth Elementary

School Assessment Report

May 20, 2016

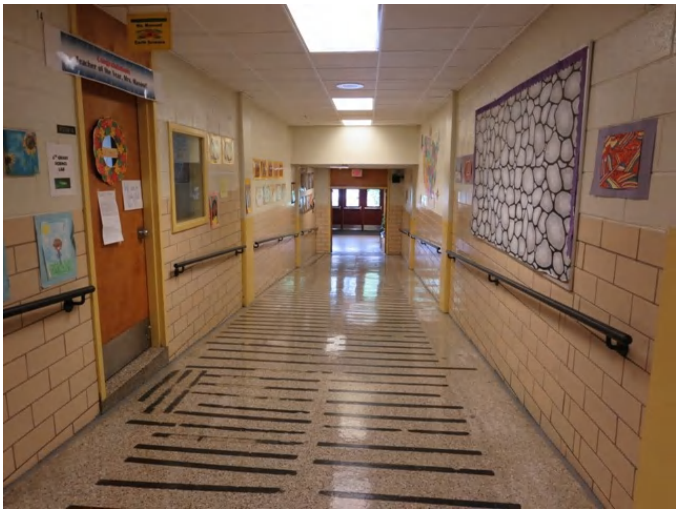
Notes: The interior doors are deteriorating due to age and use, and are not ADA and building code compliant.

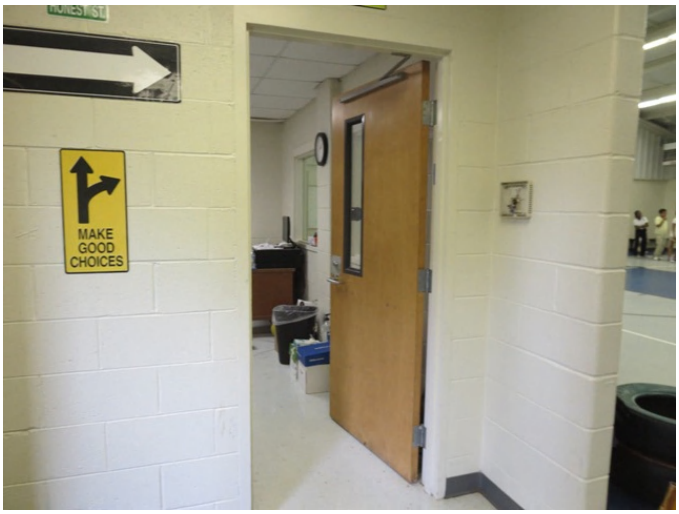
System: C3010 - Wall Finishes - Paint

Location: Throughout Building
Distress: Beyond Service Life
Category: Deferred Maintenance
Priority: 3 Priority
Correction: Renew System
Qty: 5,478.00
Unit of Measure: S.F.
Estimate: $8,496.00
Assessor Name: Ben Nixon
Date Created: 06/03/2015

Notes: The painted wall finish is deteriorating due to age and use, and should be replaced.

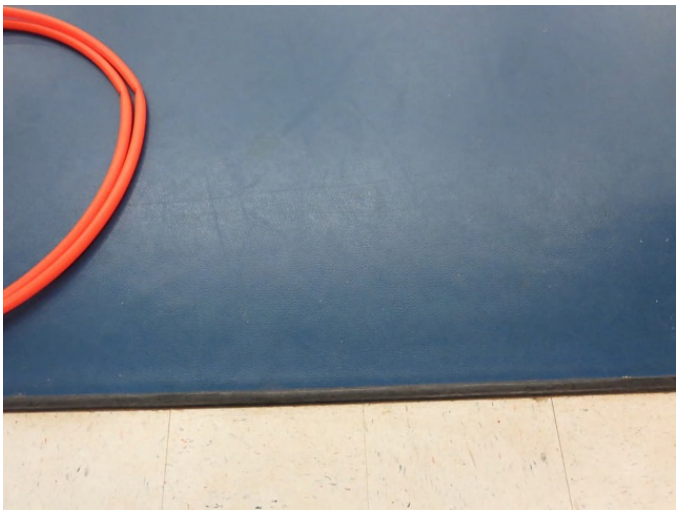
System: C3020 - Floor Finishes - Neoprene

Location: Basketball Court
Distress: Beyond Service Life
Category: Deferred Maintenance
Priority: 3 Priority
Correction: Renew System
Qty: 4,656.00
Unit of Measure: S.F.
Estimate: $74,058.00
Assessor Name: Ben Nixon
Date Created: 06/16/2015
