DeKalb County School District/Elementary Schools

Snapfinger Elementary

School Assessment Report

May 20, 2016

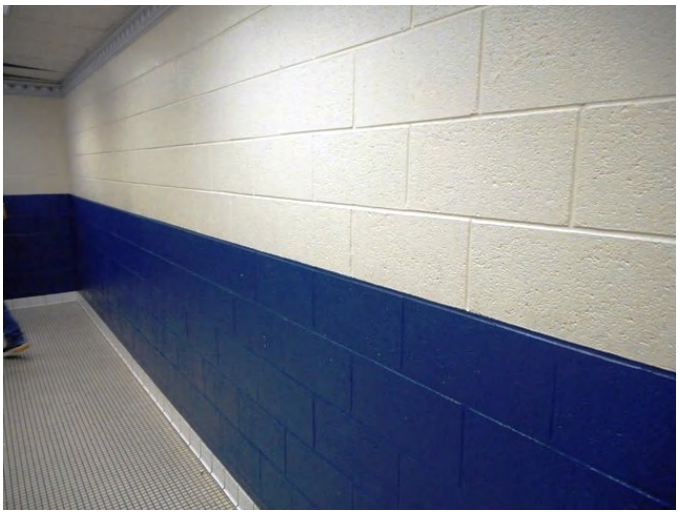
System: C3010 - Wall Finishes - Paint

Notes: The painted wall finishes are beyond their expected service life, stained, and should be replaced.
