Regarding: Short Term Radon Testing
Arleta Elementary School
5109 SE 66th Street
Portland, Oregon 97206

Arleta Elementary School
5109 SE 66th Street 97206
Facility Plan

Short-Term Radon Testing Locations

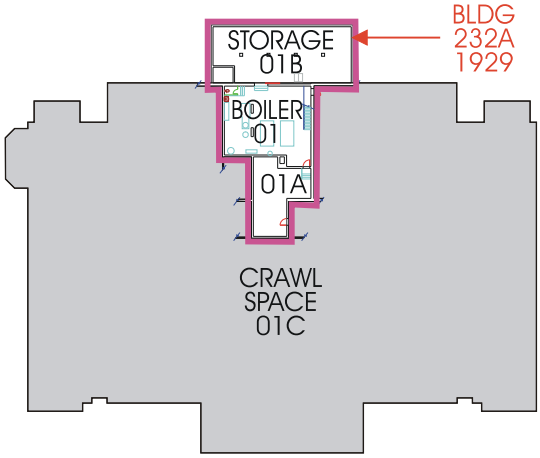
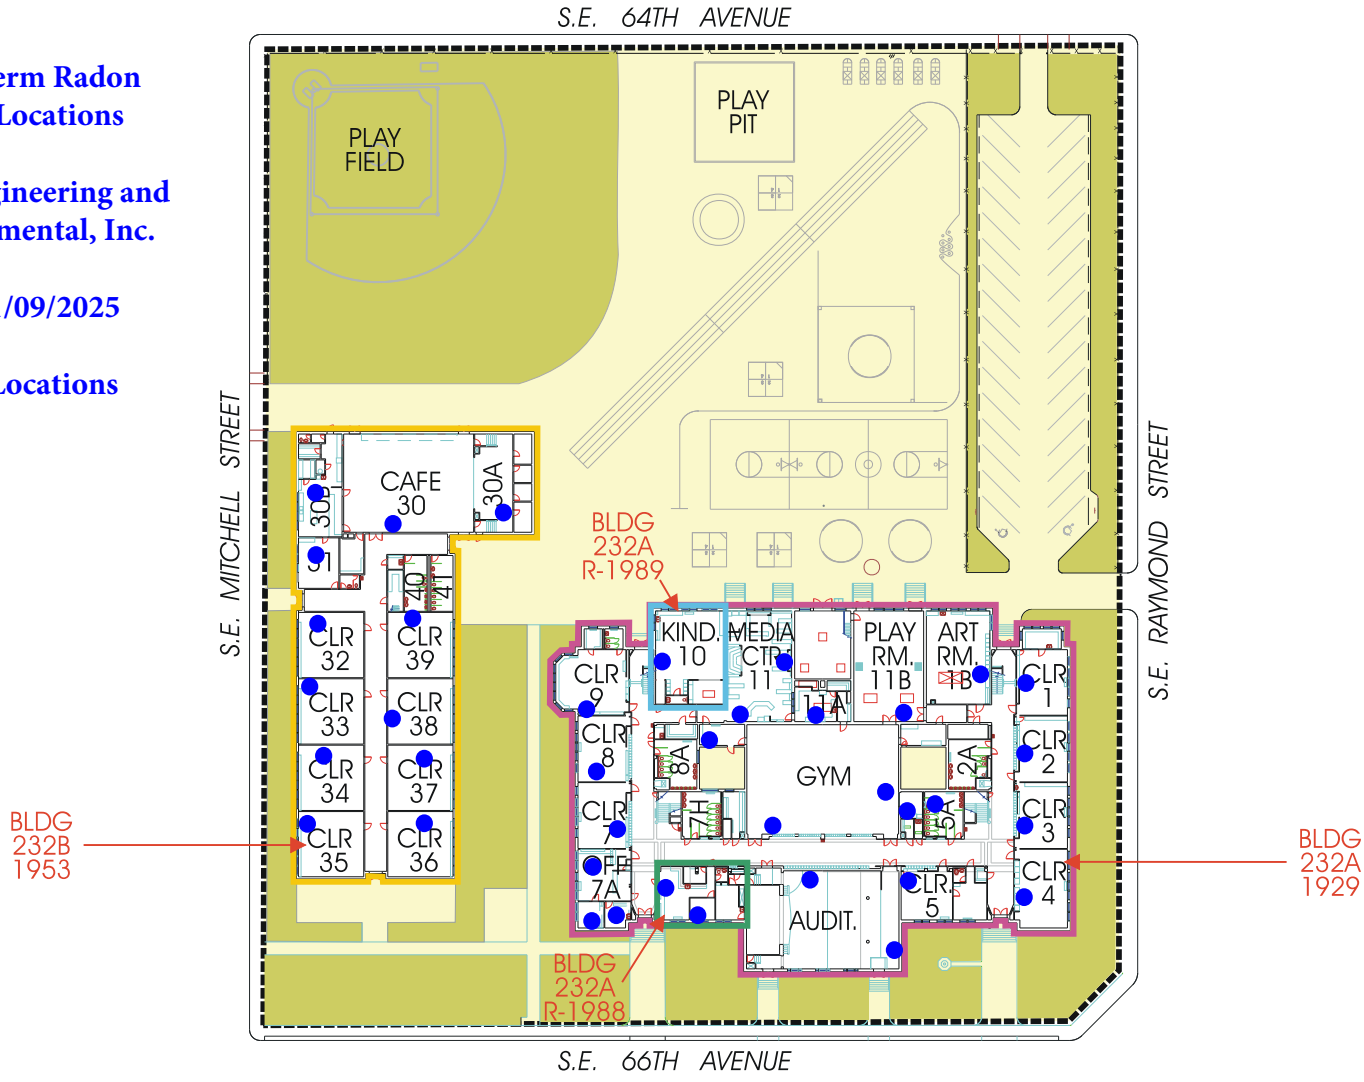
Test Kit Number	Sample Location	Radon Level (pCi/L)
RK110765	1953 Annex Cafeteria Stage	6.0 ± 0.7

PBS found results were also close to the action level in the 1953 annex cafeteria adjacent to the stage. See the attached laboratory analysis report for more details and the attached informal sample location map approximate locations of where samples were collected.

- **If the result is from 4.0 pCi/L to 8.0 pCi/L,** perform a follow-up measurement of that room using a long-term test. This test should be conducted over as much of a nine-month school year as possible, when the room is likely to be occupied. If that result is equal to or greater than 4.0 pCi/L, the radon in the room should be fixed (i.e., lowered).
