Regarding: Short Term Radon Testing
Lincoln High School
1750 SW Salmon Street
Portland, Oregon
PBS Project 25000.241 Phase 0025

Short-Term Radon Testing Locations
PBS Engineering and Environmental, Inc.

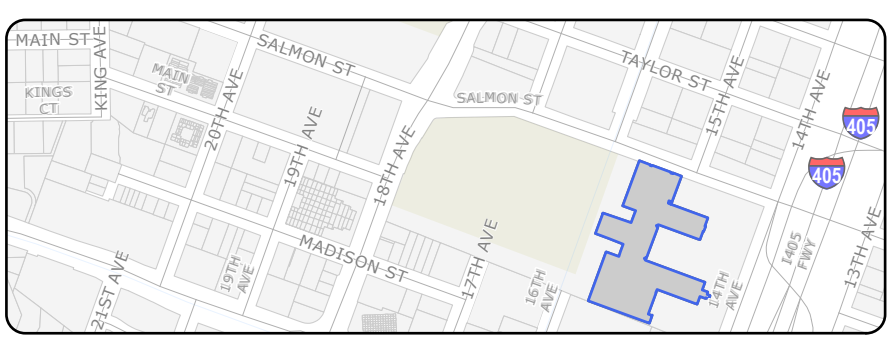
LINCOLN: First Floor

Laboratory results found concentrations below the EPA action level in all tested locations in the building. See the attached laboratory analysis report for more details and the attached informal sample location map approximate locations of where samples were collected.
