Regarding: Short Term Radon Testing
Rose City Park Elementary School
2334 NE 57th Avenue
Portland, Oregon
PBS Project 25000.241 Phase 0018

RADON MONITORING REPORT

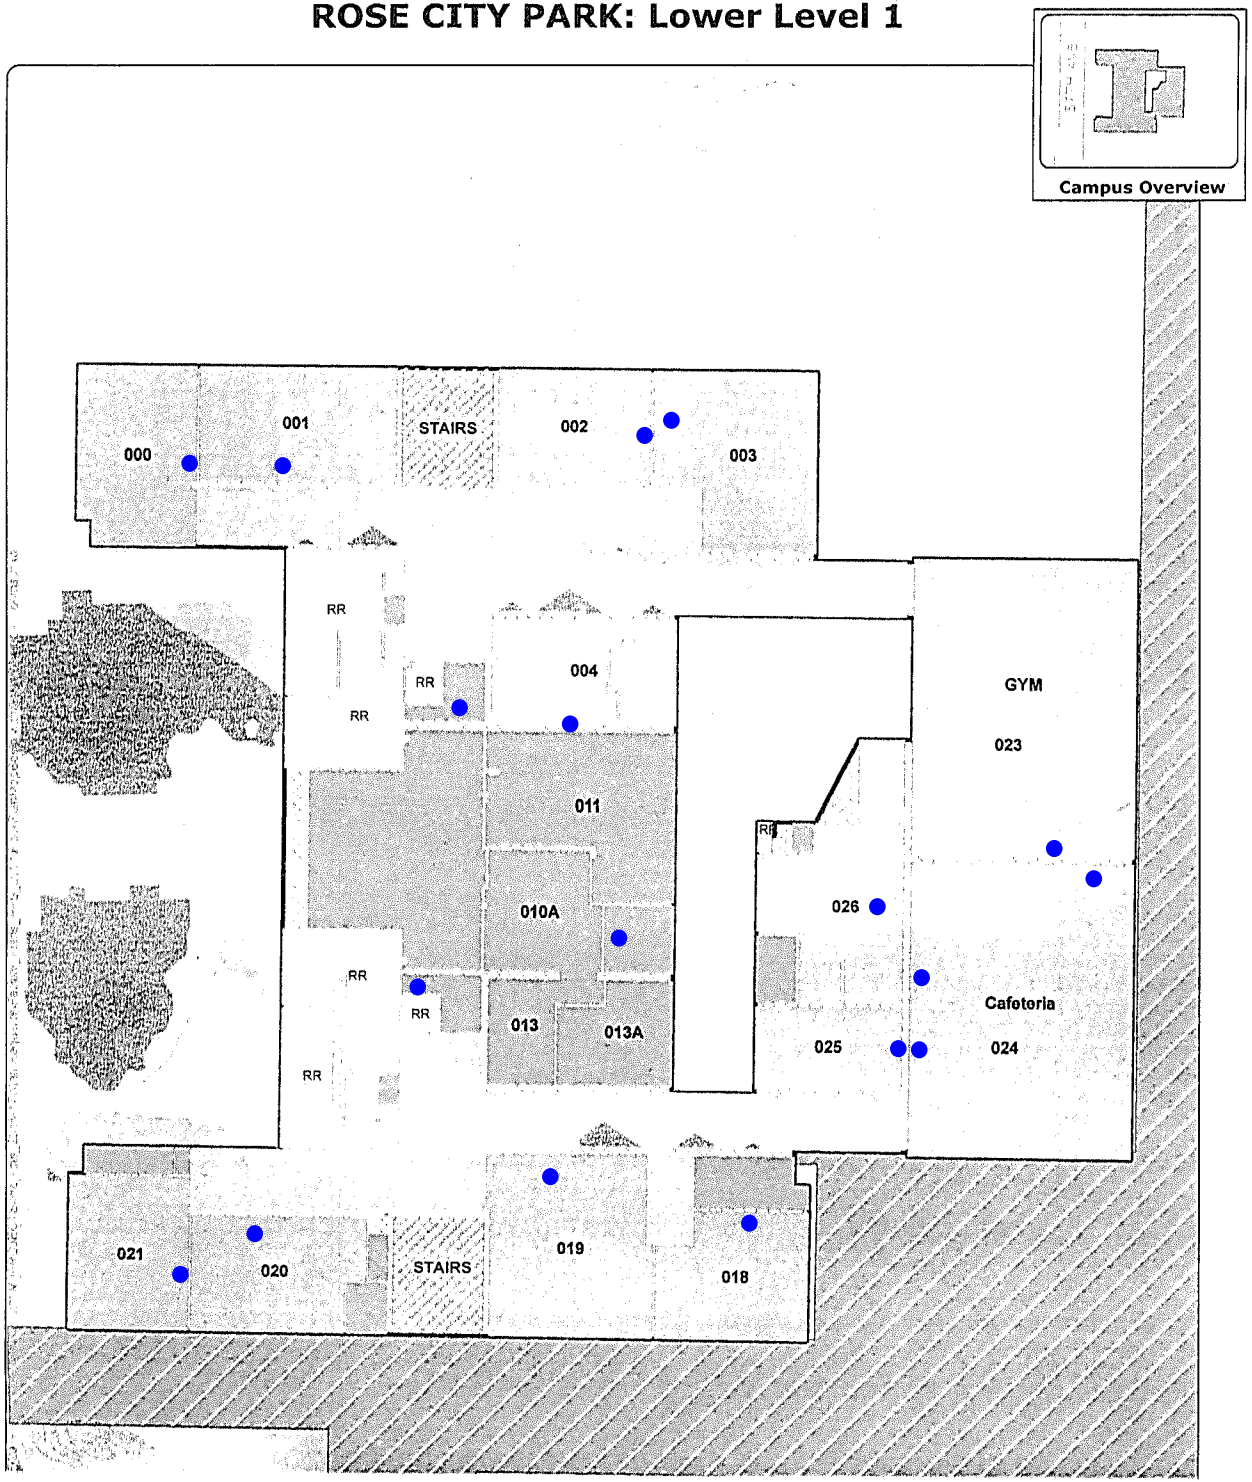
ROSE CITY PARK: Lower Level 1

Short-Term Radon Testing Locations
PBS Engineering and Environmental, Inc.
2/14-2/17/2023
