February 14, 2025

Steve Aldrich
Director of Facilities and Grounds
Liberty School District
801 Kent Street
Liberty, Missouri 64068

Project: Limited Lead in Drinking Water Testing
Address: 1500 South Withers Road, Liberty, Missouri 64068

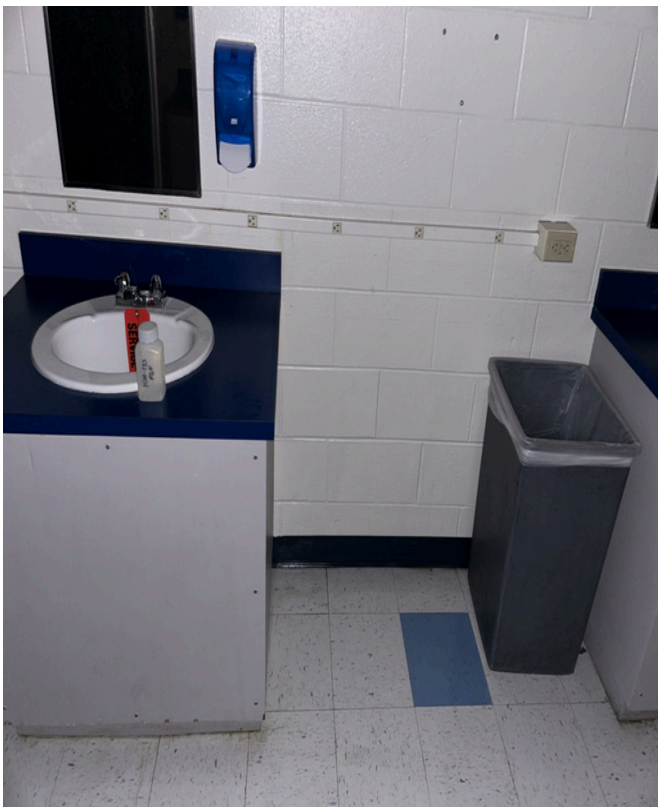
7/2/2024 - 1500-132 - Liberty Middle School - 004315-Boys Lockers

Determination of Total Metals	Result	RL	Units	DF	Note	Prepared	Analyzed	Analyst
200.8								
Lead, total	**8.7**	0.4	ppb	2		07/24/24 0323	07/24/24 0323	RVV

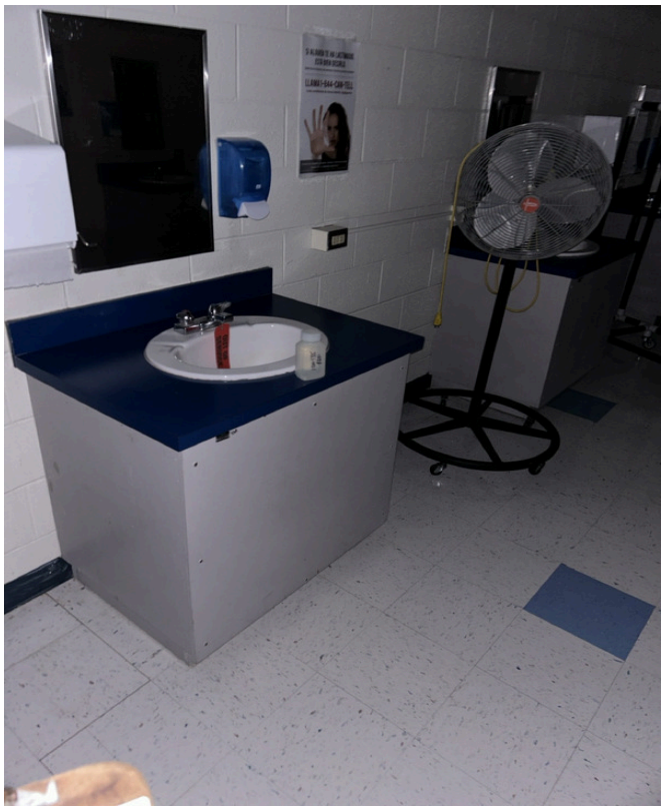
7/2/2024 - 1500-133 - Liberty Middle School - 004316-Boys Lockers

Determination of Total Metals	Result	RL	Units	DF	Note	Prepared	Analyzed	Analyst
200.8								
Lead, total	**11.4**	0.4	ppb	2		07/24/24 0326	07/24/24 0326	RVV

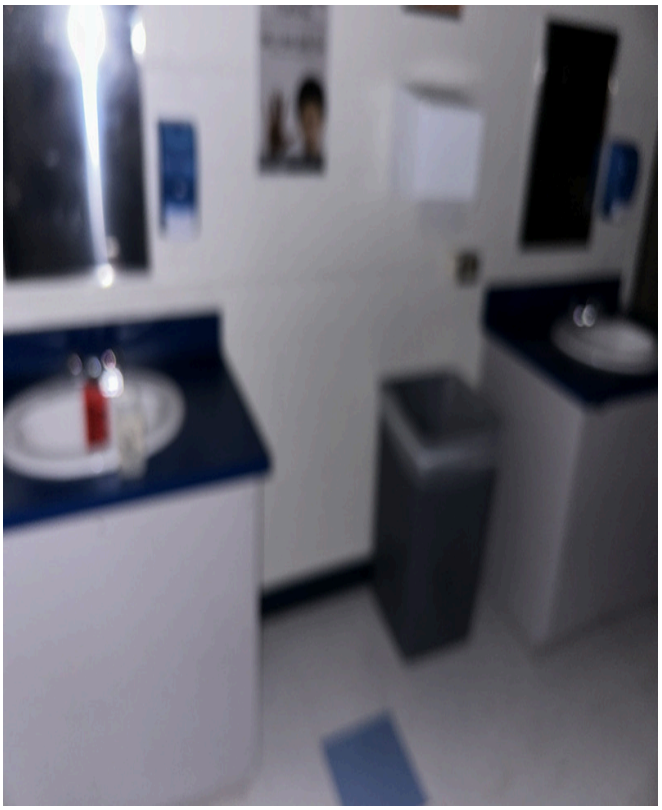
7/2/2024 - 1500-135 - Liberty Middle School - 004304-Girls Lockers

Determination of Total Metals	Result	RL	Units	DF	Note	Prepared	Analyzed	Analyst
200.8								
Lead, total	**1.5**	0.4	ppb	2		07/24/24 0329	07/24/24 0329	RVV
