ROOFING REPLACEMENT AT DATA MIDDLE SCHOOL

ADDENDUM #01

Limited Lead-Based Paint Investigation and Report

DeAnza Academy (DATA)
2060 Cameron Street
Ventura, CA 93003

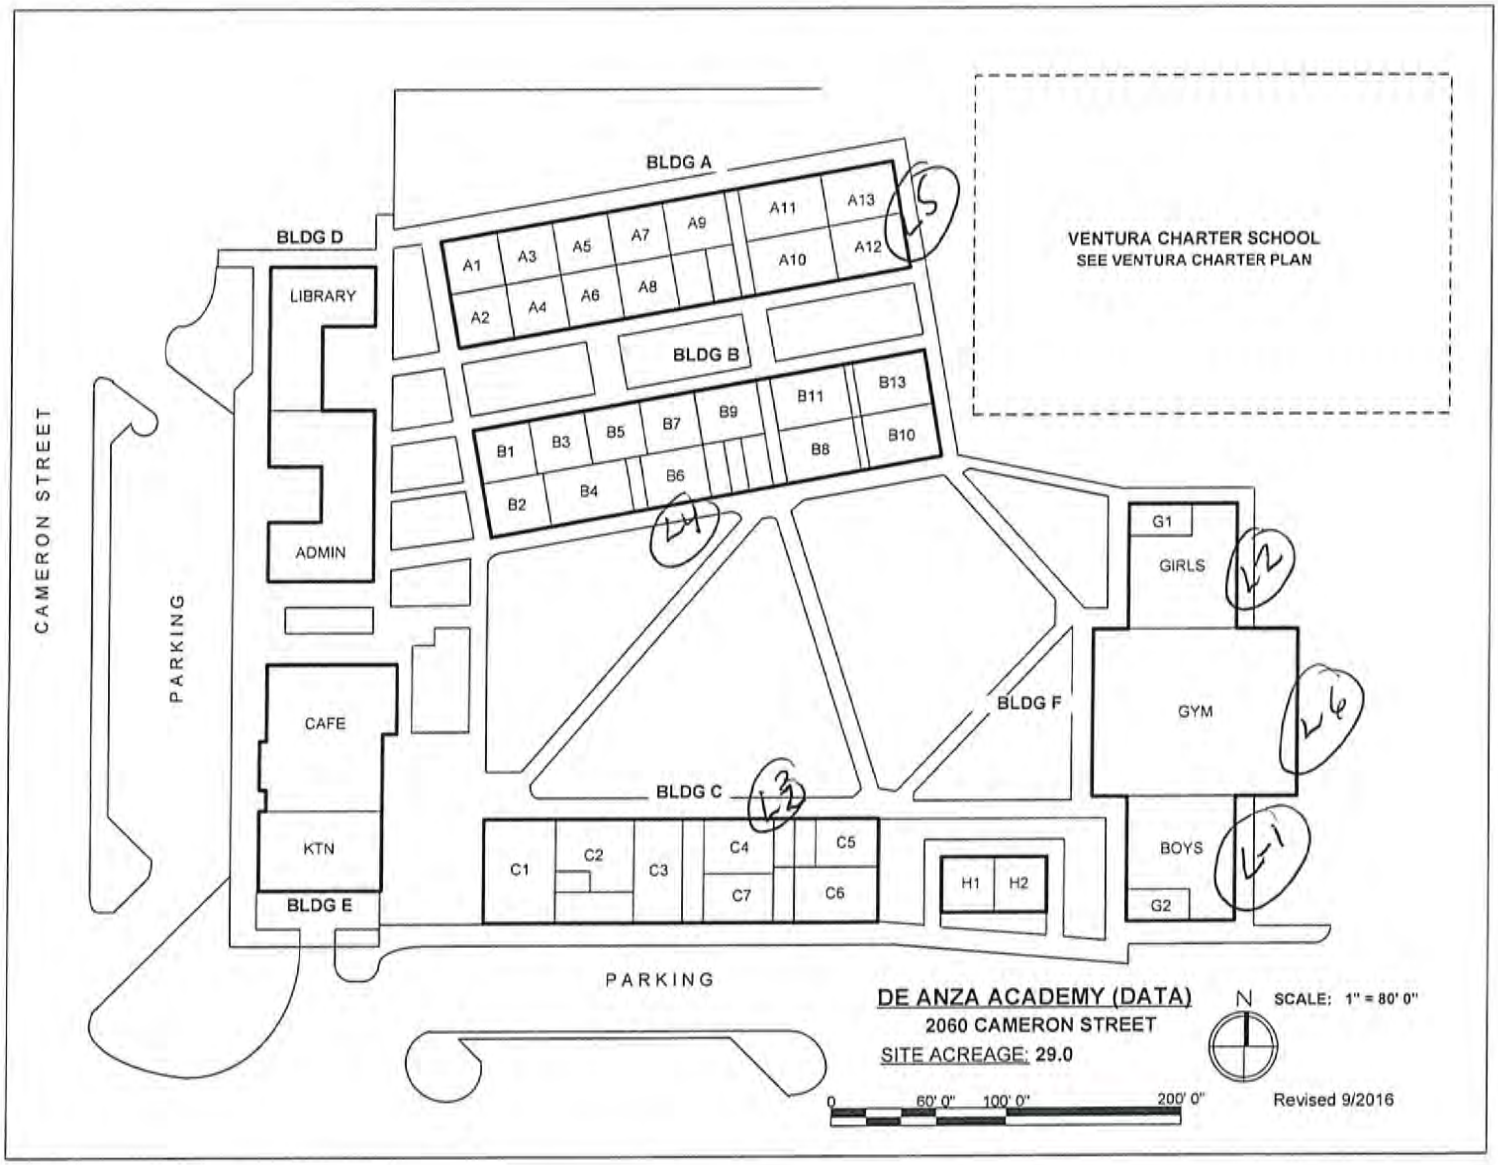
L-5: Fascia	**2.0 % wt.**

L-1: Fascia	**0.420% wt.**
L-2: Fascia	**0.200% wt.**
L-3: Fascia	**0.280% wt.**
L-4: Fascia	**0.019% wt.**

L-6: Stucco System	**0.006% wt.**
