AHERA ASBESTOS MANAGEMENT PLAN

KYRENE APRENDE MIDDLE SCHOOL
777 NORTH DESERT BREEZE BLVD E.
CHANDLER, ARIZONA 85226

Dominion Environmental Consultants, Inc.
20045 North 19th Avenue, Building 7
Phoenix, Arizona 85027
(623) 516-1415

August 2, 2025

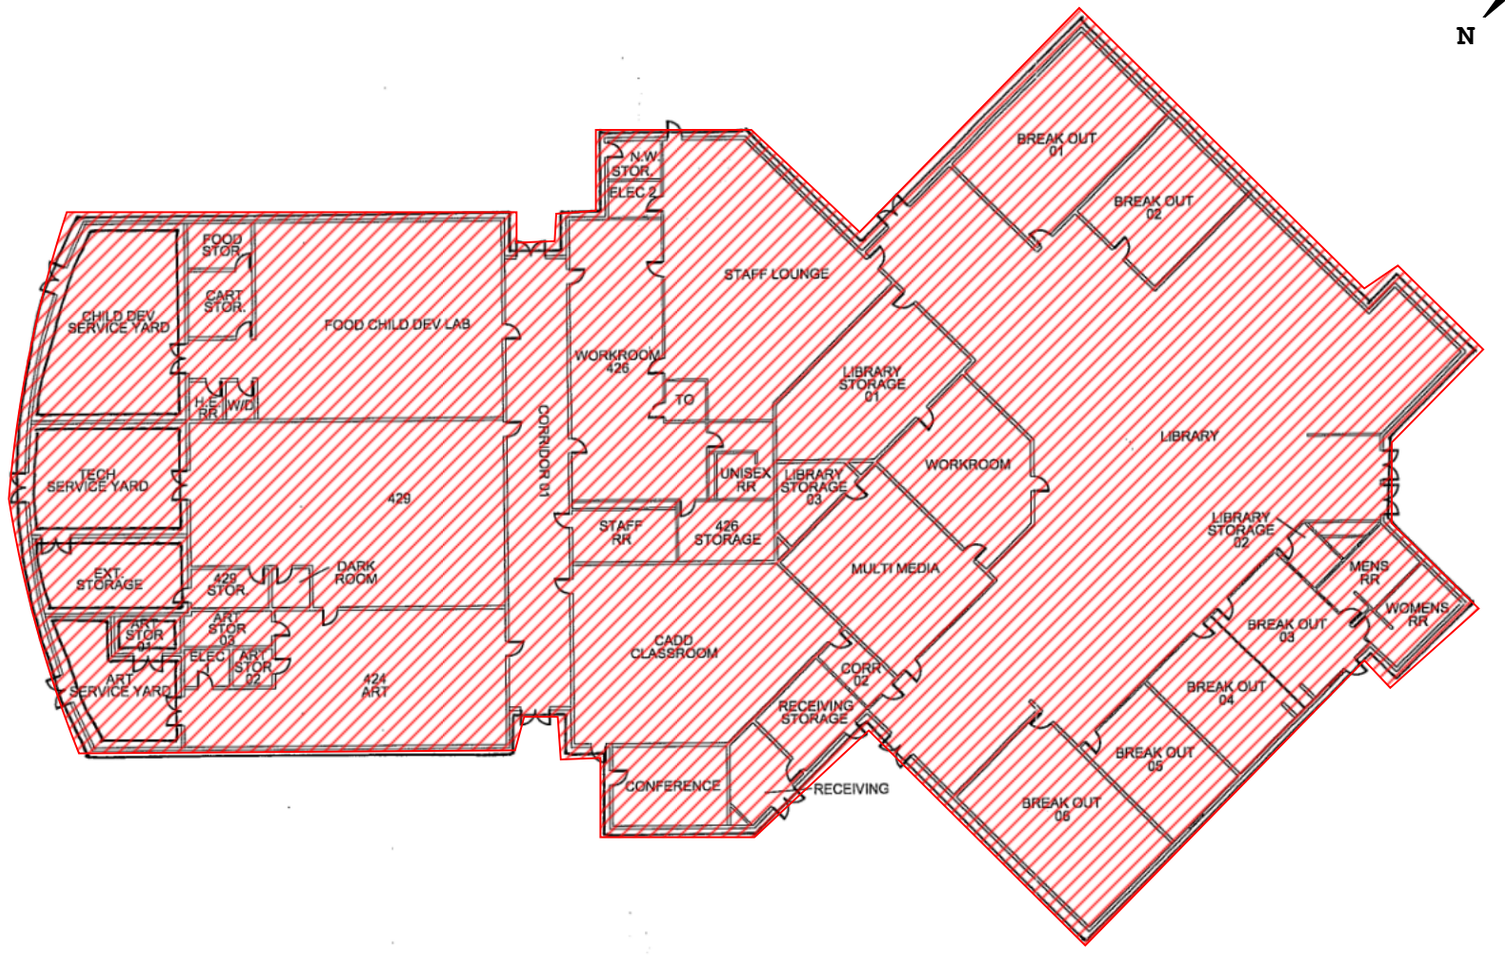
Assumed Asbestos-Containing Material Location Map (3)
Kyrene Aprende Middle School
777 North Desert Breeze Blvd. E, Chandler, Arizona

Black Chalk Board

Gray Cove Base & Mastic

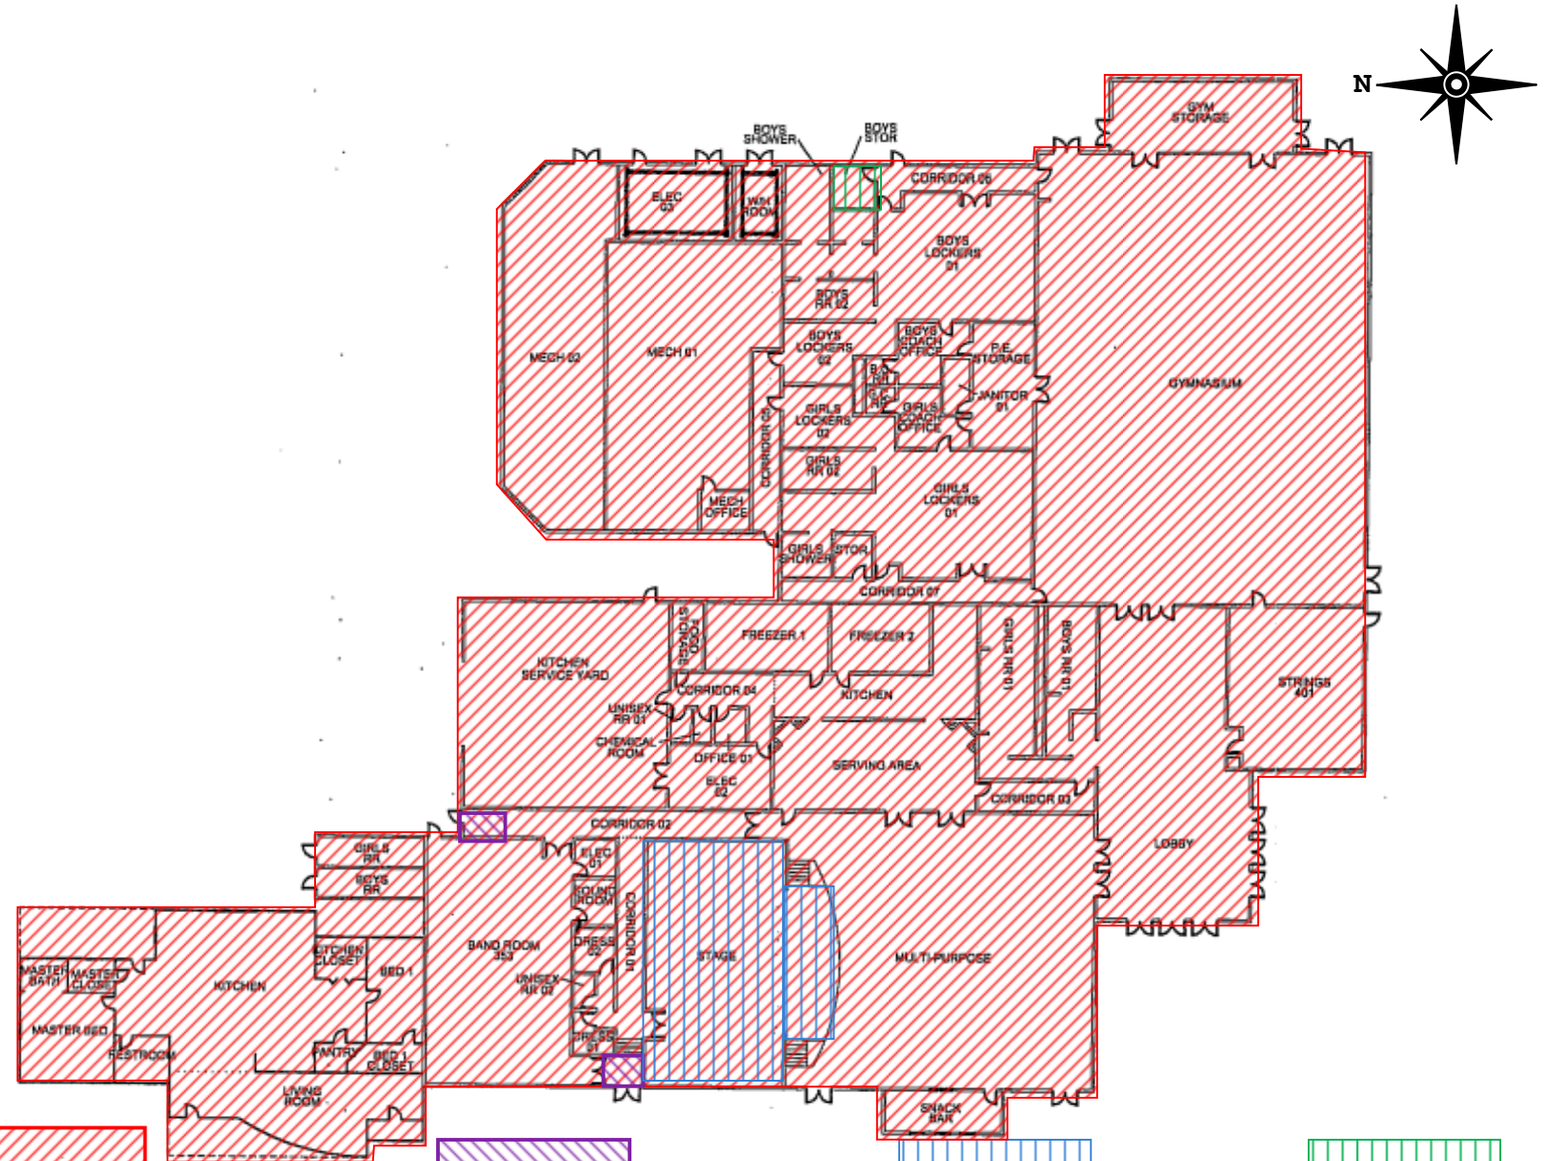
Assumed Asbestos-Containing Material Location Map (4) — Project No. AZ1418.55

Untextured Drywall System, Ceiling Wrap Backing & Insulation, Gray Duct Mastic, Silver Flex Duct Wrap & Insulation, Silver Duct Wrap & Insulation, Pipe Wrap & Insulation, & Red Fire Stop Caulking

*** Above the Plenum**

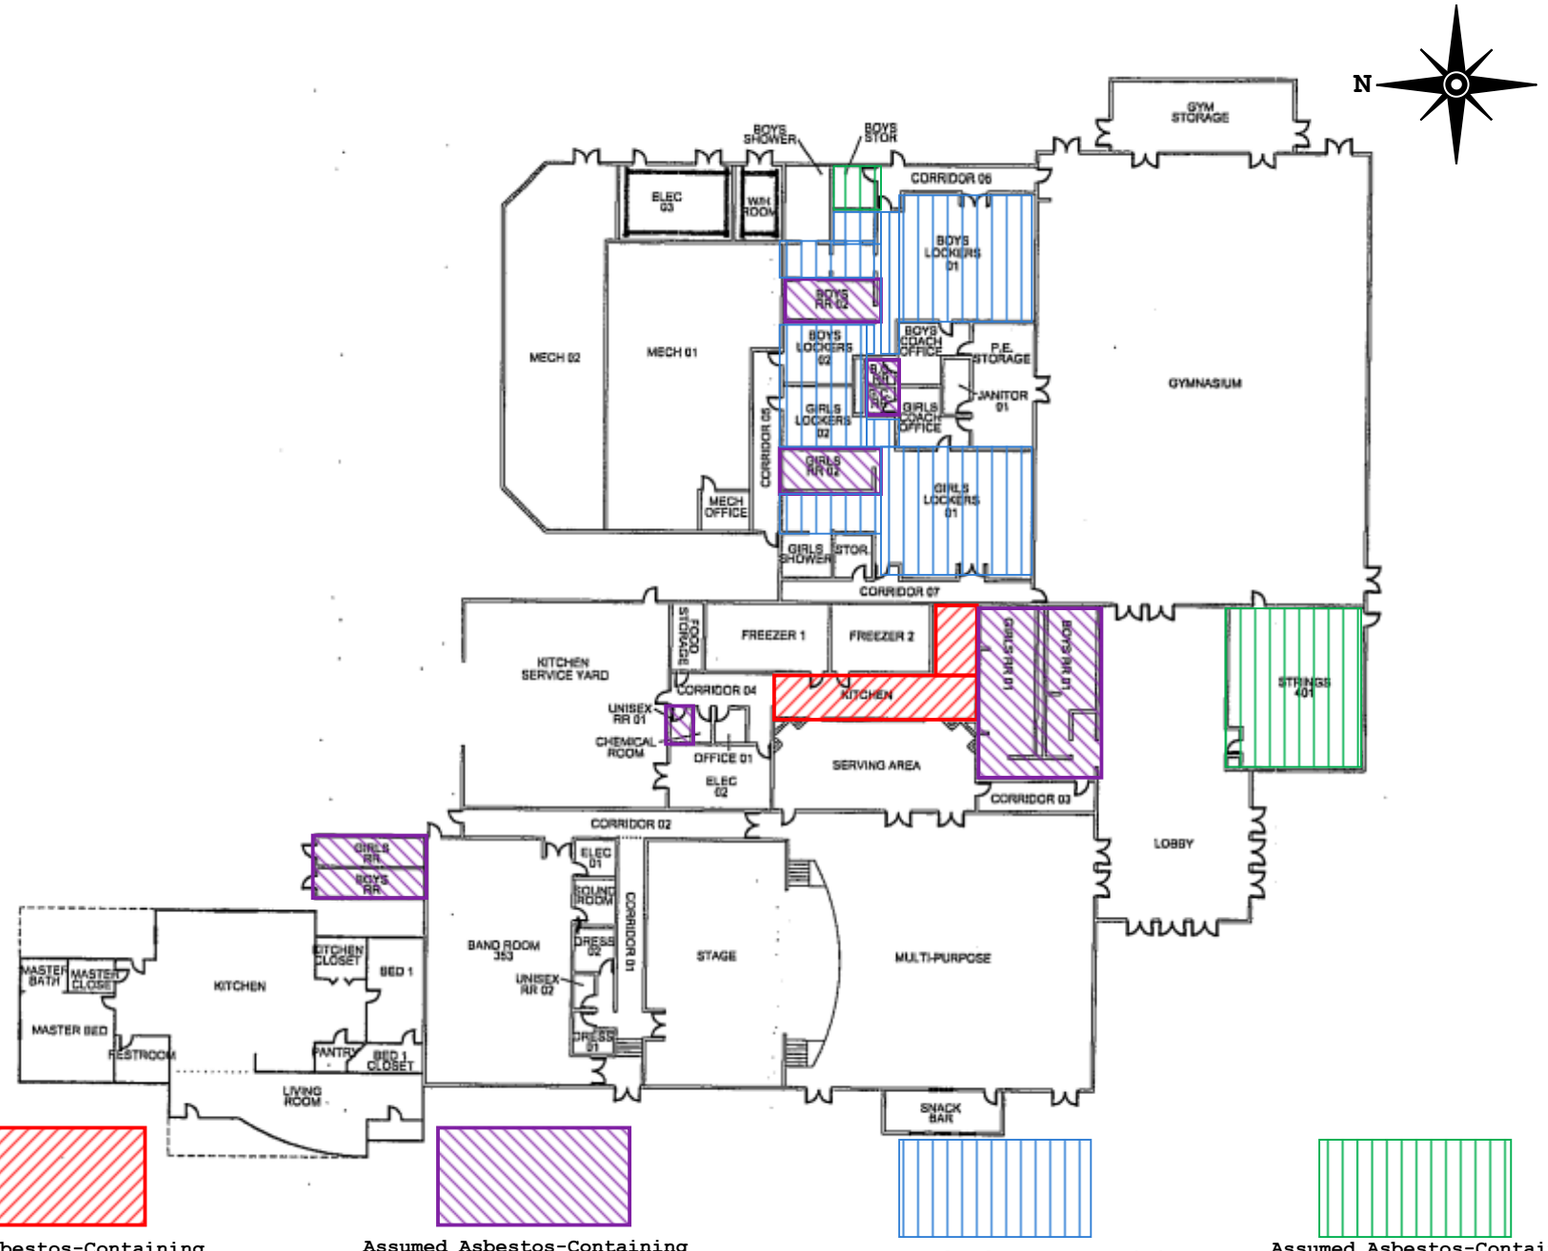
Assumed Asbestos-Containing Material Location Map (1)
Kyrene Aprende Middle School
777 North Desert Breeze Blvd. E, Chandler, Arizona

Black Floor Coating

Gray Carpet & Mastic

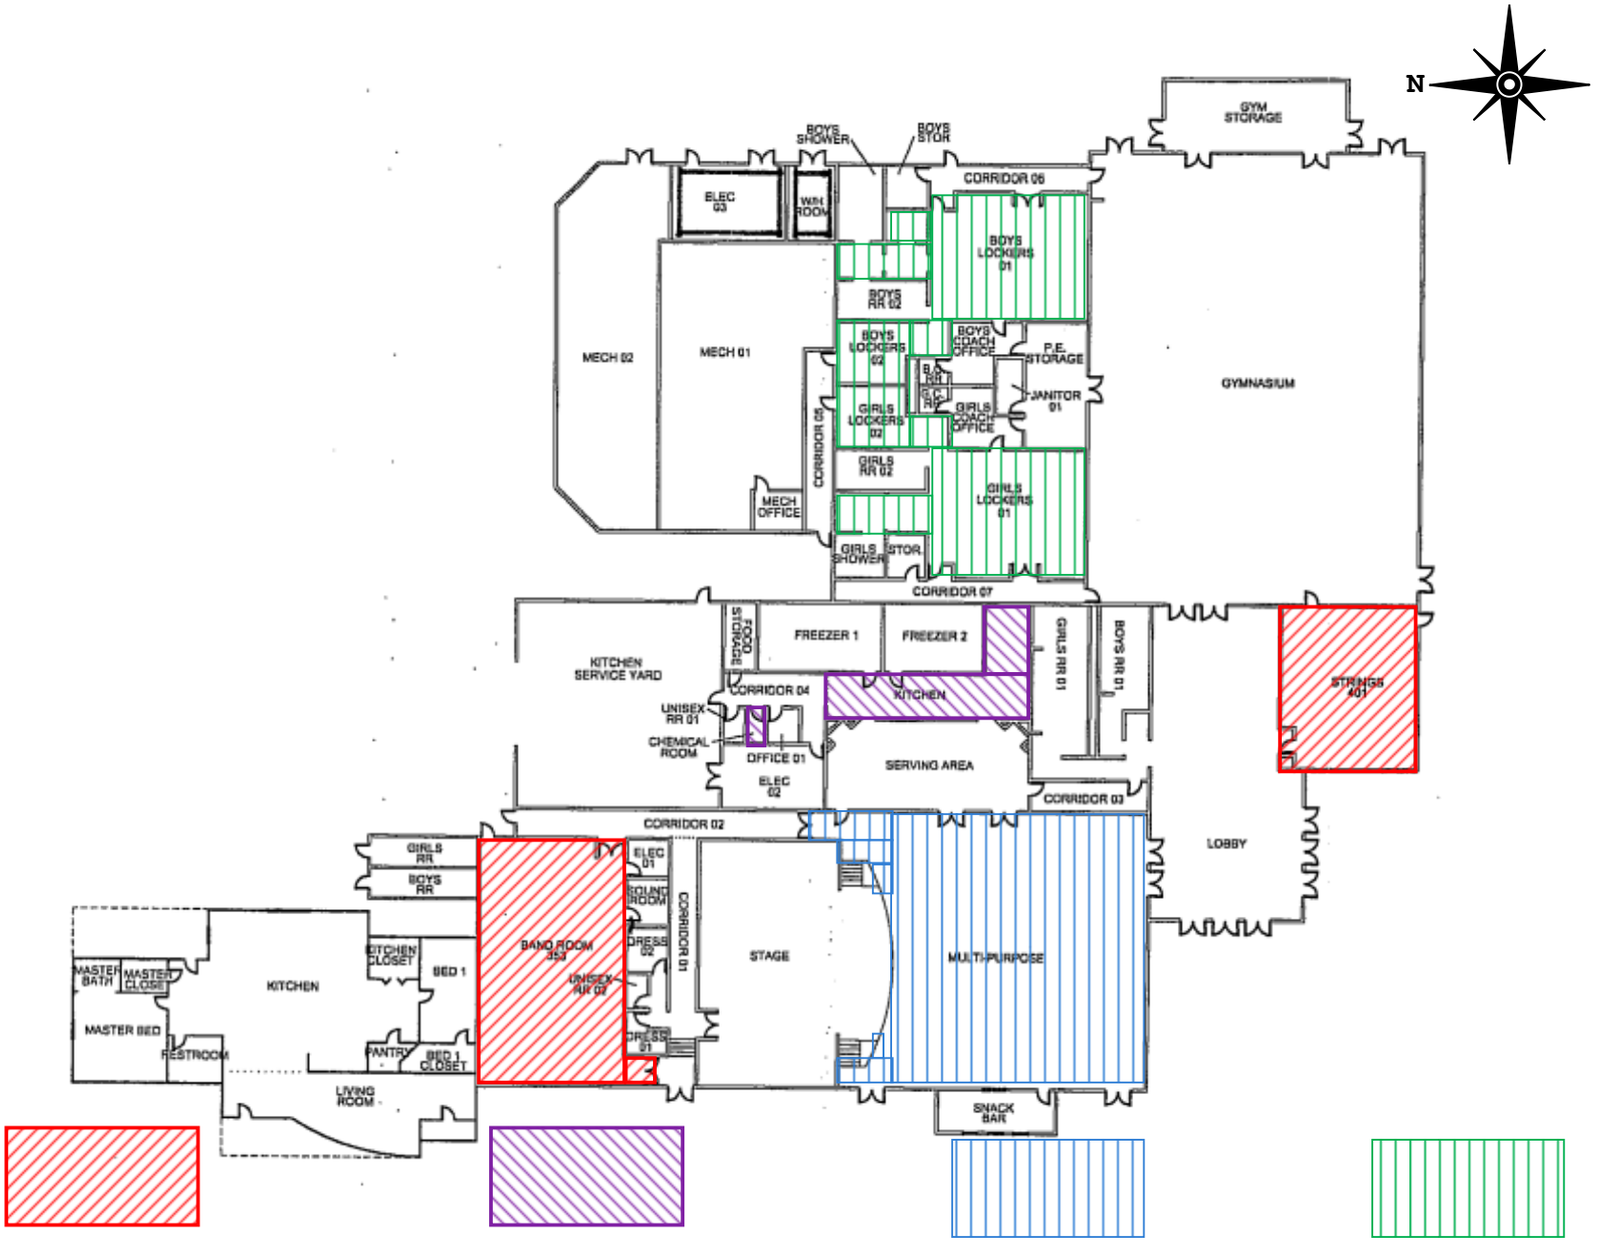
Assumed Asbestos-Containing Material Location Map (2)
Kyrene Aprende Middle School
777 North Desert Breeze Blvd. E, Chandler, Arizona

Gray 3" x 6" Ceramic Cove Base, Grout, & Mastic

Black 4" Cove Base & Mastic & Black Flooring & Mastic

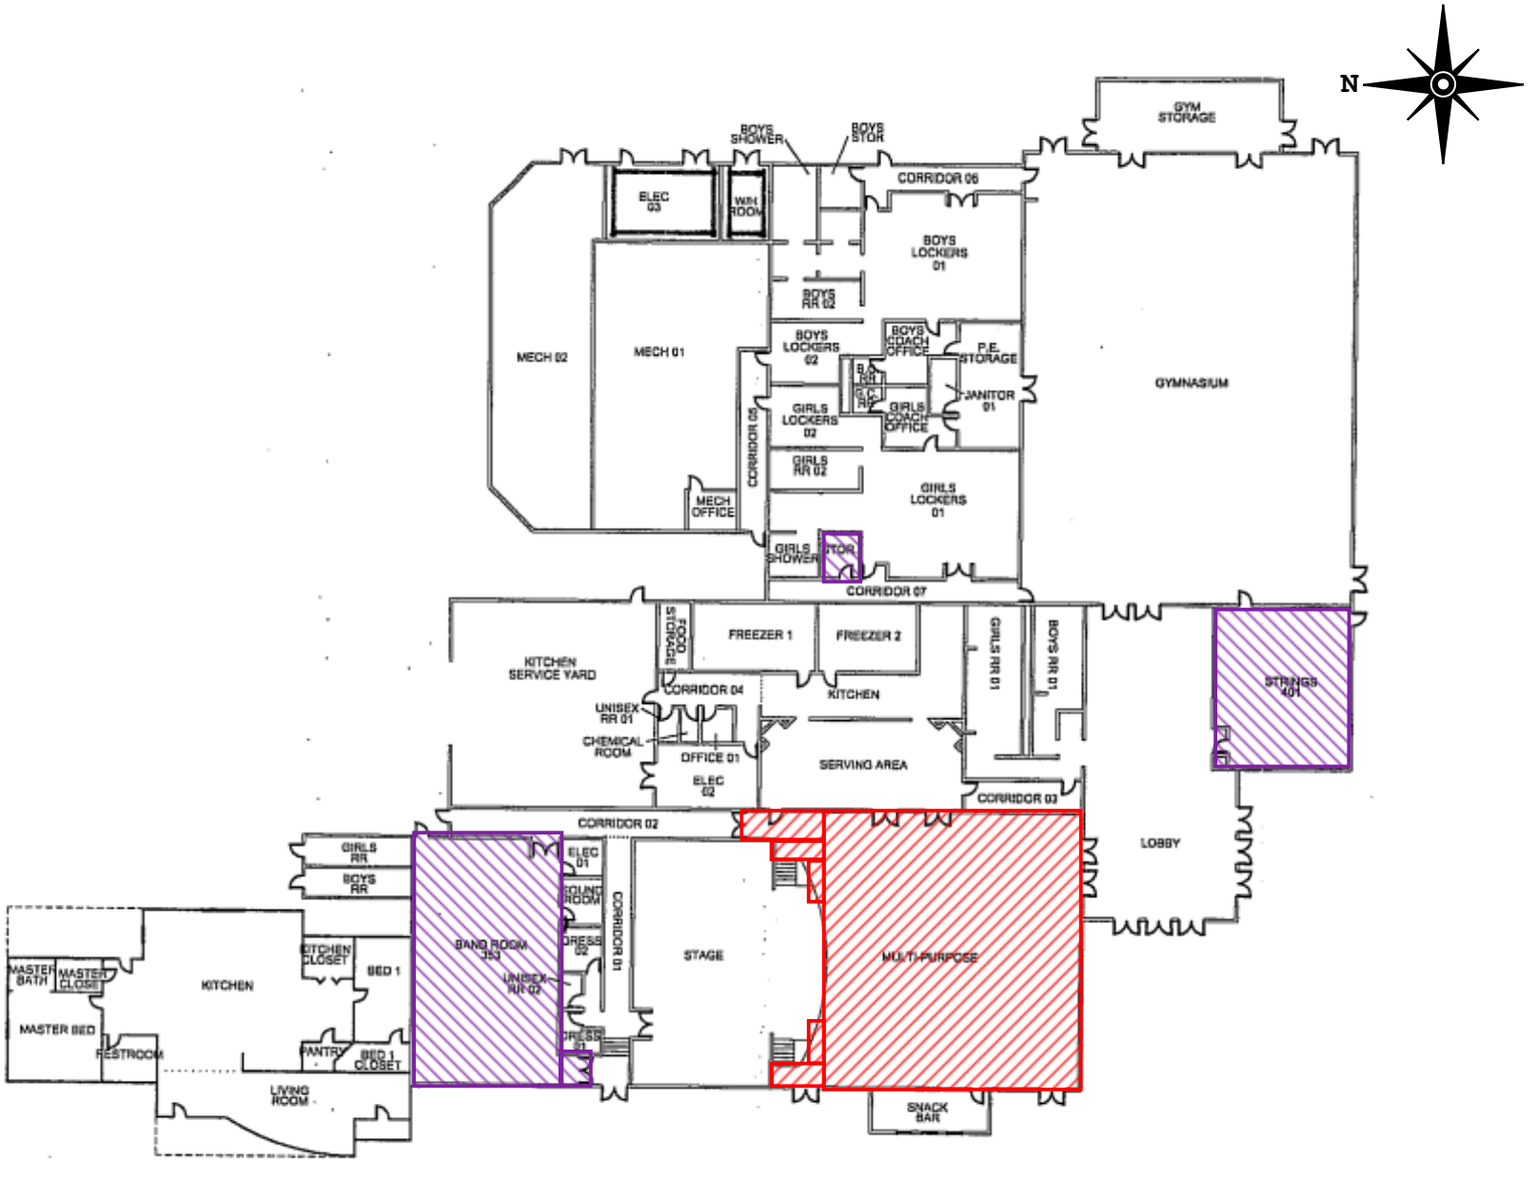
Assumed Asbestos-Containing Material Location Map (3)
Kyrene Aprende Middle School
777 North Desert Breeze Blvd. E, Chandler, Arizona

4" Gray Cove Base & Mastic & Silver Backing & Insulation

Beige 4" x 4" Ceramic Wall Tile & Grout
