AHERA ASBESTOS MANAGEMENT PLAN

KYRENE DE LA MARIPOSA SCIENCE ACADEMY
50 EAST KNOX ROAD
TEMPE, ARIZONA 85384

Dominion Environmental Consultants, Inc.
20045 North 19th Avenue, Building 7
Phoenix, Arizona 85027
(623) 516-1415

July 30, 2025

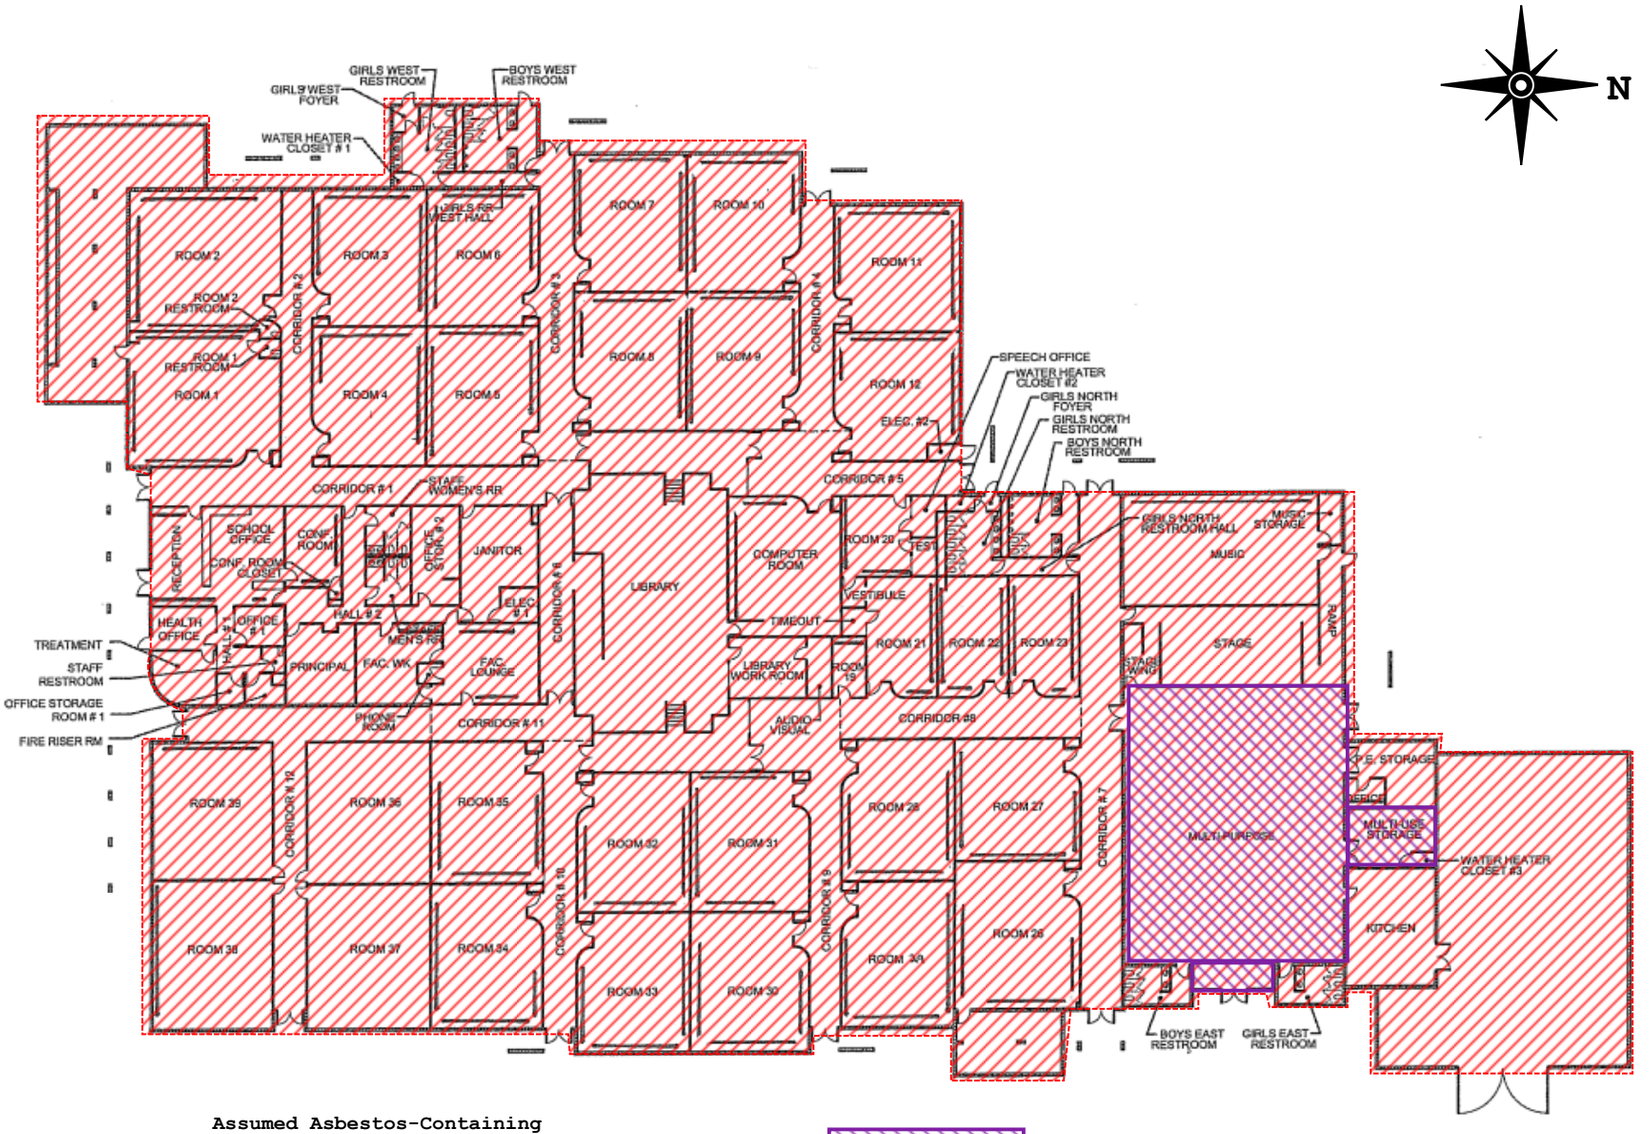
Main Building

Assumed Asbestos-Containing

Interior Caulking, White w/ Gray 12" x 12" Vinyl Floor Tile & Mastic, White Sink Coating, Gray 6" x 6" Ceramic Floor Tile, Grout, & Thinset, White 4" x 4" Ceramic Wall Tile, Grout, & Mastic, Beige 4" x 4" Ceramic Wall Tile, Grout, & Mastic, Tacboard, Glass Block Mortar, Divider Wall, & Brick & Mortar

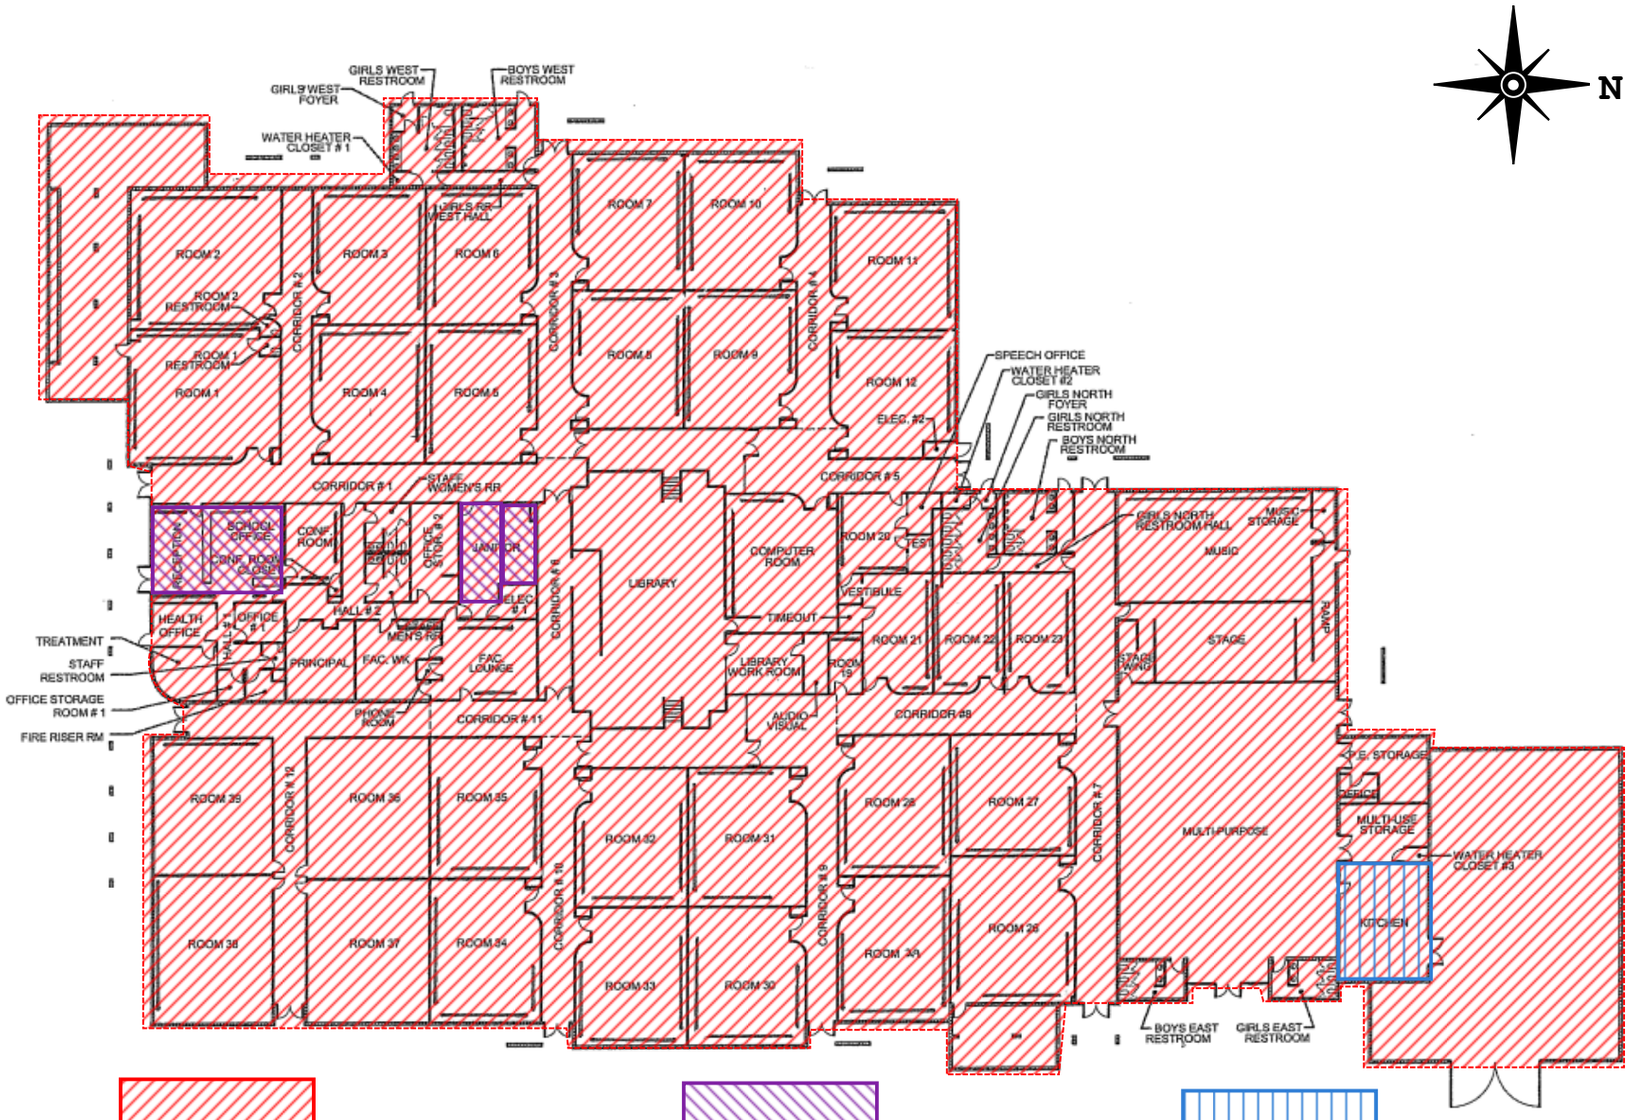
Main Building

Assumed Asbestos-Containing

Black Chiller Tank Foam,
Gray Chiller Mastic, &
White Chiller Mastic

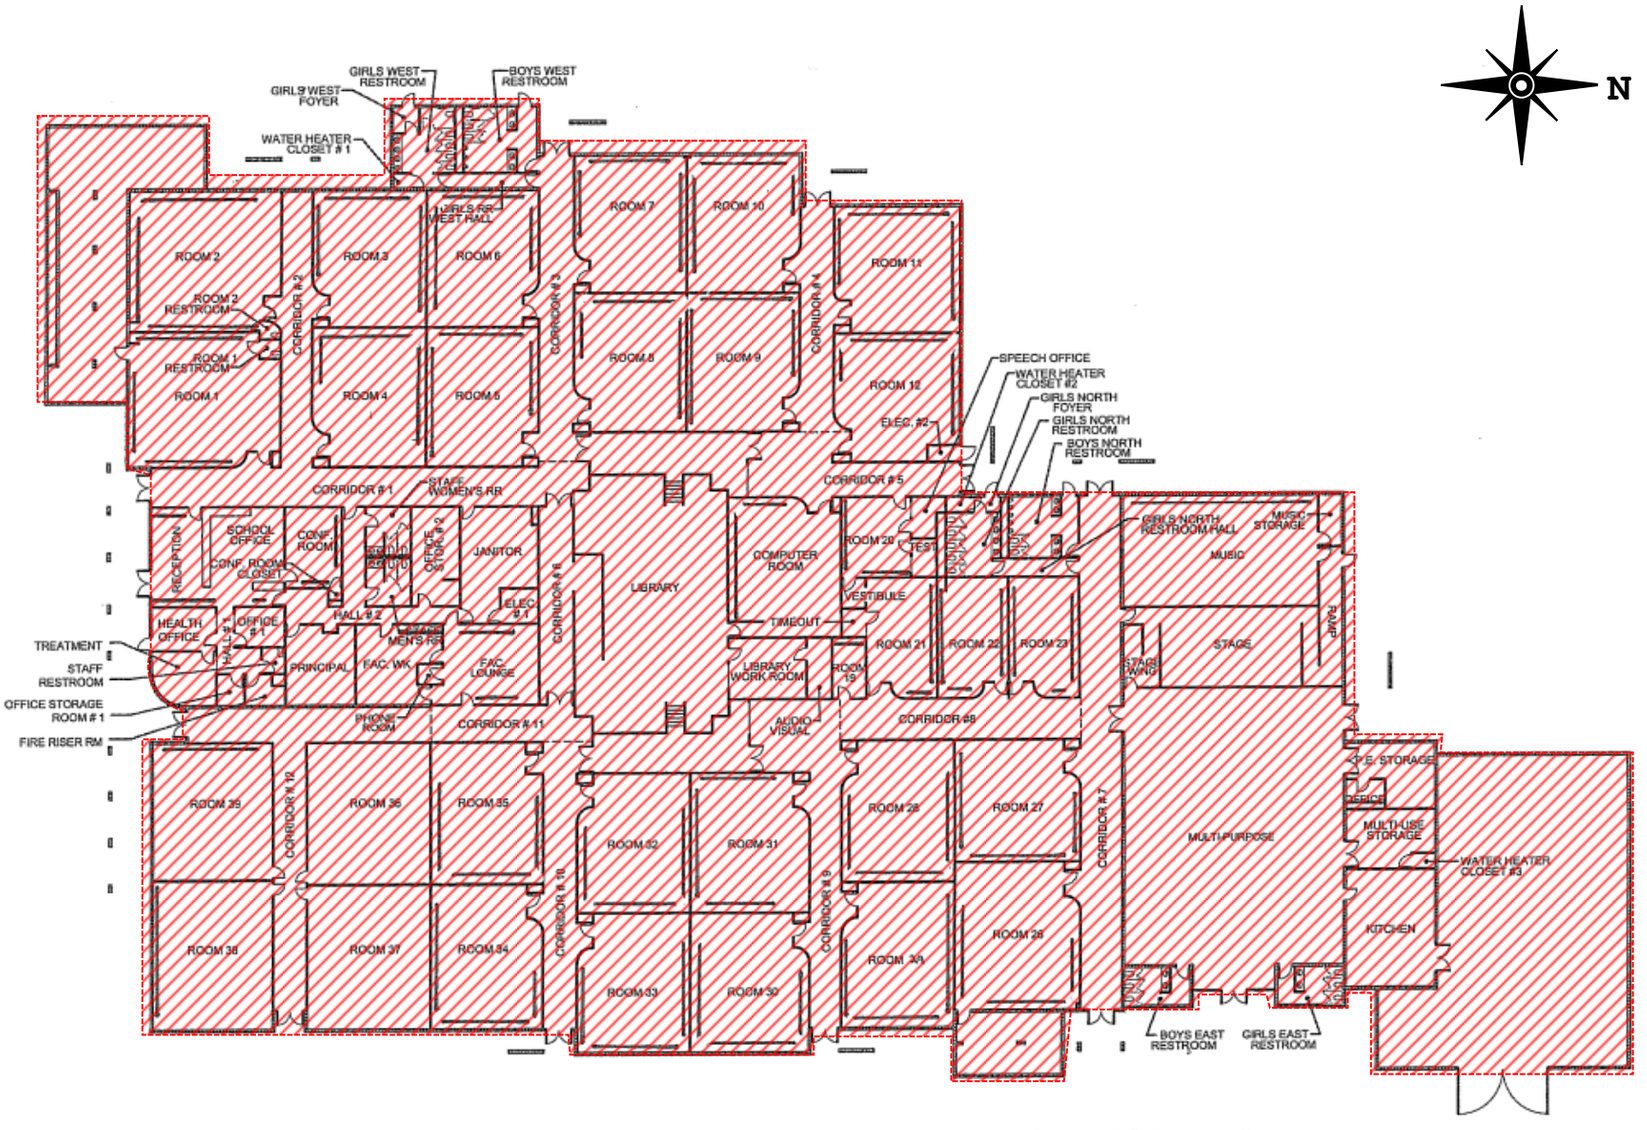
Assumed Asbestos-Containing

Silver Duct Wrap, Gray Flex Duct Wrap, Silver Duct Tape, Unfinished Drywall System, Ceiling Insulation & Backing, Gray Duct Mastic, Large White Pipe Wrap & Mastic, Small White Pipe Wrap & Mastic, & Black Foam Pipe Insulation
