Kyrene Elementary School District
8700 South Kyrene Road
Tempe, Arizona 85284

AHERA ASBESTOS MANAGEMENT PLAN

KYRENE DE LA PALOMA ARTS ACADEMY
5000 W. WHITTEN ST.
CHANDLER, ARIZONA 85226

July 26, 2025

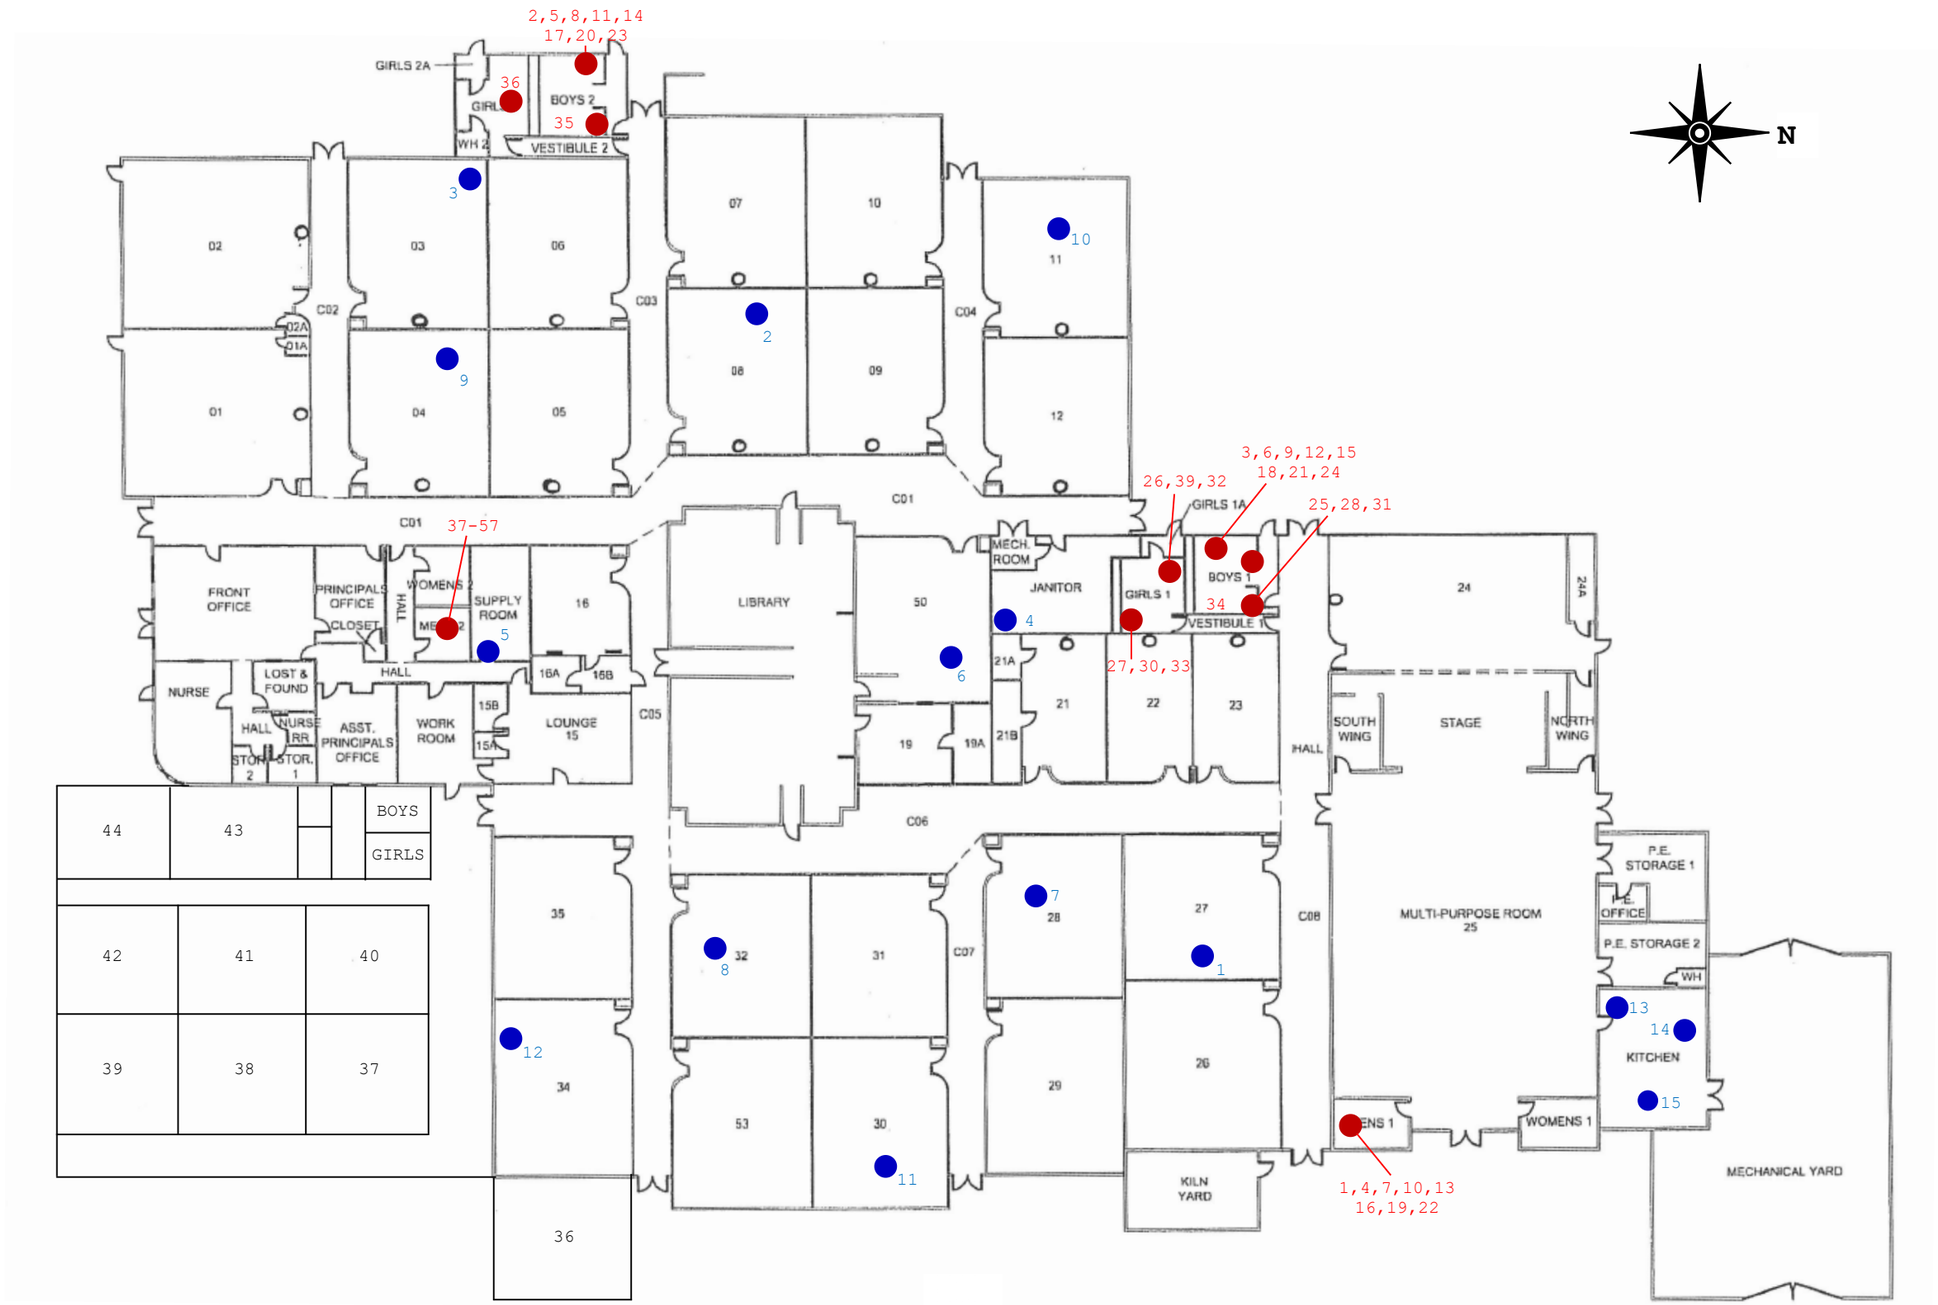
PLM Sample Location Map
Kyrene De La Paloma Arts Academy
5000 W Whitten St, Chandler, AZ 85226

Sample Date: February 28, 2024 **Sample Date: June 26, 2025**

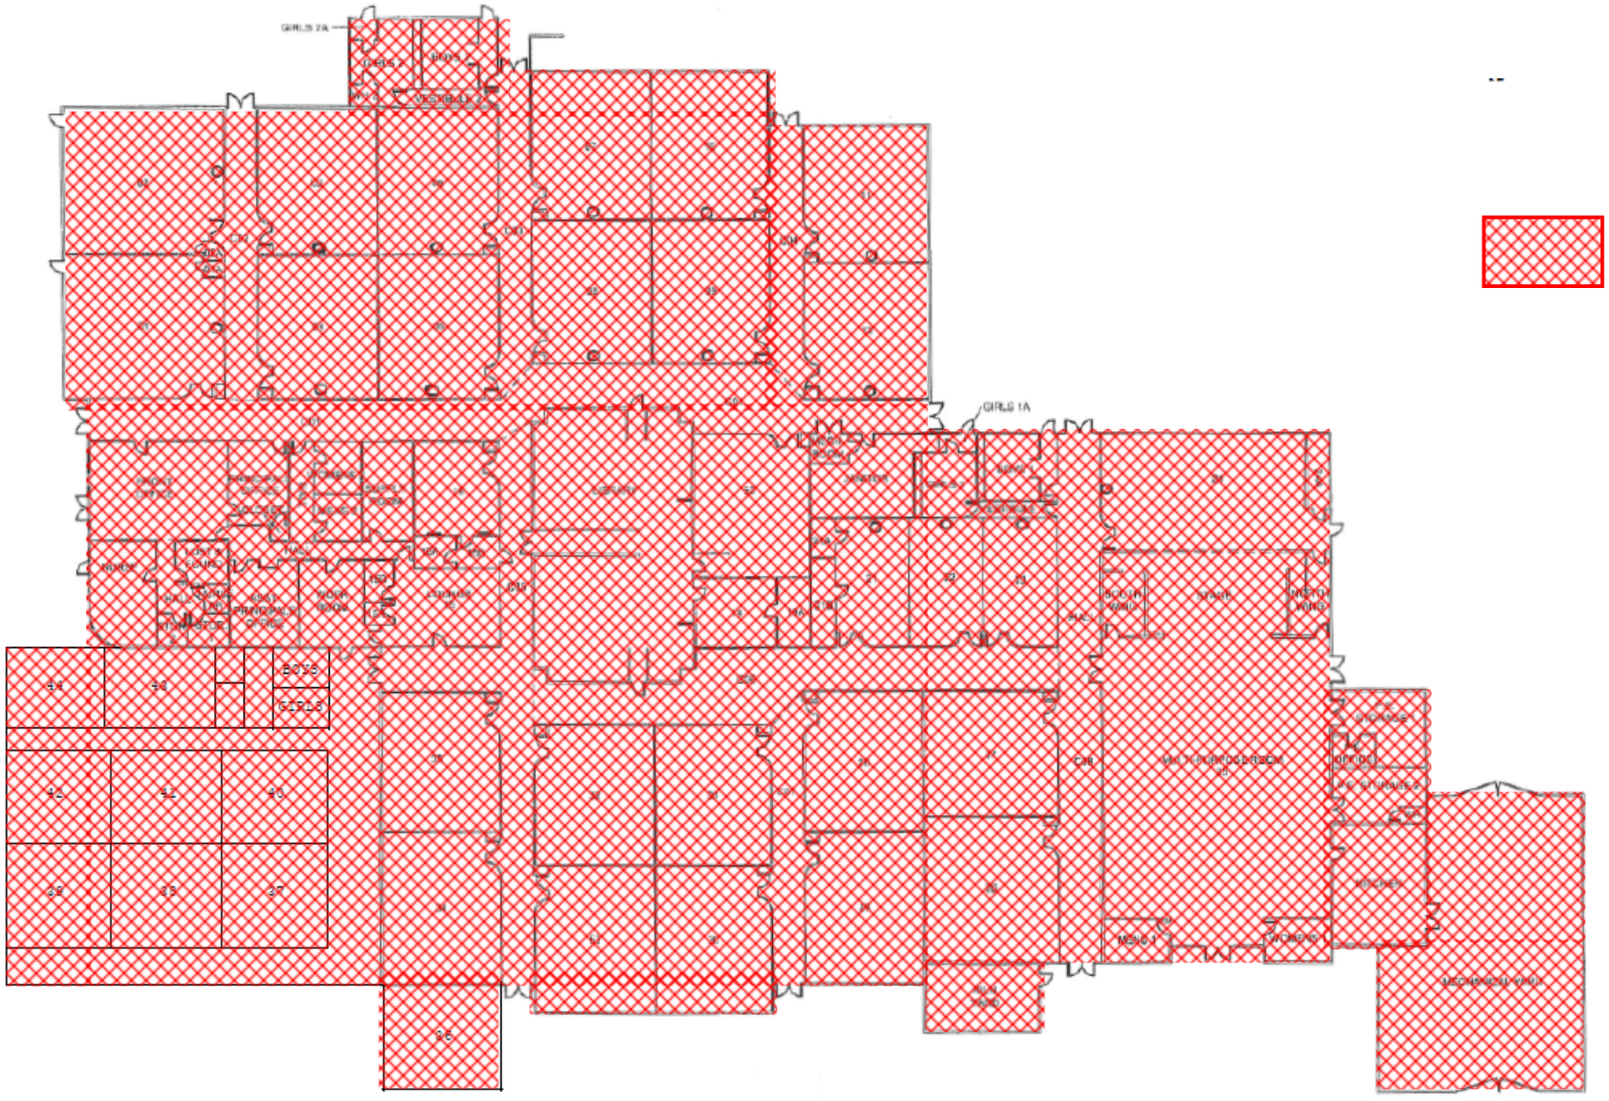
Main Bldg.

Assumed Asbestos-Containing
Tan 12"x12" VCT & Mastic
Interior/Exterior Caulking
White Sink Coating
Glass Block Mortar
Divider Wall
Brick & Mortar
Tacboard & Mastic

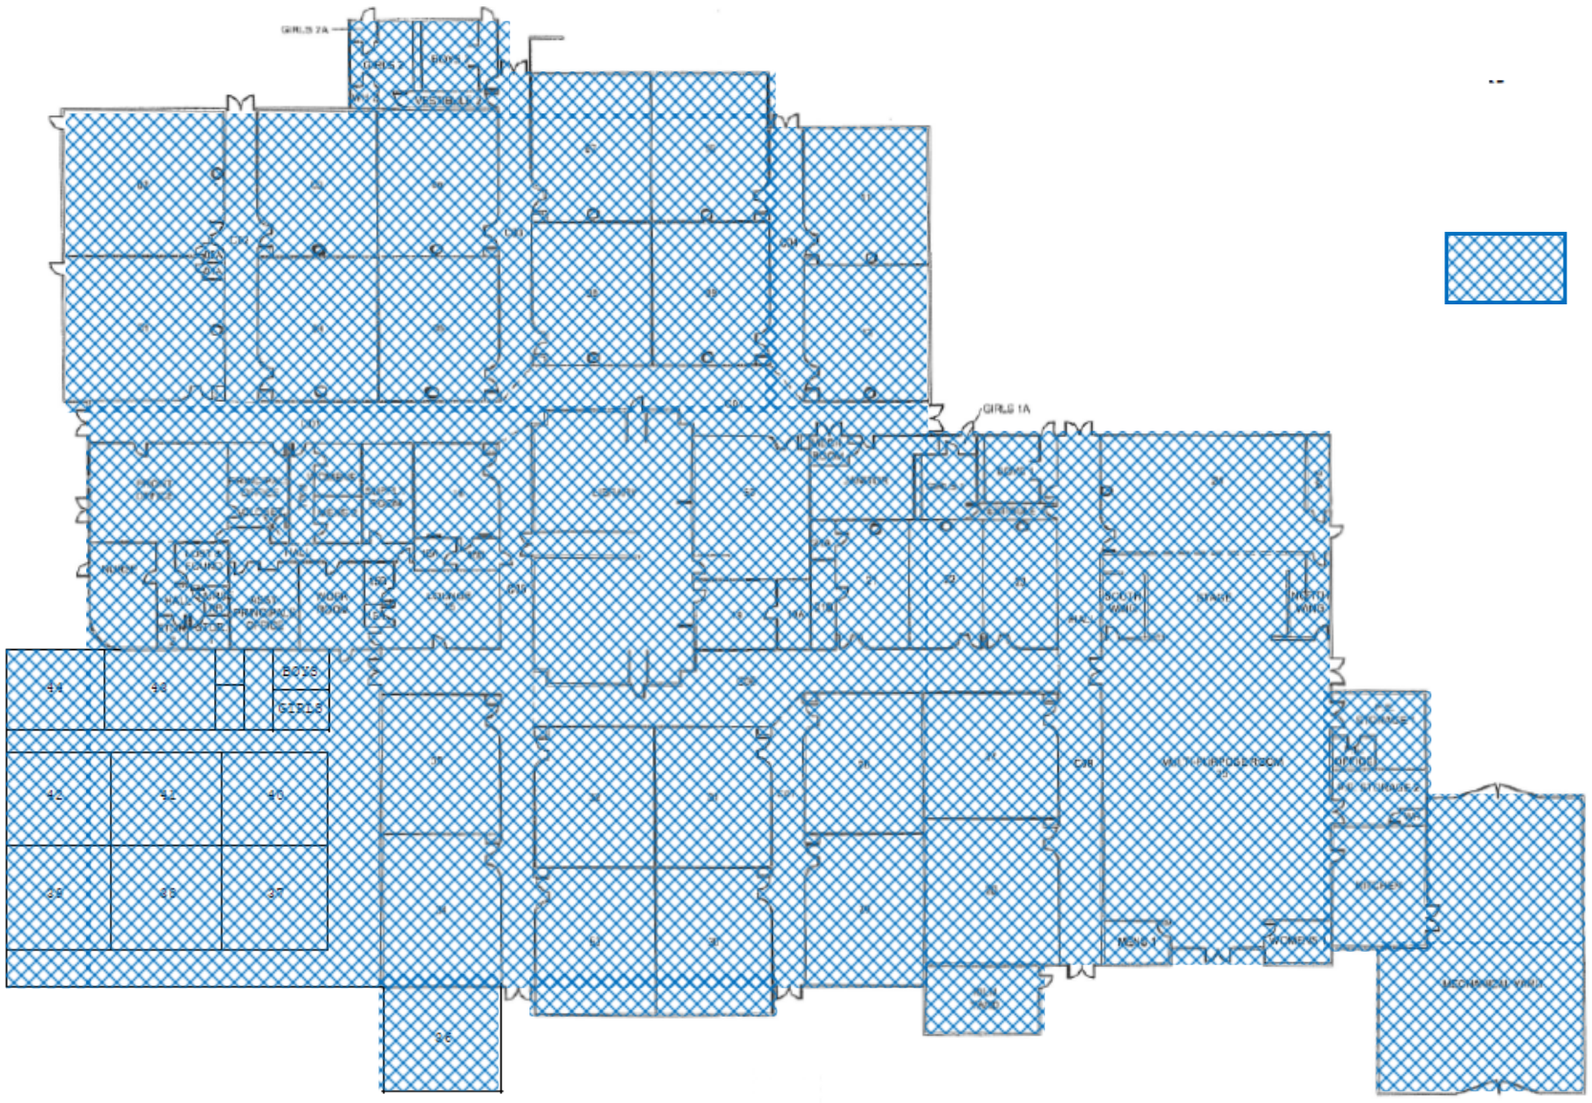
Main Bldg.

Assumed Asbestos-Containing
Gray Flex Duct Wrap
Silver Duct Wrap
Skylight Insulation Panel
Unfinished Drywall System
Silver Duct Tape
Ceiling Insulation Backing
White Duct Seam Tape & Mastic
Black Foam Pipe Insulation
