MOLD AND MOISTURE ASSESSMENT

ACPS WILLIAM RAMSEY ES R-WING

5700 SANGER AVENUE
ALEXANDRIA, VIRGINIA 22311

SEPTEMBER 17, 2025

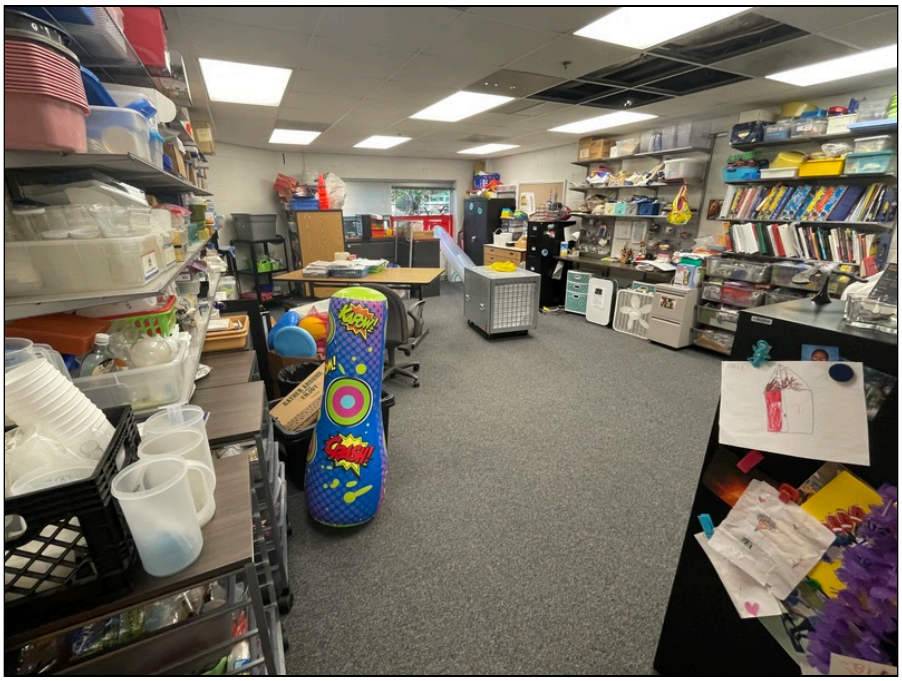
2 - Room R-9 on September 2nd with ceiling tiles removed

3 - Room R-1 on September 2nd with ceiling tiles removed

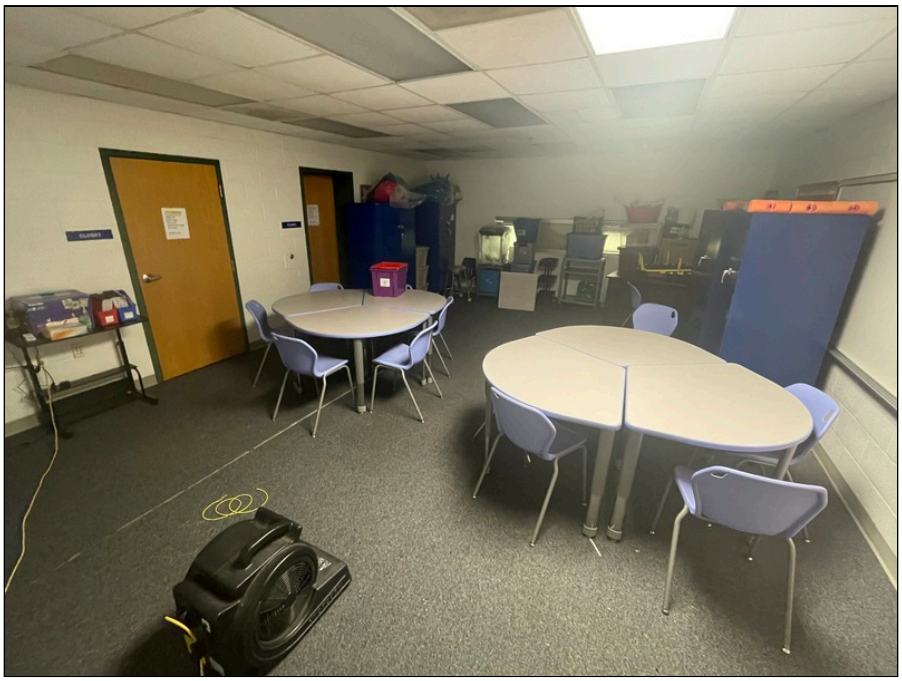
4 - Room R-8 on September 2nd with ceiling tiles removed

5 - View of Science Room with air scrubber running on September 2nd

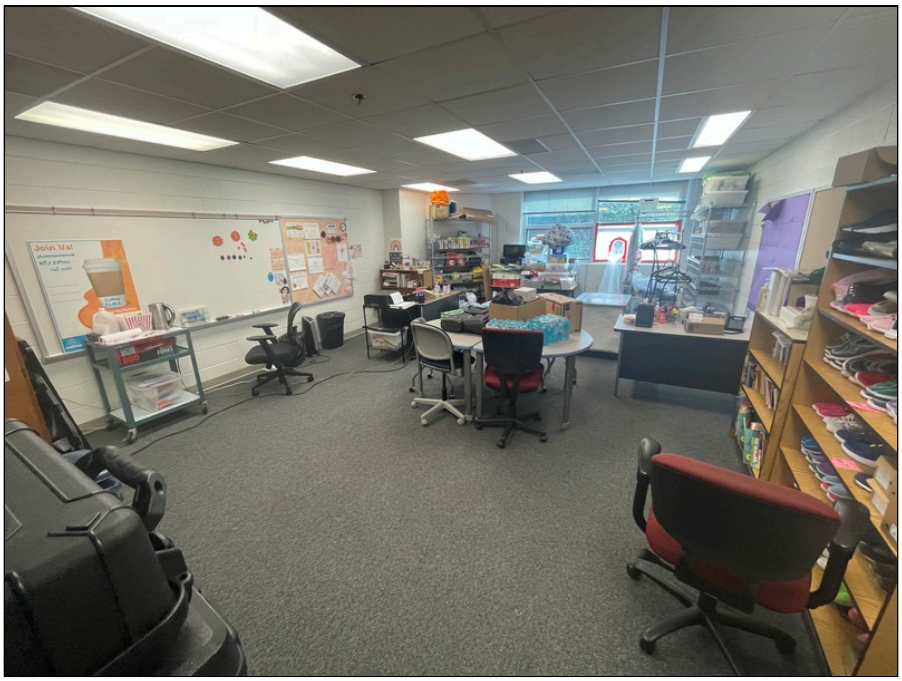
6 - Room R-9 on September 11th with partial ceiling tile replacement

7 - Room R-8 on September 11th with partial ceiling tile replacement

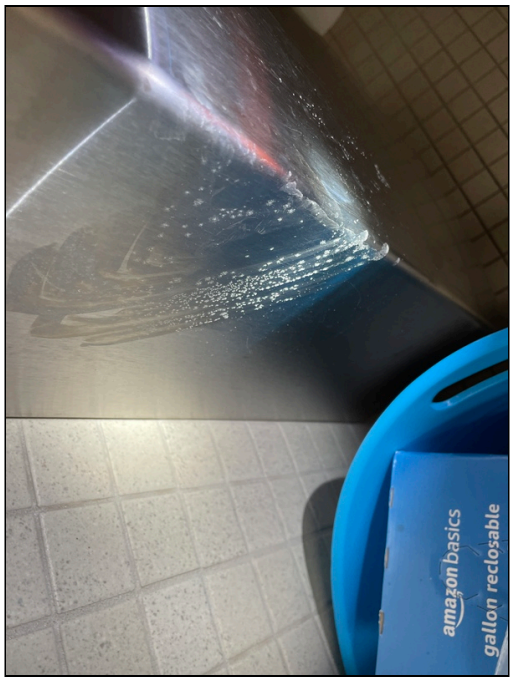
14 - View of room R3

15 - Mold growth on trash receptacle in bathroom of room R3

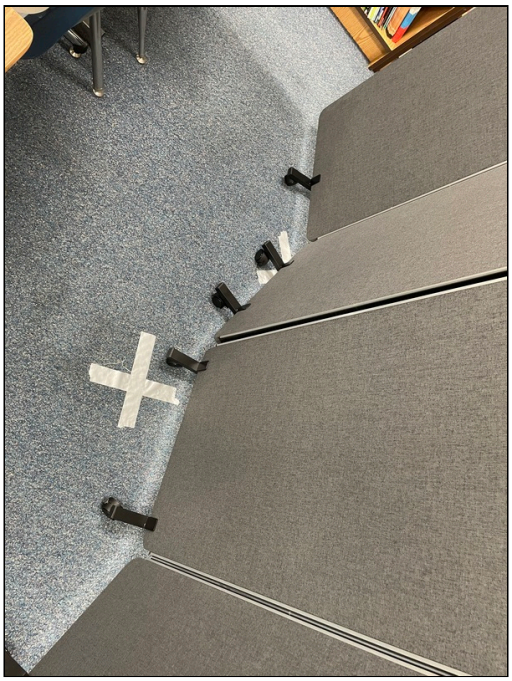
23 - View of room 12

24 - Area in room 12 where mold was previously growing
