Building Information - Plain Local (49932) - Avondale Elementary

Building Pictures - Plain Local(49932) - Avondale Elementary(1404)

Building Construction Information - Plain Local (49932) - Avondale Elementary (1404)

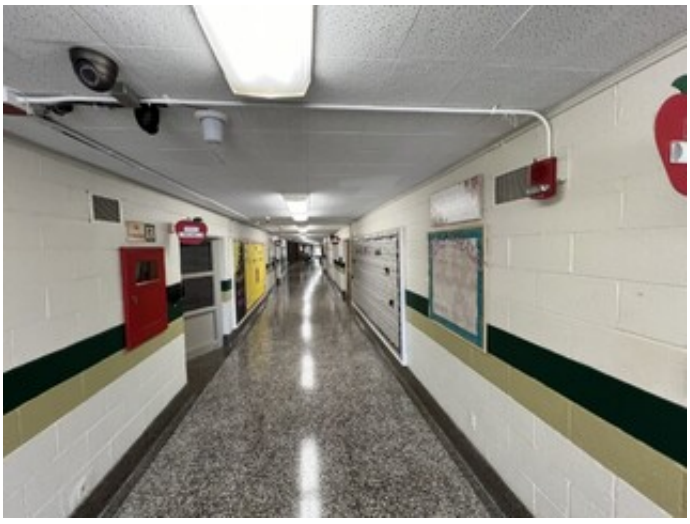
Description: The overall facility contains an Altronix motion detector, CCTV, door contact type security system in good to fair condition. Motion detectors are inadequately provided in main entries, central gathering areas, offices, main Corridors, and spaces where 6 or more computers are located. Exterior doors are not all equipped with door contacts. An automatic visitor control system is provided. Administrative offices are located adjacent to the Main Entrance to the facility, and a secure entrance vestibule is provided. Compliant color CCTV cameras are provided at main entry areas, parking lots, central gathering areas, and main Corridors. CCTV is monitored in Administrative Area with the use of a TV and computer based hard disk recording device. A compliant computer controlled access control system integrating alarms and video signals, with appropriate UPS backup, is provided. The system is equipped with card readers. The system is equipped with panic alarms. The system is not equipped with lockdown capabilities. The security system is not adequately provided throughout, and the system is not fully compliant with Ohio School Design Manual guidelines. There are no playground fencing issues requiring attention. The exterior site lighting system is equipped with surface mounted LED & HID entry lights in good to poor condition. Pedestrian walkways are not adequately illuminated. Parking and bus pick-up / drop off areas are not fully illuminated by pole mounted LED fixtures in good condition. The exterior site lighting system provides inadequate illumination due to sparse placement of fixtures.

Rating: 3 Needs Replacement

CCTV monitor in Administrative Office & Secure Visitor Entry Vsibule

Main Corridor Camera & Shelter In Place System Light

Recommendations: Provide complete replacement of security system to meet Ohio School Design Manual guidelines. Provide complete replacement of exterior site lighting system to meet Ohio School Design Manual guidelines.

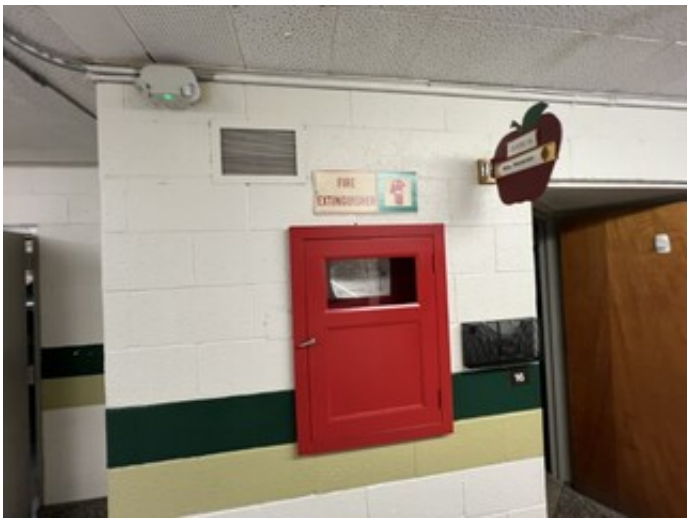
Description: The overall facility is equipped with an emergency egress lighting system consisting of non compliant incandescent, plastic construction exit signs, and the system is in fair condition. The facility is inadequately equipped with emergency egress floodlighting, and the system is in fair condition. The system is provided with appropriate battery backup on separate circuits. The School is not equipped with an emergency generator. The system is not adequately provided throughout, and does not meet Ohio School Design Manual and Ohio Building Code requirements.

Rating: 3 Needs Replacement

Non-illuminated Exit Signage

Egress Light Wall Pack with Battery Backup

Recommendations: Provide complete replacement of emergency / egress lighting system to meet Ohio School Design Manual and Ohio Building Code guidelines.

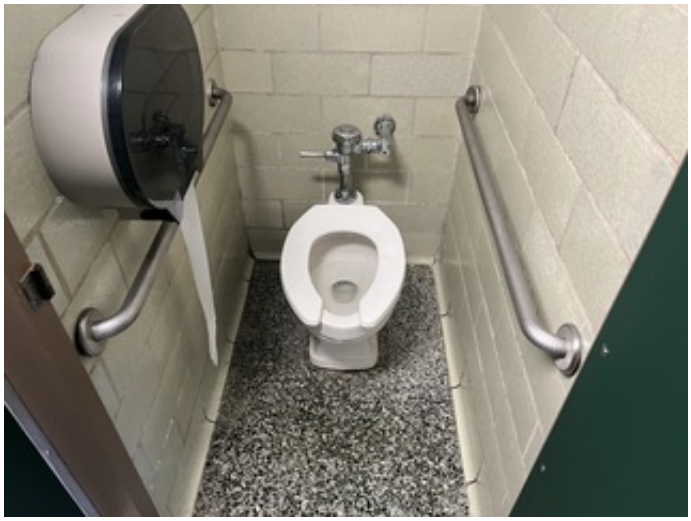
Rating: 2 Needs Repair

Recommendations: Provide ADA-compliant signage, 2 power assist door opener, 4 toilets, 2 urinals, door hardware in the overall facility, to facilitate the school's meeting of ADA requirements. Parking issues are corrected in Item P.

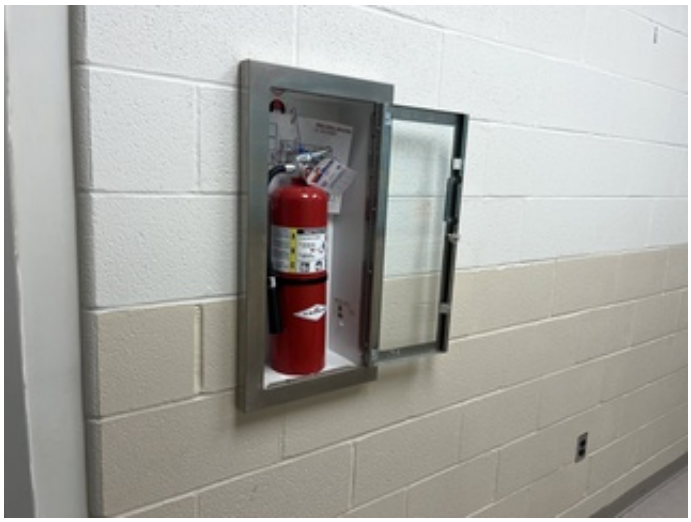
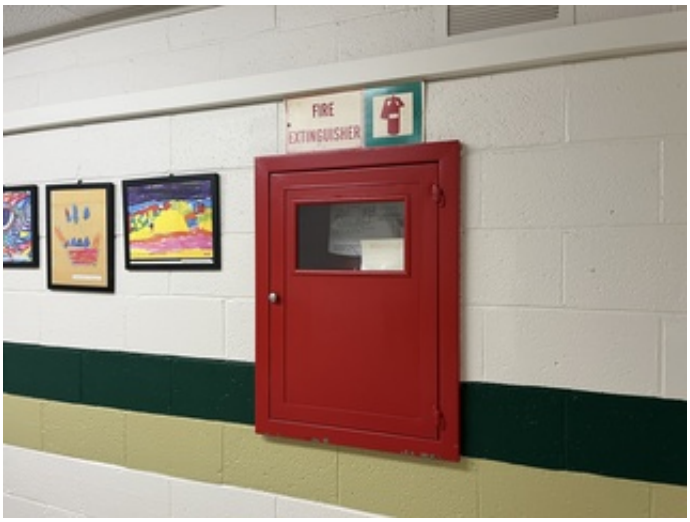
Description: The overall facility is not equipped with an automated fire suppression system. Exit Corridors are situated such that dead-end Corridors are not present. Stair towers and guardrails are not present in this single story structure. The facility does not have any exterior stairways from intermediate floors. The Kitchen hood is in good condition, and is not equipped with the required UL 300 compliant wet chemical fire suppression system. The required 6'' overhang of the cooking equipment is provided by the hood. Kitchen hood exhaust ductwork is of proper construction / material / insulation / and installed as required by the OSDM and OBCMC. The cooking equipment is not interlocked to shut down in the event of discharge of the fire suppression system. Fire extinguishers meeting requirements of NFPA 10 are provided in sufficient quantity. Recessed or semi-recessed fire extinguisher cabinets are provided. Existing fire extinguishers are adequately spaced. The facility is not equipped with an emergency generator The existing water supply is provided by a tie-in to the municipal system, and is insufficient to meet the future fire suppression needs of the school. Rooms with a capacity greater than 50 occupants are equipped with adequate egress. Provisions for compliance with OBC Storm Shelter protection, designated Area Of Refuge, and FEMA ''National Performance Criteria for Tornado Shelters'' are currently provided.

Rating: 2 Needs Repair

Recommendations: Provide new automated fire suppression system to meet Ohio School Design Manual guidelines. Provide increased water service of a capacity sufficient to support the fire suppression system, funding included in fire suppression funding. Provide new emergency generator, with funding provided via complete replacement of electrical system in Item D. Provide new Kitchen hood with a UL 300 compliant wet chemical fire suppression system. Provide interlock to de-energize cooking equipment upon discharge of the Kitchen hood fire suppression system.
