Building Information - Plain Local (49932) - Barr Elementary

Program Type	Expedited Local Partnership Program (ELPP)
Setting	Small City
Assessment Name	Barr Elementary (031070)
Assessment Date (on-site; non-EEA)	2024-05-30
Kitchen Type	Full Kitchen
Cost Set:	2024
Building Name	Barr Elementary
Building IRN	31070
Building Address	2000 47th St NE
Building City	Canton
Building Zipcode	44705
Building Phone	330-491-3730
Acreage	40.00
Current Grades:	K-4
Teaching Stations	25
Number of Floors	1
Student Capacity	388
Current Enrollment	345
Enrollment Date	2024-06-07
Enrollment Date is the date in which the current enrollment was taken.	
Number of Classrooms	22
Historical Register	NO
Building's Principal	Mrs. Camile Anderson
Building Type	Elementary

Building Pictures - Plain Local(49932) - Barr Elementary(31070)

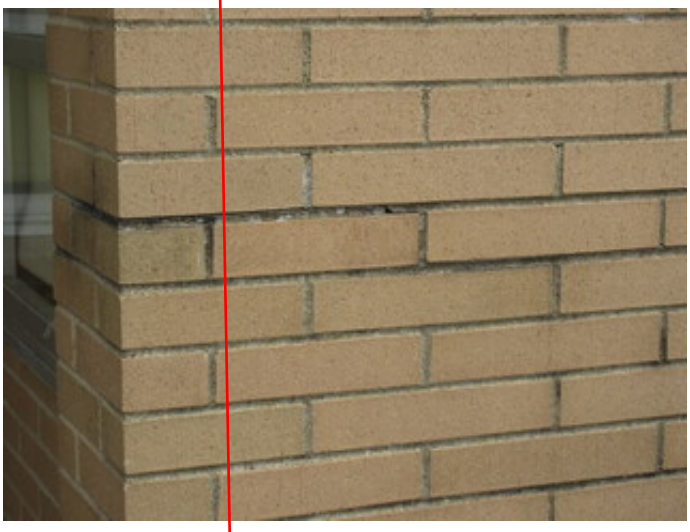
Description: The overall facility has a brick veneer on load bearing masonry wall system, which displayed locations of deterioration, and is in fair condition. The exterior masonry appears to have inappropriately spaced and inadequately caulked control joints. Control joints are not provided at lintel locations, at doors and windows, building corners, and wall offsets. The school does not have sufficient expansion joints. The 1996 Addition has a brick veneer on load bearing masonry wall system, which displayed no locations of deterioration, and is in good condition. The exterior masonry appears to have no control joints, nor any expansion joints, but there is minimal cracking / settling observed. Exterior walls in the overall facility are adequately insulated. Brick veneer masonry walls are cavity walls. Exterior walls in the 1996 Addition are adequately insulated. Brick veneer masonry walls are cavity walls. Weep holes are provided in sufficient quantity at lintels, below sills, and the base of masonry cavity walls, and are in good condition. Weep holes are not rope type weeps. Vents are not provided in sufficient quantity. The exterior masonry has not been cleaned and sealed in recent years and shows evidence of mortar deterioration in and has locations of efflorescence and mold. Architectural exterior accent materials consist of metal, glazed brick, and plaster which are in fair to good condition. Exterior building fenestration in the overall facility represents 8.88% of the exterior surfaces. Exterior building fenestration in the 1996 Addition represents 9.20% of the exterior surfaces. The overall facility features 21 unit-ventilators in fair condition. These will need to be removed and infilled with the installation of a new OSDM compliant HVAC system. Interior Corridor and demising walls are concrete masonry units, project full height from floor to bottom of deck, and are in fair condition. Interior masonry appears to have adequately spaced and caulked control joints in good condition. Interior soffits are of gypsum board type construction, and in good condition. The windowsills are an element of the aluminum window system, and are in fair condition. The exterior lintels are precast steel, and are rusting. There are no chimneys. Canopies over entrances are plaster type construction, and are in fair condition. Exterior soffits are of plaster type construction, and in fair condition. The school is provided with a covered concrete conventional loading dock to facilitate the receipt of products, supplies, and foodstuffs, 95 square feet in size. The dock itself is in good condition and is equipped with bumper pads in fair condition.

Recommendations: Provide tuckpointing in all areas of mortar deterioration as required through the overall facility. AND Provide masonry cleaning, sealing, and caulking as required through the overall facility. AND Re-caulk existing control joints.

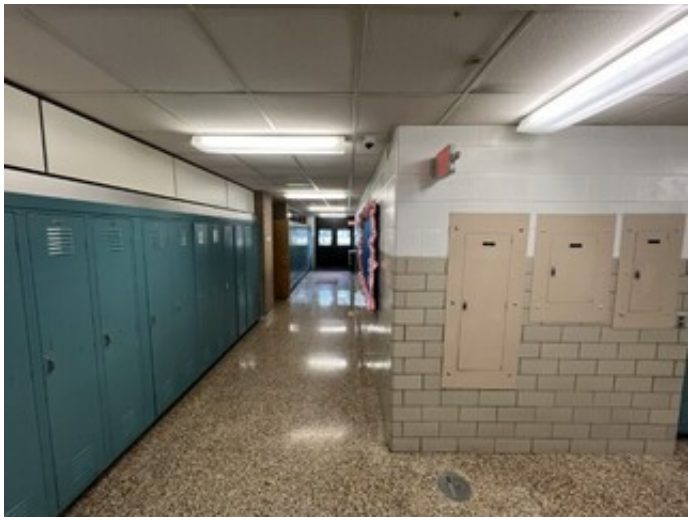
Description: Daylighting strategies, complemented with photo-cell control of lighting fixtures are (not) currently featured in the building's design. The typical Classrooms in the overall facility are equipped with T-8 1x4 suspended indirect fluorescent fixtures retrofitted with LED T8 bulbs with dual level switching. Classroom fixtures are in fair condition, providing an average illumination of 42 FC, thus complying with the 40 FC recommended by the OSDM. The typical Corridors in the overall facility are equipped with T-8 1x4 surface mount fluorescent fixtures retrofitted with LED T8 bulbs with dual level switching. Corridor fixtures are in fair to poor condition, providing an average illumination of 18 FC, thus complying with the 15 FC recommended by the OSDM. The Primary Gymnasium spaces are equipped with T-8 1x4 surface mount fluorescent fixtures retrofitted with LED T8 bulbs type lighting, in fair condition, providing an average illumination of 37 FC, thus complying with the 30 FC recommended by the OSDM. The Media Center is equipped with 2x4 lay-in T-8 fluorescent fixtures retrofitted with LED bulbs type lighting in good to fair condition, providing an average illumination of 33 FC, thus complying with the 30 FC recommended by the OSDM. The Student Dining spaces are equipped with 2x4 direct / indirect suspended T-8 fluorescent fixture type lighting retrofitted with LED T8 bulbs with multi level switching. Student Dining fixtures are in fair condition, providing an average illumination of 34 FC, which is less than the 40 FC recommended by the OSDM. The Kitchen spaces are equipped with 1x4 surface mounted T-8 fluorescent fixture type lighting retrofitted with LED T8 bulbs with single level switching. Kitchen fixtures are in fair to poor condition, providing an average illumination of 57 FC, thus complying with the 50 FC recommended by the OSDM. The Service Areas in the overall facility are equipped with 1x4 direct suspended T-8 or pendant fluorescent fixture type lighting in fair to poor condition. The typical Administrative spaces in the overall facility are equipped with 2x4 lay-in T-8 LED fluorescent fixture type lighting in good condition, providing adequate illumination based on OSDM requirements. The overall lighting systems of the facility are not fully compliant with Ohio School Design Manual requirements due to age and condition, inadequate lighting levels, and lack of multi-level switching.

Typical Corridor Lighting

Typical Classroom Lighting

Recommendations: Provide complete replacement of interior lighting system due to condition, lighting levels, lack of multilevel switching and installation of systems outlined in Items A, C, D, & E.

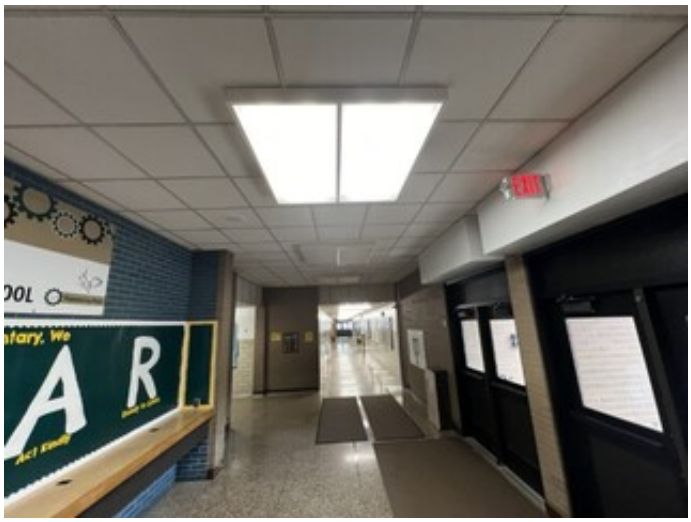
Description: The overall facility is equipped with an emergency egress lighting system consisting of non compliant incandescent, plastic construction exit signs, and the system is in fair condition. The facility is inadequately equipped with emergency egress floodlighting, and the system is in fair condition. The system is provided with appropriate battery backup on separate circuits. The School is not equipped with an emergency generator. The system is not adequately provided throughout, and does not meet Ohio School Design Manual and Ohio Building Code requirements.

Internally Lit Exit Sign with Integral Floodlights At Egress

Internally Lit Exit Sign with Integral Floodlights

Recommendations: Provide complete replacement of emergency / egress lighting system to meet Ohio School Design Manual and Ohio Building Code guidelines.

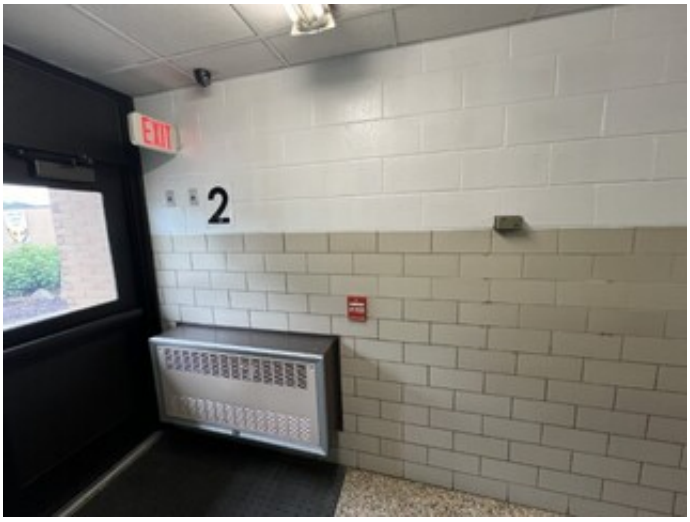
Description: The overall facility is equipped with a Honeywell type fire alarm system, installed in 1967, and in poor condition, consisting of manual pull stations, horn and strobe indicating devices. The system is not addressable. The main control panel is not located in the administrative area. Remote annunciators are provided at main entries. The system is automatic and is remotely monitored by a third party. The fire alarm system is not connected to an automatic digital communicator that is monitored by a central station. The system is equipped with connected door hold-open devices, controlled by smoke detectors at doors. The system is adequately equipped with both primary and secondary compliant power sources. The system is equipped with sufficient audible horns / strobe indicating devices and smoke detectors. The system is not equipped with any tamper switches, flow switches or heat sensors. The system will not support future fire suppression systems. The system has sufficient expansion capabilities, with additional zone capabilities, to support the future needs of the school. The system does meet current code requirements. The system is not adequately provided throughout. The system is not fully compliant with Ohio Building Code, NFPA, ADA, and Ohio School Design Manual requirements.

Fire Alarm Control Panel Located In Mechanical Room

Pull Station Located at Exterior Door

Recommendations: Provide complete replacement of fire alarm system to meet OBC, NFPA, ADA, and Ohio School Design Manual guidelines.

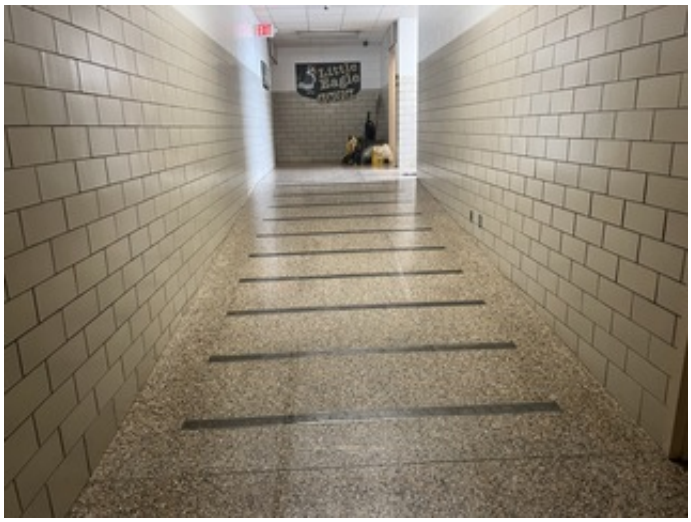
Rating: 2 Needs Repair

Recommendations: Provide ADA-compliant signage, 2 power assist door openers, 5 toilets, 3 sinks, 1 urinals, 1 toilet partitions, 1 toilet accessories to facilitate the school's meeting of ADA requirements. Parking issues are corrected in Item P.

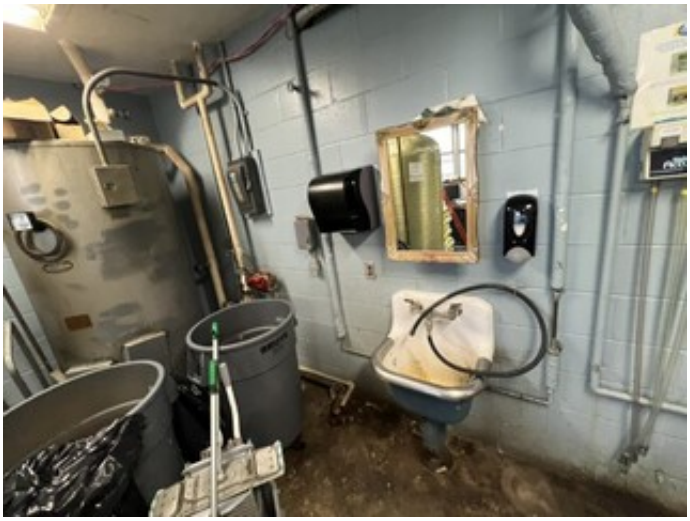
Description: The sanitary sewer system is tied in to the county system, and is in good to fair condition. No significant system deficiencies were reported by the school district or noted during the physical assessment.

Floor Drain & Grease Interceptor Located in Kitchen

Floor Drain in Mechanical Room

Recommendations: Existing conditions require no renovation or replacement at the present time.

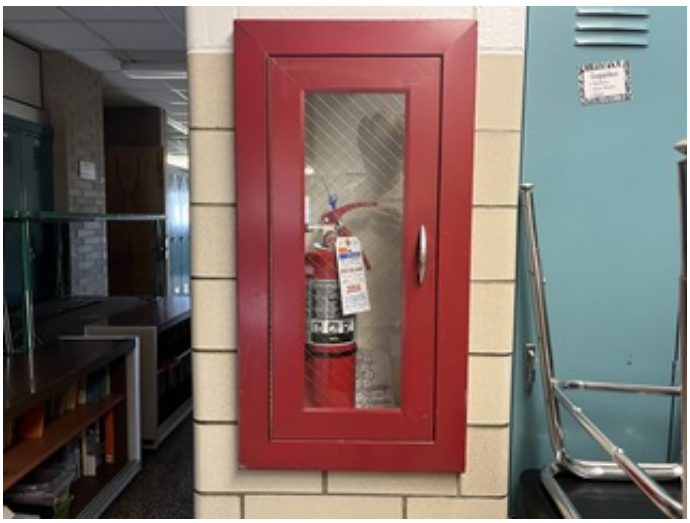
Rating: 3 Needs Replacement

Recommendations: Provide new automated fire suppression system to meet Ohio School Design Manual guidelines. Provide new emergency generator, with funding provided via complete replacement of electrical system in Item D. Provide new Kitchen hood with a UL 300 compliant wet chemical fire suppression system. Provide interlock to de-energize cooking equipment upon discharge of the Kitchen hood fire suppression system. Provide additional well, well booster pump, storage tank, and generator to support sprinkler system capacity.

City water is available within 2 blocks of the site - assessment should include cost to extend city water in lieu of including a new well and fire pump for long term reliability.
