Building Information - Plain Local (49932) - Warstler Elementary

Building Pictures - Plain Local(49932) - Warstler Elementary(5926)

Building Construction Information - Plain Local (49932) - Warstler Elementary (5926)

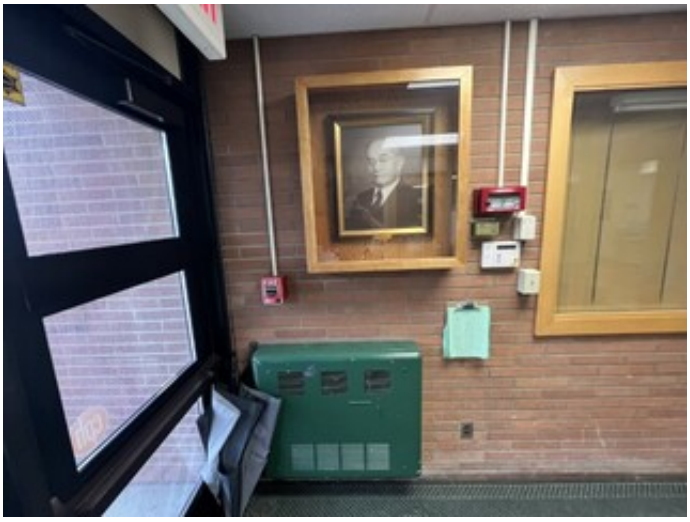
Description: The overall facility is equipped with a FCI 7100 Series type fire alarm system, installed in 2006, and in good condition, consisting of manual pull stations, horn and strobe indicating devices. The system is addressable. The main control panel is not located in the administrative area. Remote annunciators are provided at main entries. The system is automatic and is remotely monitored by a third party. The fire alarm system is connected to an automatic digital communicator that is monitored by a central station. The system is equipped with connected door hold-open devices, controlled by smoke detectors at doors. The system is adequately equipped with both primary and secondary compliant power sources. The system is equipped with sufficient audible horns / strobe indicating devices and smoke detectors. The system is not equipped with sufficient flow switches or heat sensors. The system is not equipped with any tamper switches. The system will not support future fire suppression systems. The system has sufficient expansion capabilities, with additional zone capabilities, to support the future needs of the school. The system does meet current code requirements. The system is not adequately provided throughout. The system is not fully compliant with Ohio Building Code, NFPA, ADA, and Ohio School Design Manual requirements.

Rating: 3 Needs Replacement

Fire Alarm Control Panel Located In Mechanical Room

Remote Enunciator Panel Located at Main Visitor Entrance and Pull Station

Recommendations: Provide complete replacement of fire alarm system to meet OBC, NFPA, ADA, and Ohio School Design Manual guidelines.

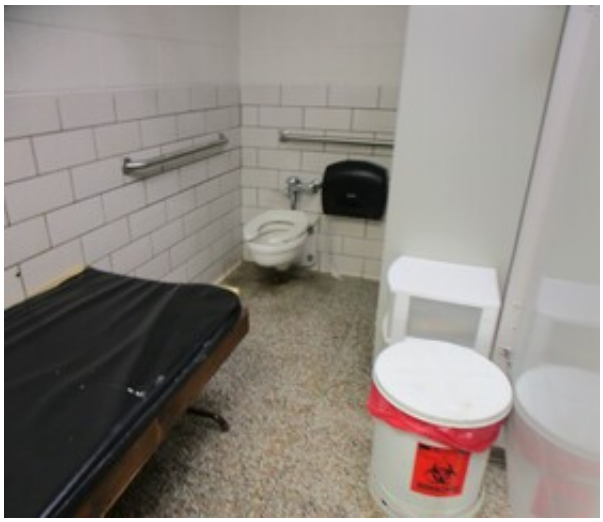
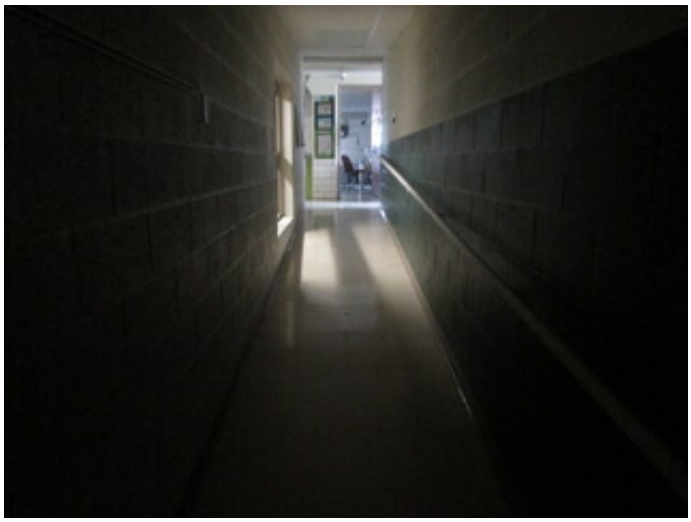
Rating: 2 Needs Repair

Recommendations: Provide ADA-compliant signage, 2 power assist door opener at Original Construction main entrance, 2 toilet, 2 urinals, door hardware in the overall facility to facilitate the school's meeting of ADA requirements. Parking issues are corrected in Item P.

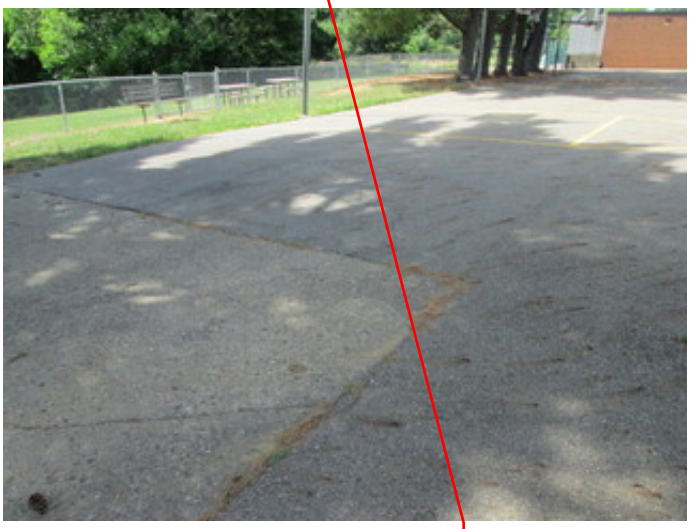
Rating: 3 Needs Replacement

Recommendations: Provide for two more accessible parking spaces. Provide for a new concrete dumpster pad. Provide new exterior stairs and railings leading up to the Kitchen Corridor. Provide for new asphalt paving to both the parking lots and the hard surface play area. Provide for new playground mulch. Provide for sitework that may need to be done due to unforeseen circumstances.

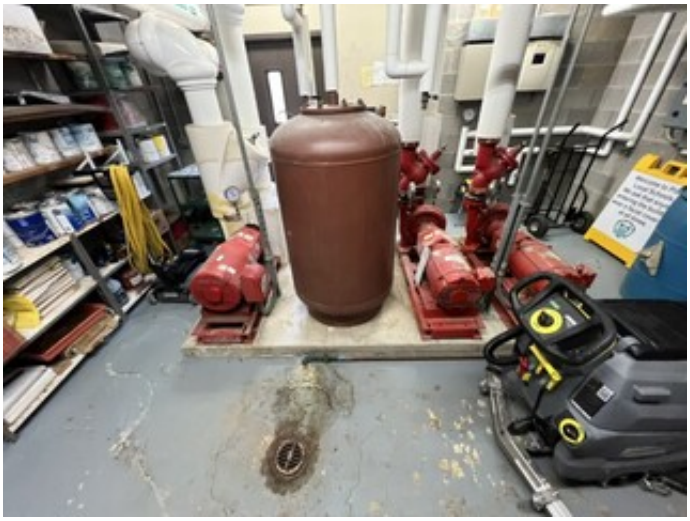
Description: The sanitary sewer system is tied in to the county system, and is in good to fair condition. No significant system deficiencies were reported by the school district or noted during the physical assessment.

Floor Drain Located in Mechanical Room

Grease Interceptor Located in Kitchen

Recommendations: Existing conditions require no renovation or replacement at the present time.

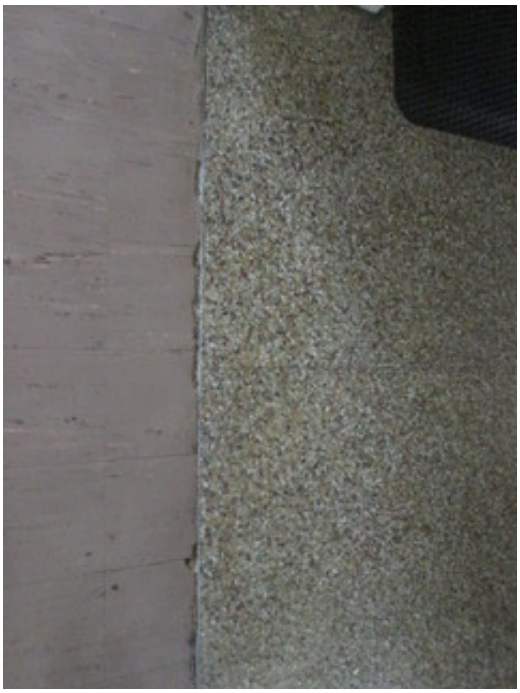
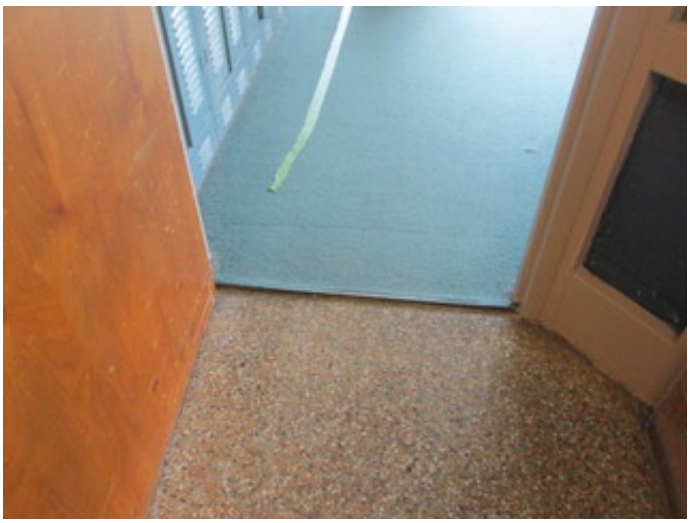
Description: The School District provided the AHERA six month reinspection reports, prepared by William Racine, and dated May 21-23, documenting known and assumed locations of asbestos and other hazardous materials. (The AHERA Reports referenced only assumed asbestos containing materials, and failed to document quantities and locations. An Enhanced Environmental Hazards Assessment (EEHA) will need to be conducted in order to establish abatement budgets.) (Vinyl asbestos floor tile and mastic / Carpet mastic / Pipe insulation containing hazardous materials are located in the overall facility in fair to poor condition. These materials were (described in the report to be in friable and non-friable condition with significant and light damage. There are no underground storage tanks on the site. Due to the construction date, there is a potential for lead based paint. Fluorescent lighting will require special disposal.

Rating: 3 Needs Replacement

Recommendations: Remove all hazardous materials, inclusive of asbestos-containing materials as noted in the attached Environmental Hazards Assessment.
