Building Information - Plain Local (49932) - Day Little Eagle Learning Center

Building Pictures - Plain Local(49932) - Day Little Eagle Learning Center(8305)

Building Construction Information - Plain Local (49932) - Day Little Eagle Learning Center (8305)

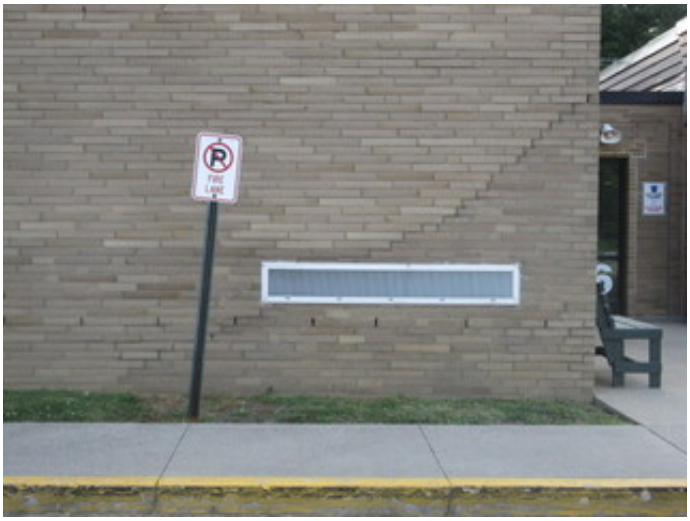
Description: The overall facility has a brick veneer on load bearing masonry wall, which displayed locations of deterioration, and is in poor condition. The exterior masonry appears to have neither control nor expansion joints and the brick exhibits cracking and separation in some areas. The 2006 Addition has a brick veneer on load bearing masonry wall system which displayed no locations of deterioration and is in good condition. The exterior masonry appears to have appropriately spaced and adequately caulked control joints in good condition. Control joints are provided at lintel locations, at doors and windows, building corners, and wall offsets and are in good condition. No repairs are needed for the Addition. Exterior walls in the overall facility are adequately insulated. Brick veneer masonry walls are cavity walls. Exterior walls in the 2006 Addition are adequately insulated. Brick veneer masonry walls are cavity walls. Weep holes are provided in sufficient quantity at lintels, below sills, and the base of masonry cavity walls, and are in fair condition. Weep holes are not rope type weeps. Vents are provided in sufficient quantity. The exterior masonry has not been cleaned and sealed in recent years and shows evidence of mortar deterioration below windowsills, at corners, and on north-facing facades and has locations of efflorescence and mold. Architectural exterior accent materials consist of metal, which are in poor condition. Exterior building fenestration in the overall facility represents 24.06% of the exterior surfaces. Exterior building fenestration in the 2006 Addition represents 21.13% of the exterior surfaces. The overall facility features 14 unit ventilators in fair condition. These will need to be removed and infilled with the installation of a new OSDM compliant HVAC system. Interior Corridor and demising walls are concrete masonry units, project full height from floor to bottom of deck, and are in good condition. Interior masonry appears to have adequately spaced and caulked control joints in good condition. Interior soffits are of gypsum board type construction, and in good condition. The windowsills are an element of the aluminum window system and are in poor condition. The exterior lintels are steel and are in fair condition. Chimneys are in fair condition with some cracking / settling of the brick surface evident. Exterior soffits are of vinyl type construction, and in poor condition. The school is provided with a covered concrete conventional loading dock to facilitate the receipt of products, supplies, and foodstuffs, 163 square feet in size. The dock itself is in fair condition and is equipped with bumper pads in poor condition.

Should be linear feet not sf.

Recommendations: Provide tuckpointing in all areas of mortar deterioration as required through the overall facility. AND Provide masonry cleaning, sealing, and caulking as required through the overall facility. AND Sawcut and caulk new appropriately spaced control joints in existing masonry through the overall facility. AND Sawcut and caulk new appropriately spaced expansion joints in existing masonry throughout the overall facility. AND Prep and paint exposed steel lintels through the overall facility. AND Exterior wall insulation deficiencies are addressed in Item J.

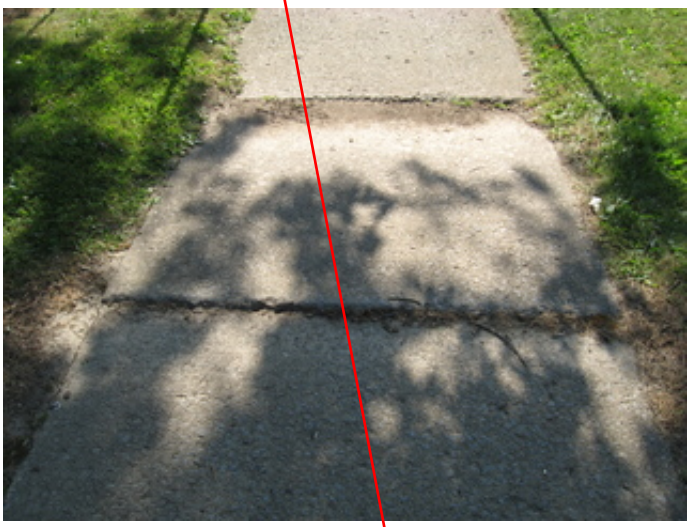
Dumpster without Concrete Pad

Sidewalk to be Replaced

Recommendations: Provide for a concrete pad for dumpster. Provide for new asphalt paving in all parking lots. (Funding shared with Taft Elementary.) Provide for new concrete sidewalk. Provide for new concrete curb. Provide for new playground equipment.

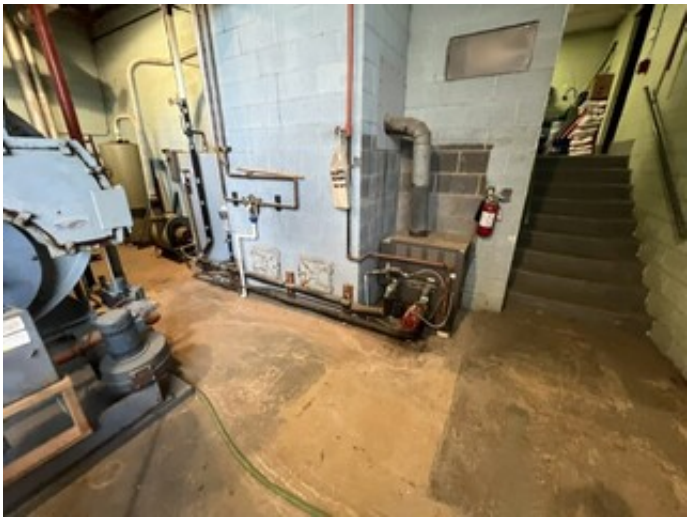
Water Main & Backflow Preventer

Hot Water Heater & Hot Water Storage Tank

Recommendations: Provide a new city water supply line of adequate capacity to support the existing needs of the facility, as well as a future automated fire suppression system. Funding provided in Item U.
