AHERA ASBESTOS MANAGEMENT PLAN

KYRENE CENTENNIAL MIDDLE SCHOOL
13808 SOUTH 36TH STREET
PHOENIX, ARIZONA 85044

Dominion Environmental Consultants, Inc.
20045 North 19th Avenue, Building 7
Phoenix, Arizona 85027
(623) 516-1415

September 12 , 2025

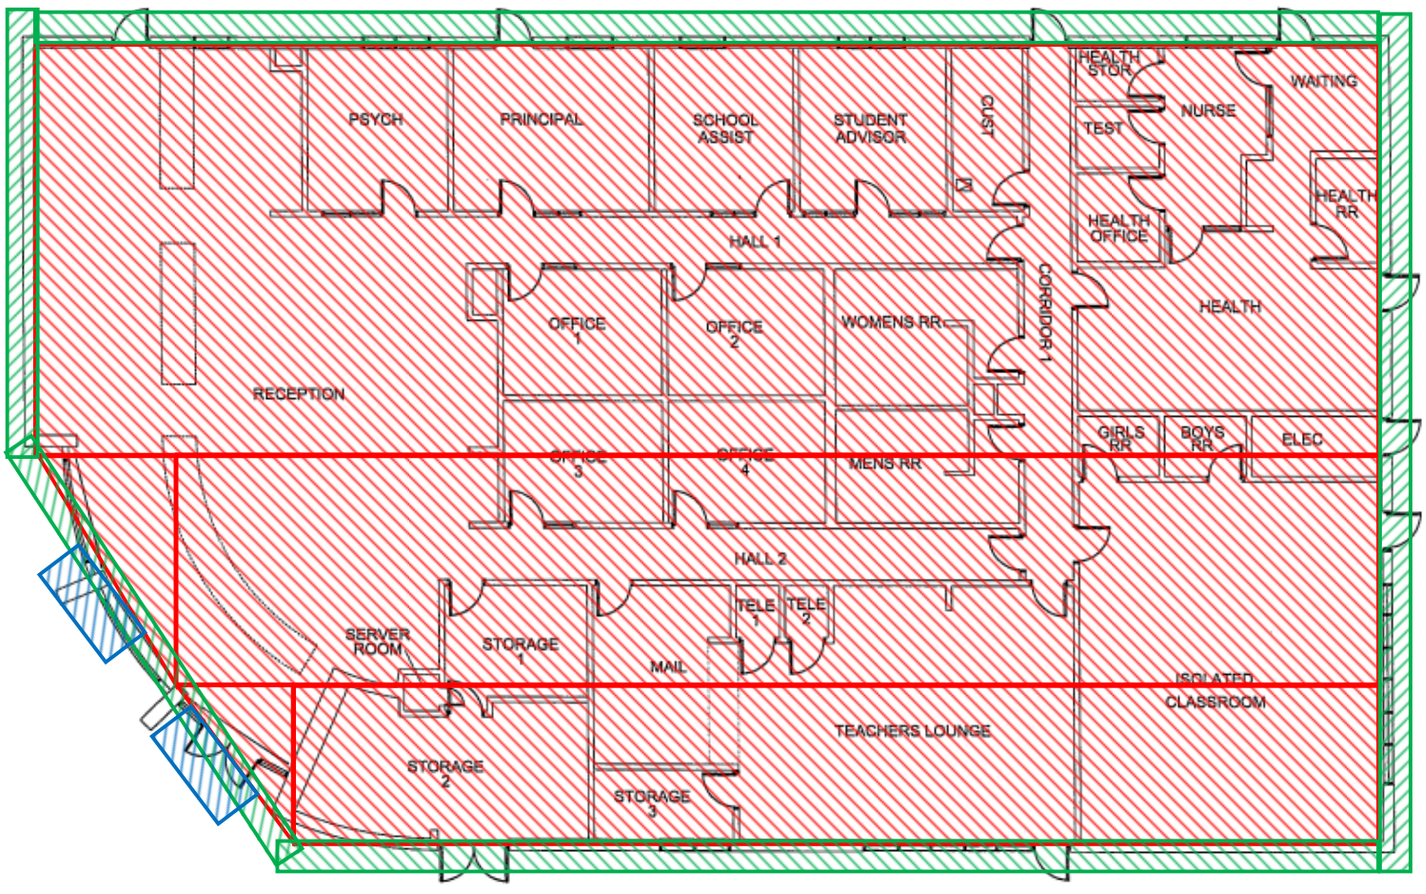
Assumed Asbestos-Containing Black Carpet Square & Mastic Interior/Exterior Caulking Window Glazing

Assumed Asbestos-Containing Brick & Mortar

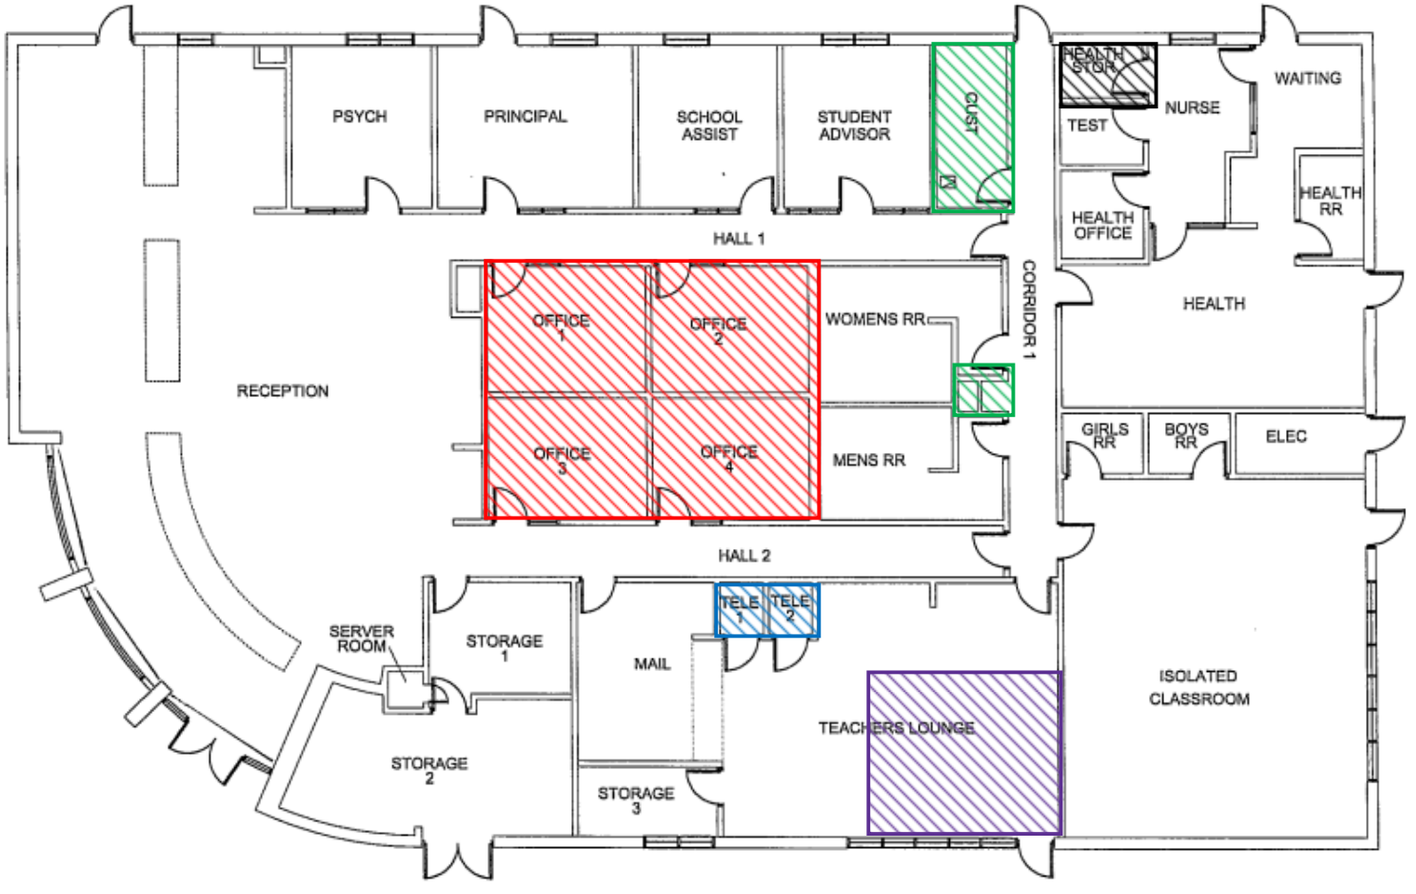
Assumed Asbestos-Containing Glass Block Mortar

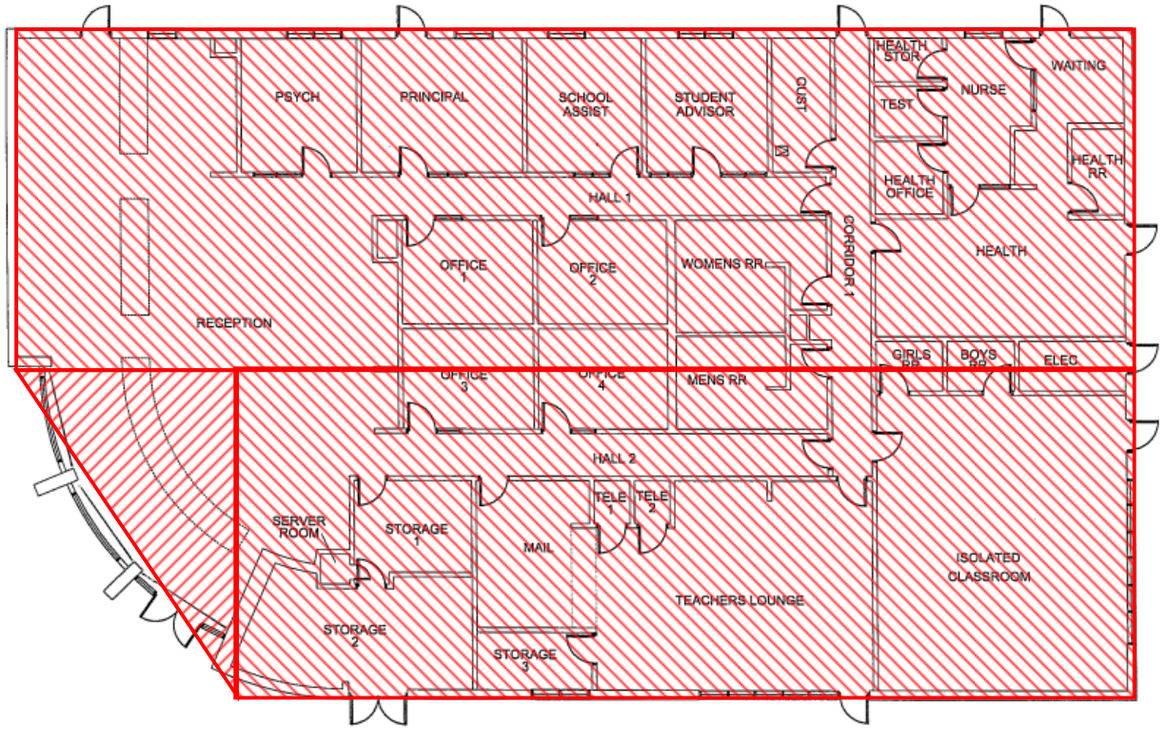
Assumed Asbestos-Containing Gray Wallpaper

Assumed Asbestos-Containing Black Sink Coating

Assumed Asbestos-Containing Tan Striped Wallpaper

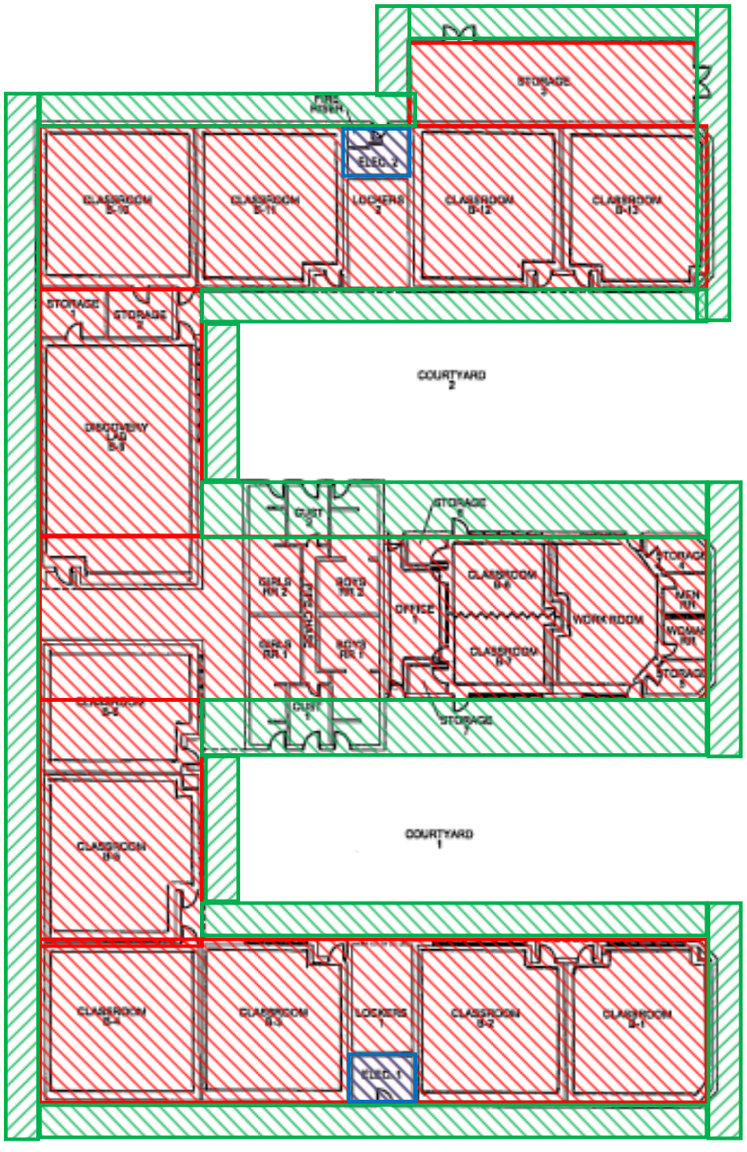
Assumed Asbestos-Containing
Black Entry Carpet & Mastic

Assumed Asbestos-Containing
White w. Black 12"x 12" VCT
(Mastic)

Assumed Asbestos-Containing
White 2"x2" Ceramic Floor Tile
Peach 2"x2" Ceramic Floor Tile
Blue 2"x2" Ceramic Floor Tile
Off-White 4"x4" Ceramic Floor Tile
Peach 4"x4" Ceramic Floor Tile
(Grout & Thinset)
Fixture Caulking

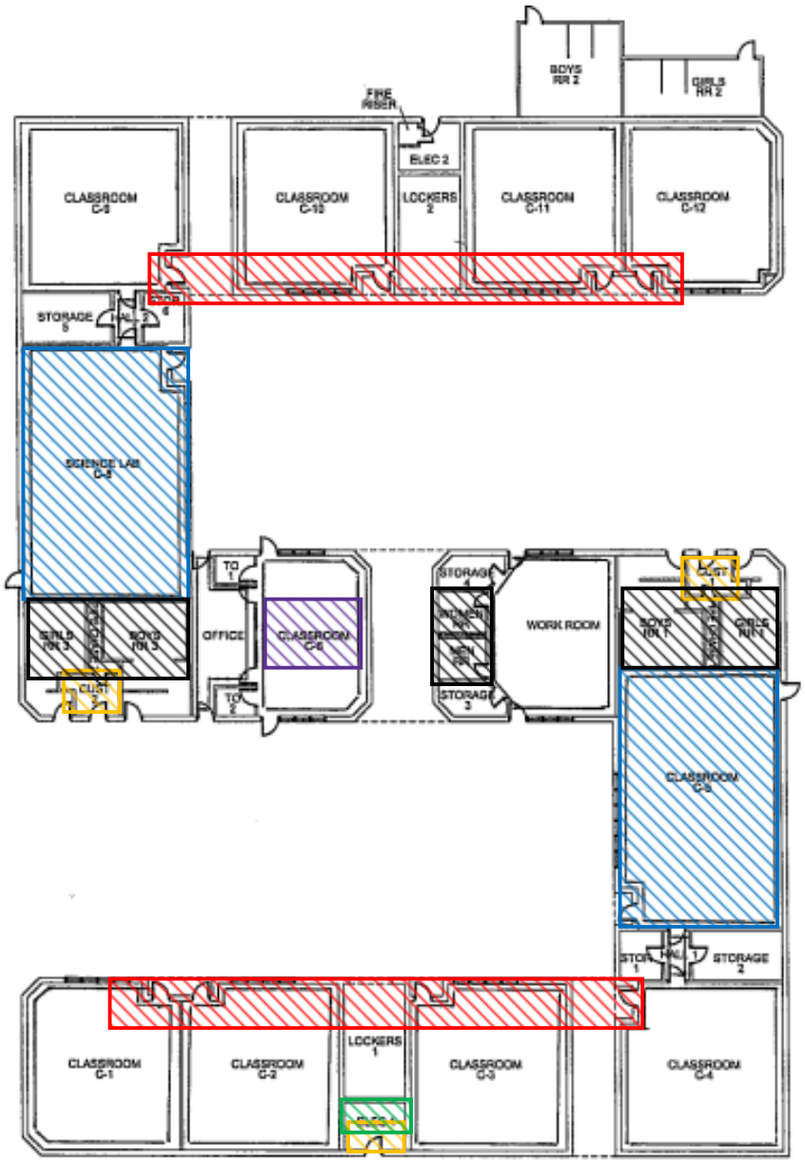
Assumed Asbestos-Containing
Silver Box Duct Wrap
Silver Duct Wrap
Silver Flex Duct Wrap
White Duct Tape
Mastic for Duct Tape
Large Pipe Wrap
Mastic for Pipe Wrap
Small Pipe Wrap
Mastic for Pipe Wrap
Unfinished Drywall System
Interior/Exterior Caulking

Assumed Asbestos-Containing
Brick & Mortar
Expansion Joint

Assumed Asbestos-Containing
Knockdown Drywall

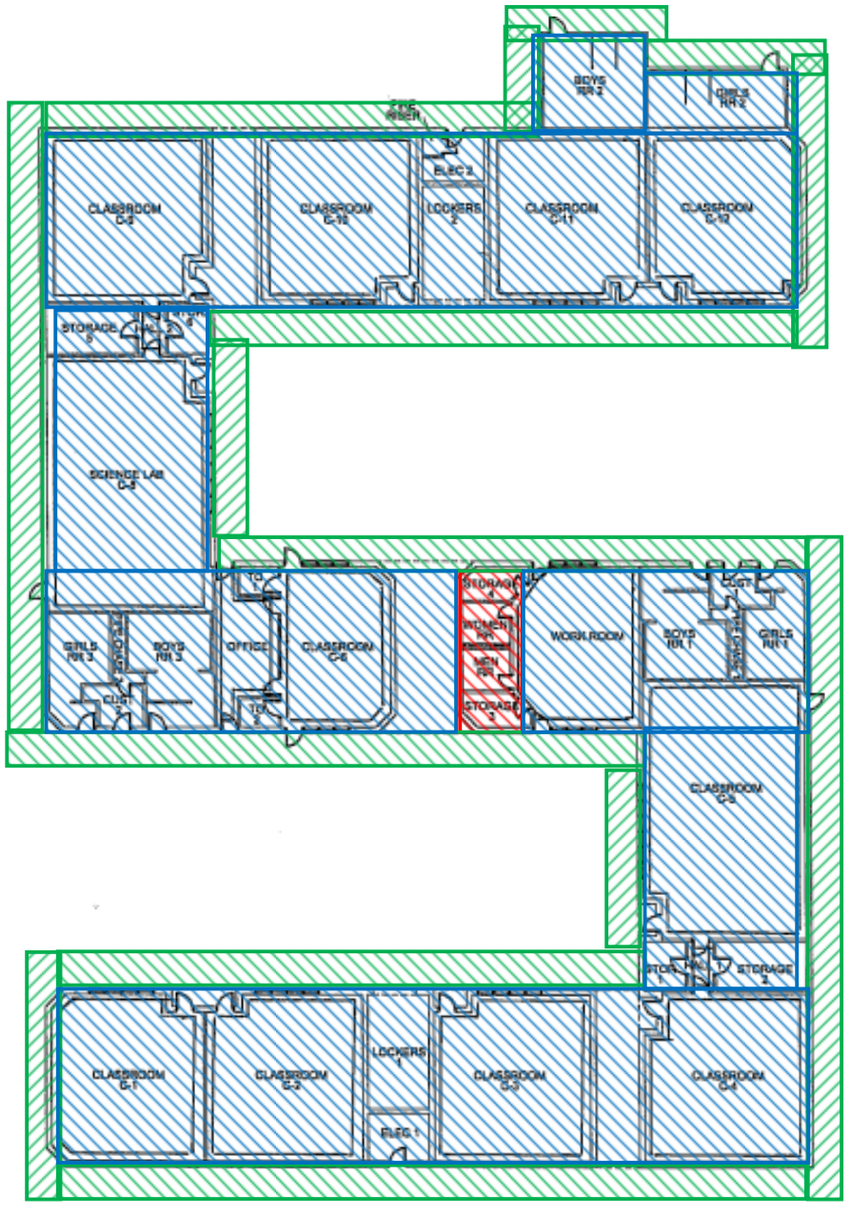
Assumed Asbestos-Containing
Black Counter Tops

Assumed Asbestos-Containing Divider Wall

Assumed Asbestos-Containing
White 2" x 2" Ceramic Floor Tile
Peach 2" x 2" Ceramic Floor Tile Blue 2" x 2" Ceramic Floor Tile Off-white 4" x 4" Ceramic Floor Tile Peach 4" x 4" Ceramic Floor Tile
(Grout, Thinset, & Mastic)
Fixture Caulking

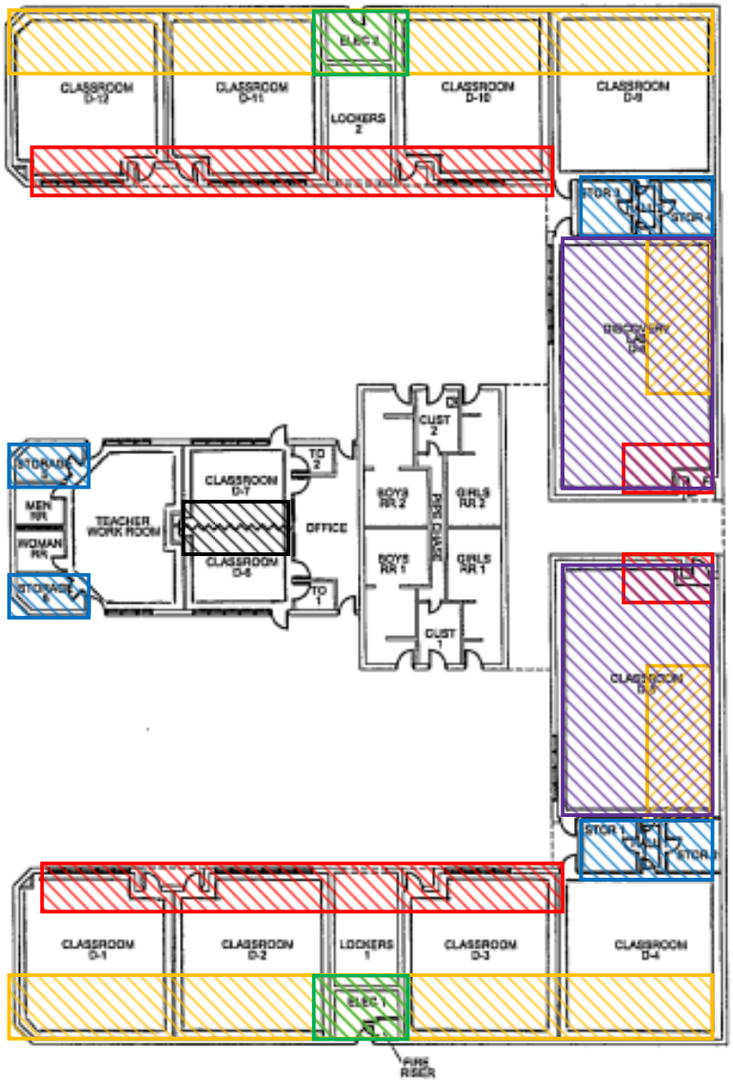
Assumed Asbestos-Containing
White w. Black 12" x 12" VCT (Mastic)

Assumed Asbestos-Containing
Brick
Mortar for Brick
Expansion Joint

Assumed Asbestos-Containing
Silver Box Duct Wrap
Silver Duct Wrap
Silver Flex Duct Wrap
White Duct Tape & Mastic
Large Pipe Wrap & Mastic
Small Pipe Wrap & Mastic
Unfinished Drywall System
Interior Caulking
Exterior Caulking
Tacboard & Mastic
Black Sink Coating

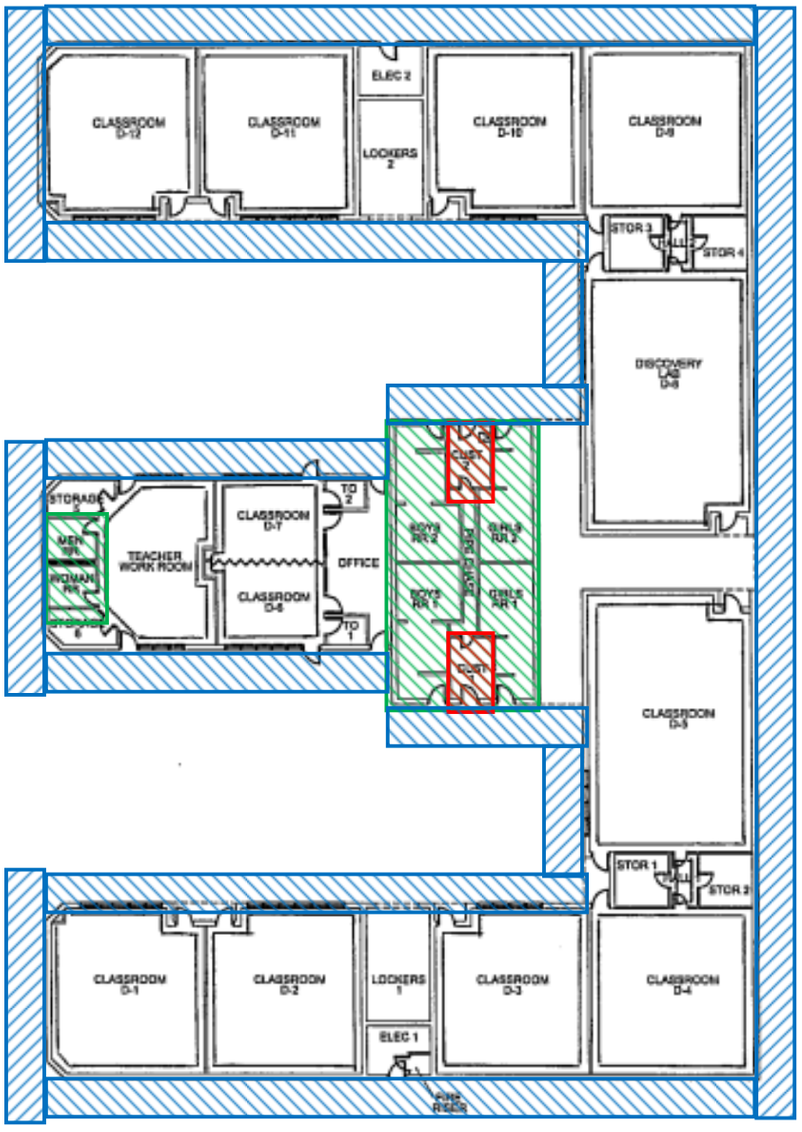
Assumed Asbestos-Containing White w. Black 12" x 12" VCT (Mastic) Brown Cove Base & Mastic

Assumed Asbestos-Containing Black Counter Tops

Assumed Asbestos-Containing Divider Wall

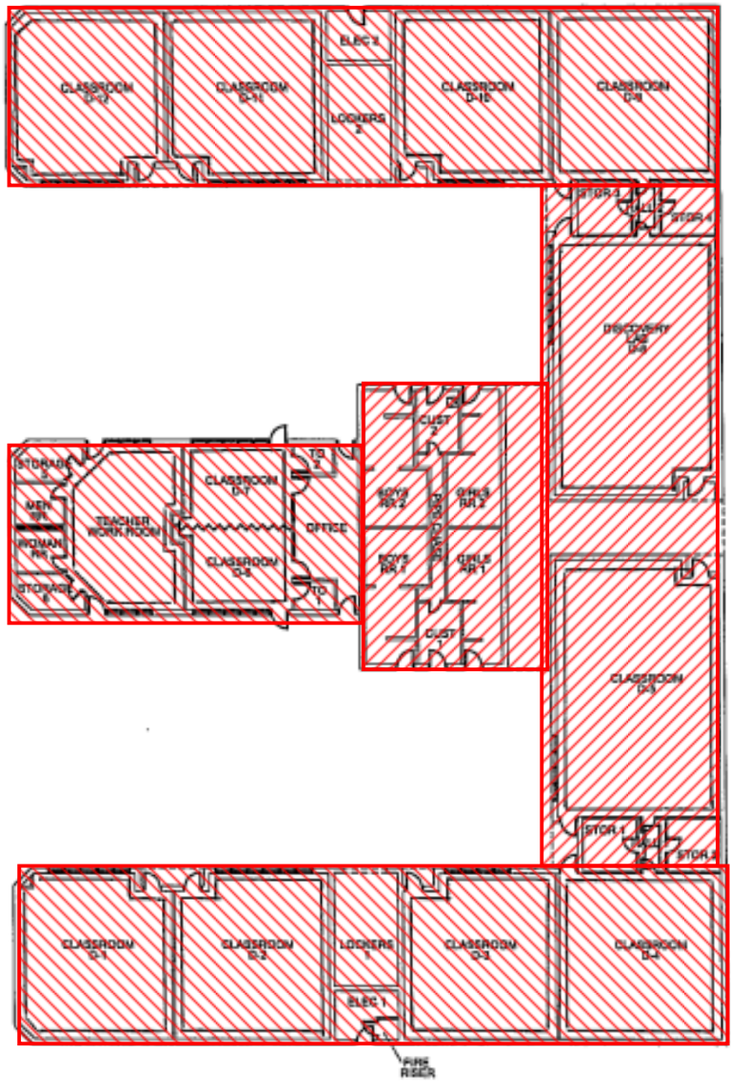
Assumed Asbestos-Containing
FRP & Mastic

Assumed Asbestos-Containing
White 2" x 2" Ceramic Floor Tile
Peach 2" x 2" Ceramic Floor Tile
Blue 2" x 2" Ceramic Floor Tile
Off-White 4" x 4" Ceramic Wall Tile
Peach 4" x 4" Ceramic Wall Tile
(Grout, Thinset, & Mastic)
Fixture Caulking

Assumed Asbestos-Containing
Brick & Mortar
Expansion Joint

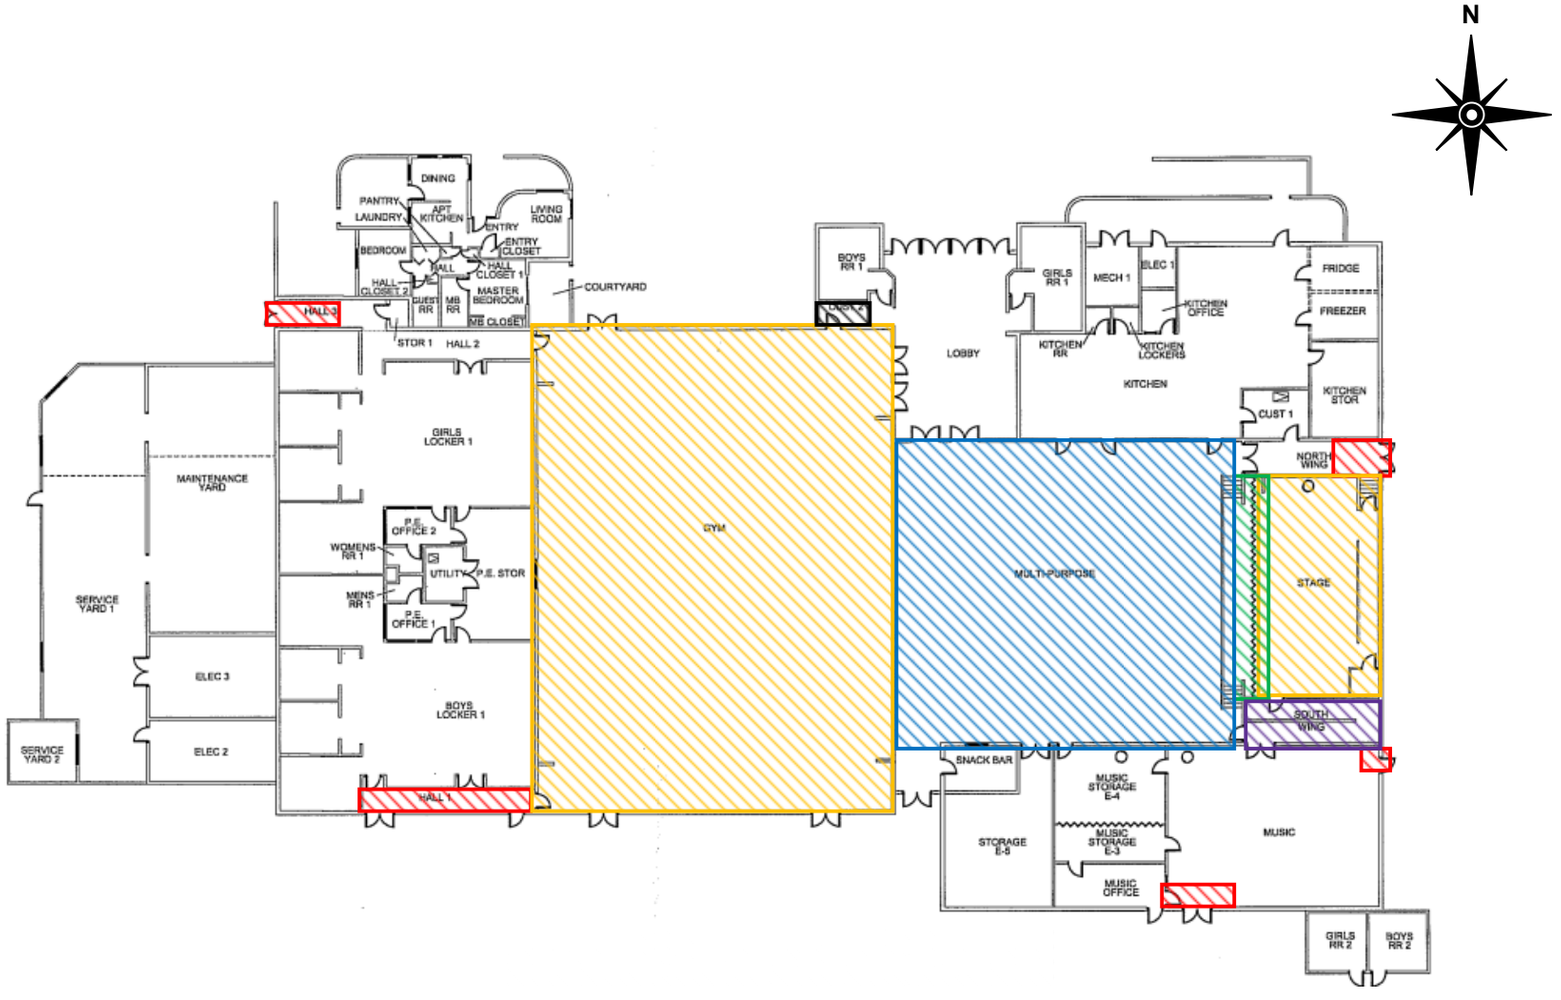
Assumed Asbestos-Containing
Silver Box Duct Wrap
Silver Duct Wrap
Silver Flex Duct Wrap
White Duct Tape & Mastic
Large Pipe Wrap & Mastic
Small Pipe Wrap & Mastic
Unfinished Drywall System
Interior/Exterior Caulking

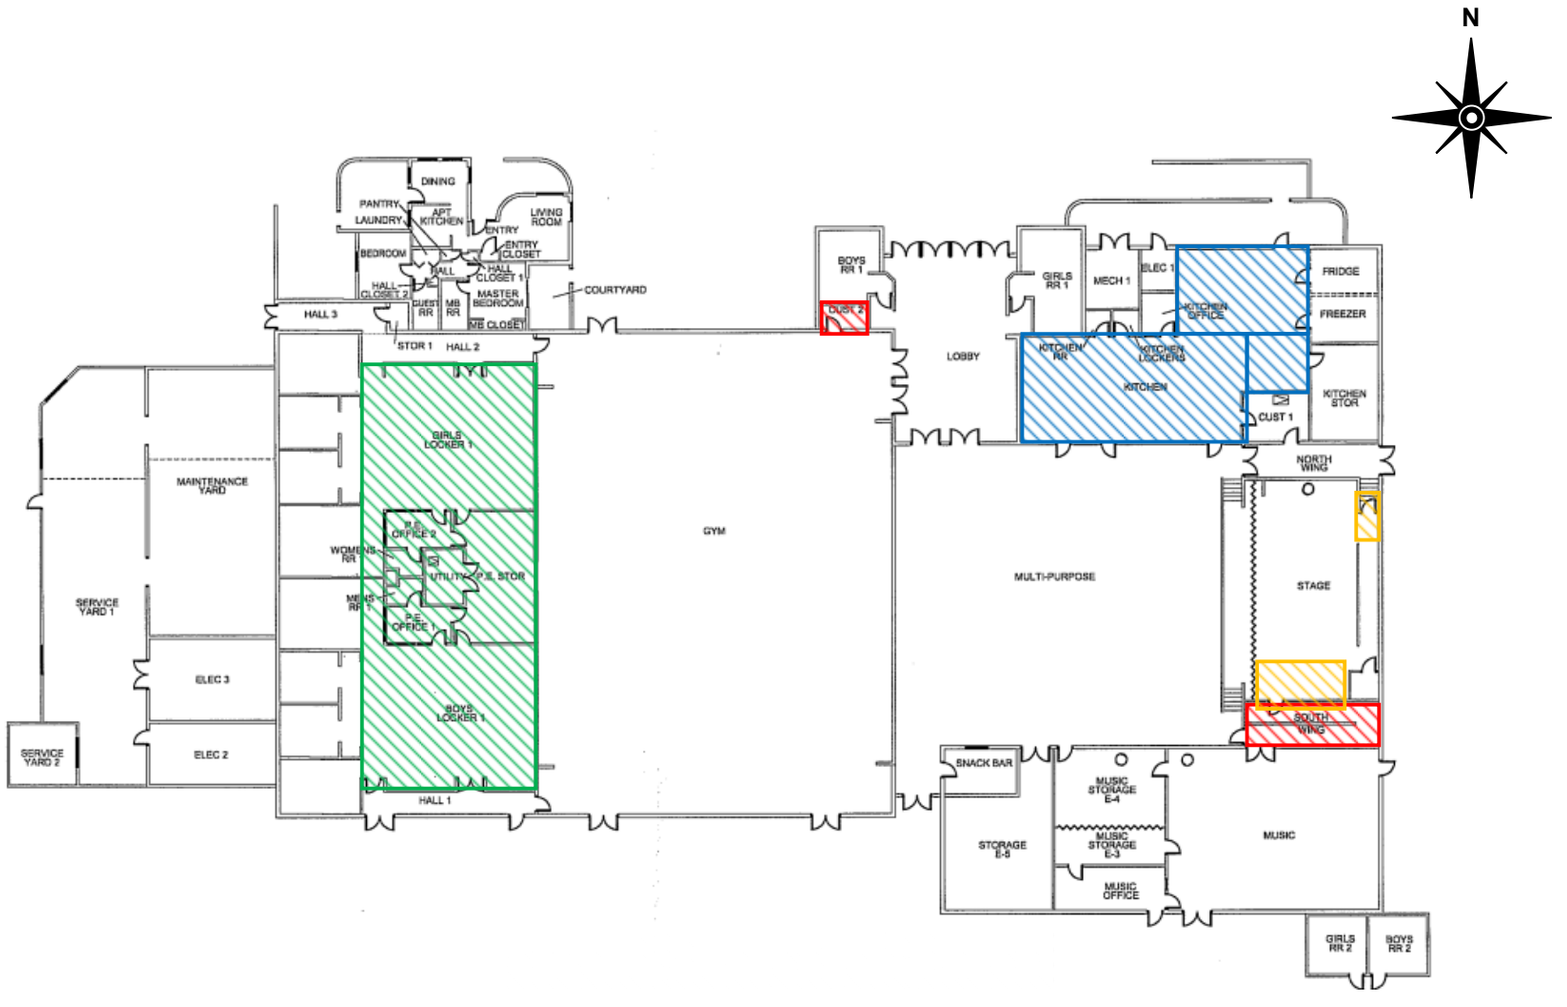
Assumed Asbestos-Containing Black 6" Cove Base & Mastic

Assumed Asbestos-Containing Blue 6" Cove Base & Mastic White w/ Gray 12" X 12" VCT (Mastic)

Assumed Asbestos-Containing Gray Speckled 12" x 12" VCT (Mastic)

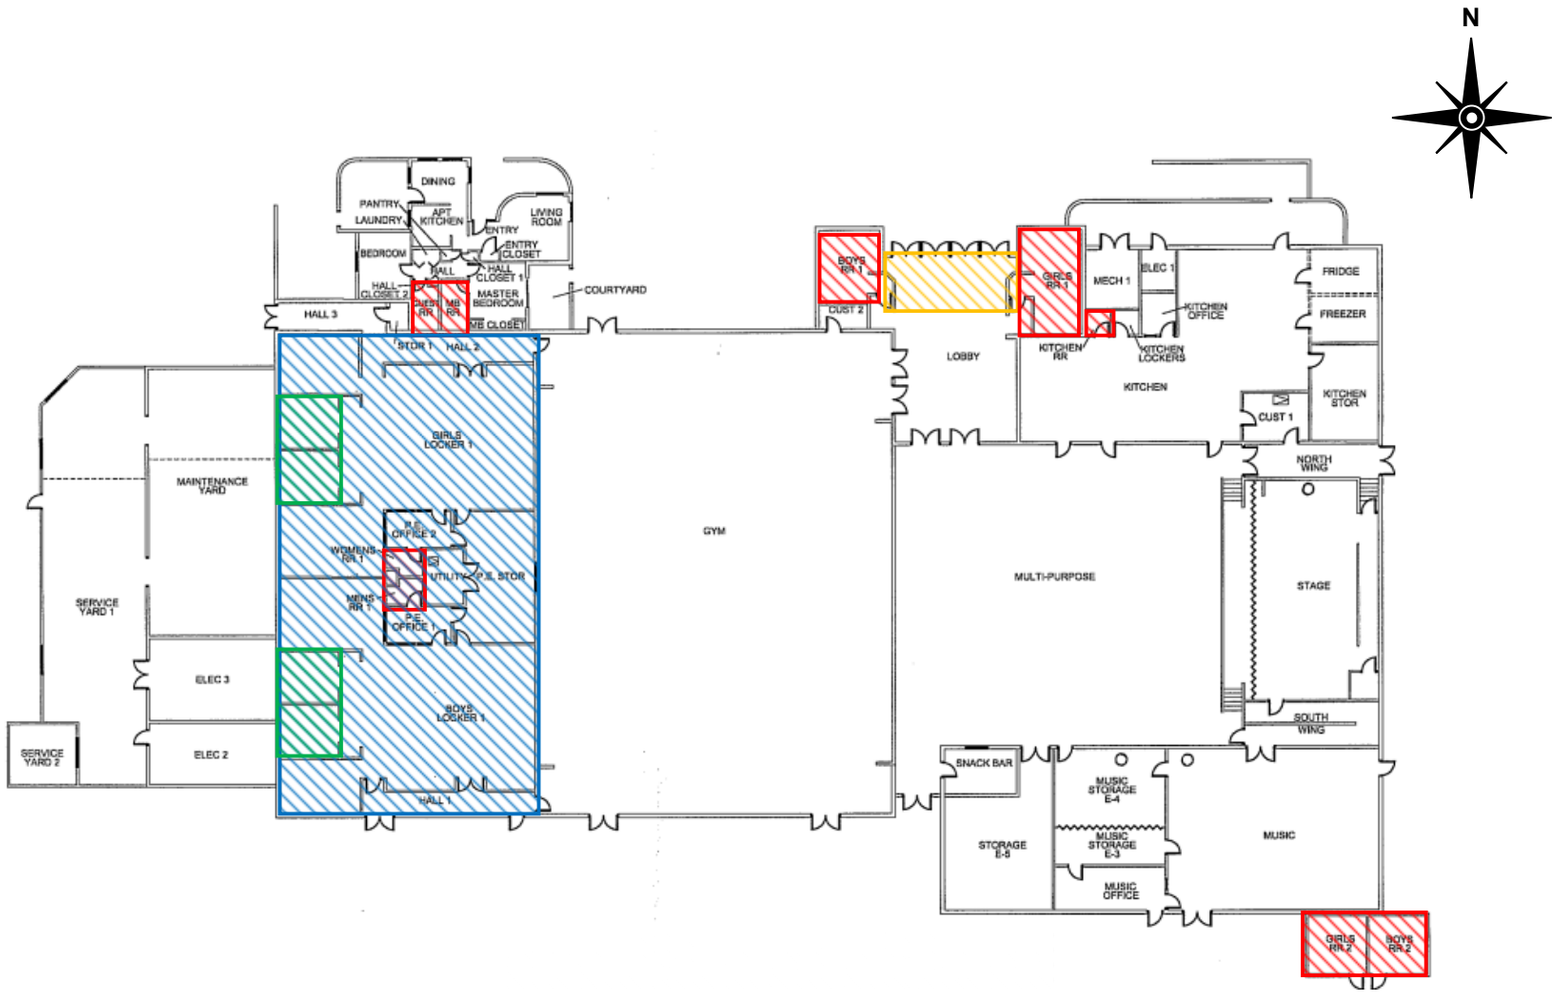
Assumed Asbestos-Containing
Brown 6" Cove Base & Mastic

Assumed Asbestos-Containing
Brown 4" Cove Base & Mastic

Assumed Asbestos-Containing
New FRP & Mastic
Brown 6" x 6" Ceramic Floor Tile
Brown 4" x 6" Ceramic Cove Base
(Grout, Thinset, and Mastic)
Drywall 2' x 4' Ceiling Tile

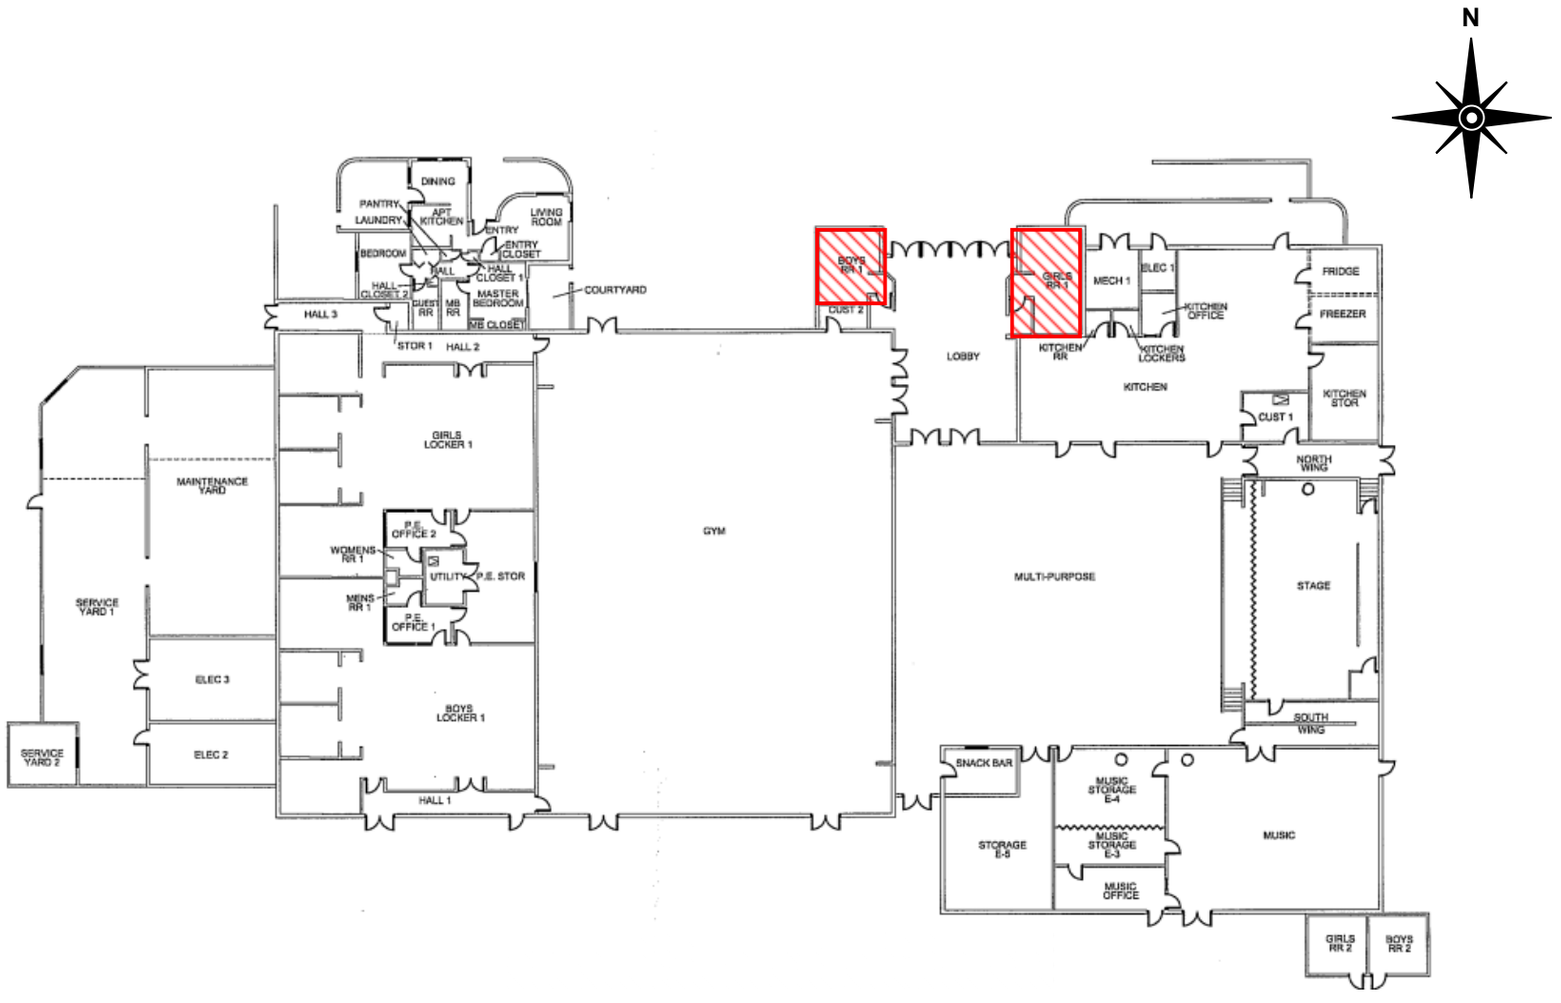
Assumed Asbestos-Containing
Glass Block Mortar

Assumed Asbestos-Containing
Gray 6" x 6" Ceramic Floor Tile
(Grout & Thinset)

Assumed Asbestos-Containing
White w. Black 12" x 12" VCT
Black 4" Cove Base
White 4" x 4" Ceramic Wall Tile
Red 4" x 4" Ceramic Wall Tile
Black 4" x 4" Ceramic Wall Tile
Gray Floor Coating
Gray FRP
(Mastic)
Concrete Benches

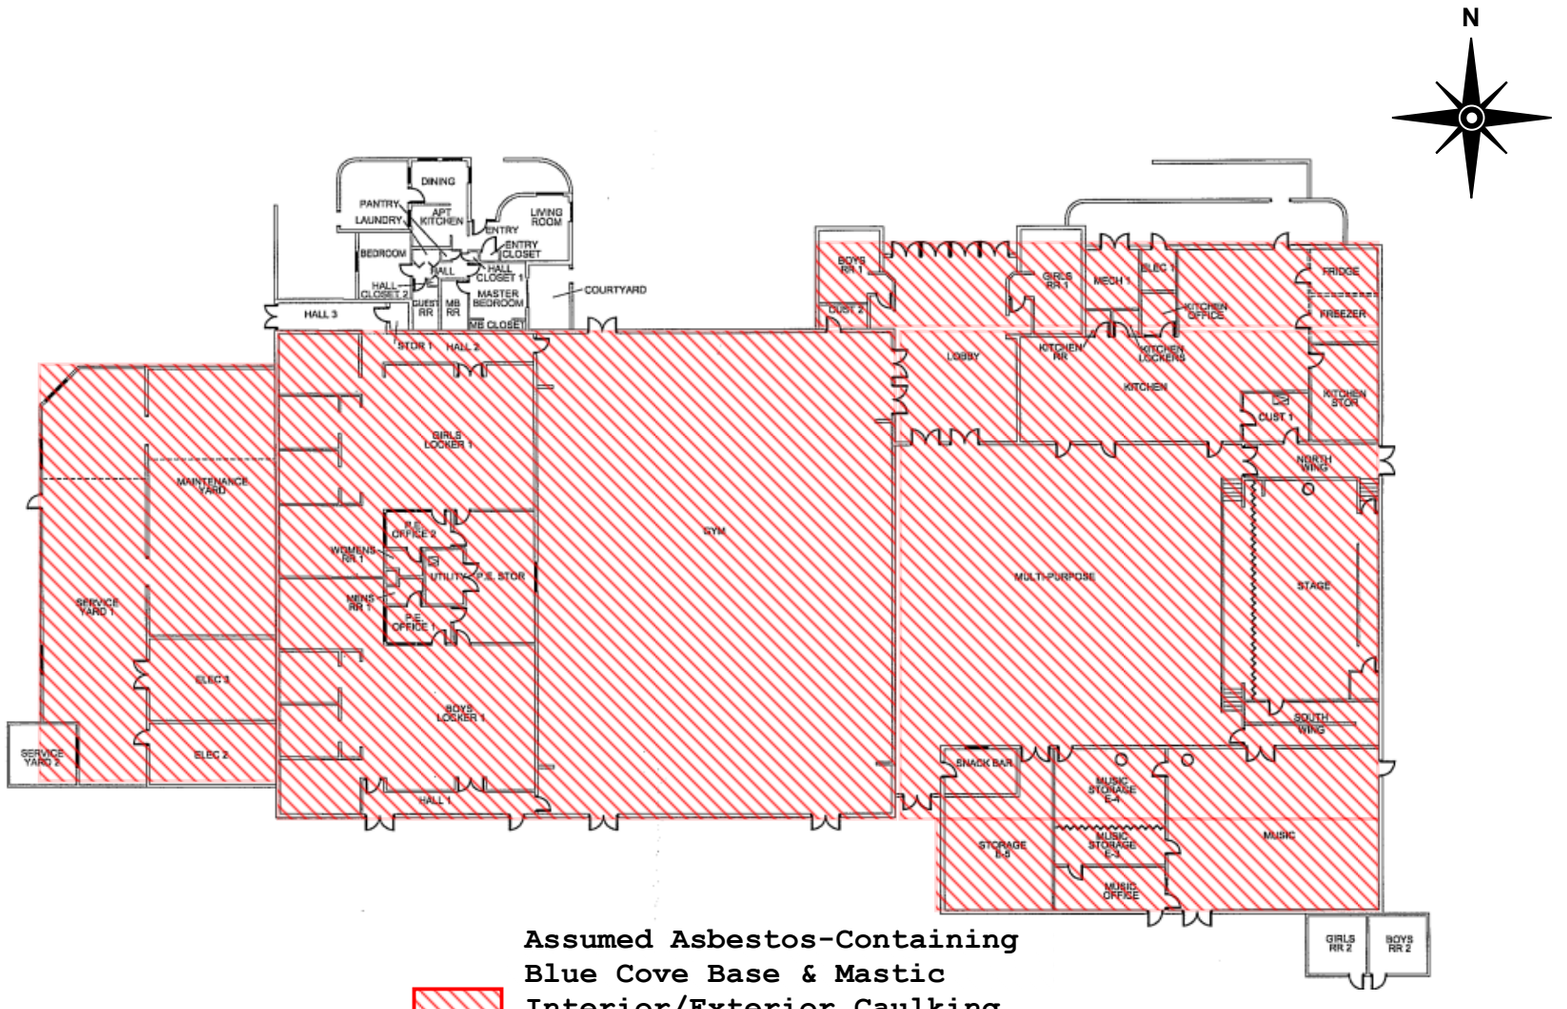
Building E

Assumed Asbestos-Containing
Blue Cove Base & Mastic
Interior/Exterior Caulking
Black Window Glazing
Polished Concrete & Expansion Joint
Silver Box Duct Wrap
Silver Duct Wrap
Silver Flex Duct Wrap
White Duct Tape & Mastic
Gray Duct Mastic
Large Pipe Wrap & Mastic
Small Pipe Wrap & Mastic
Unfinished Drywall
Black Sink Coating

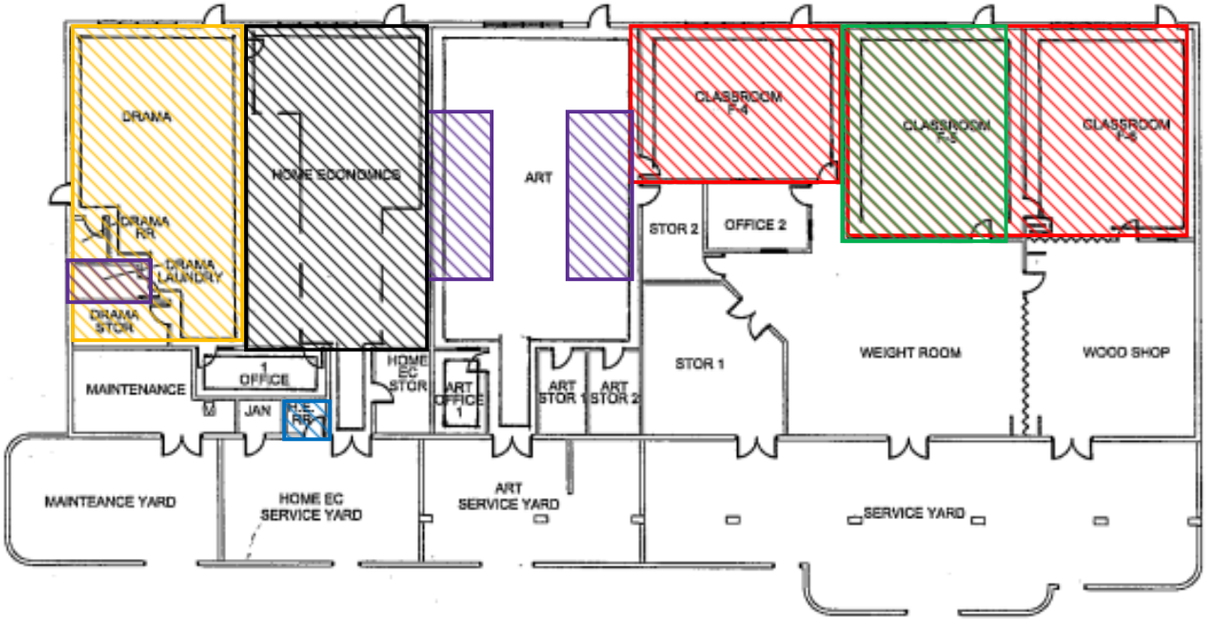
Building E

Assumed Asbestos-Containing Blue Cove Base & Mastic Tacboard & Mastic

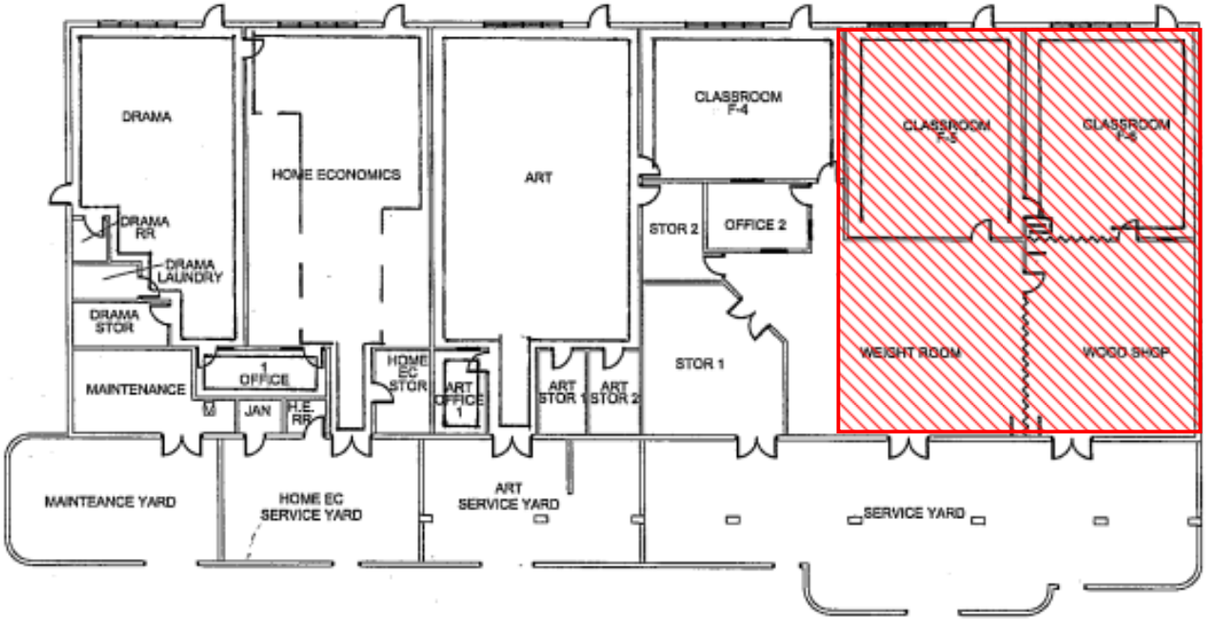
Assumed Asbestos-Containing Fixture Caulking

Assumed Asbestos-Containing Gray Sink Coating

Assumed Asbestos-Containing Polished Concrete Floor Expansion

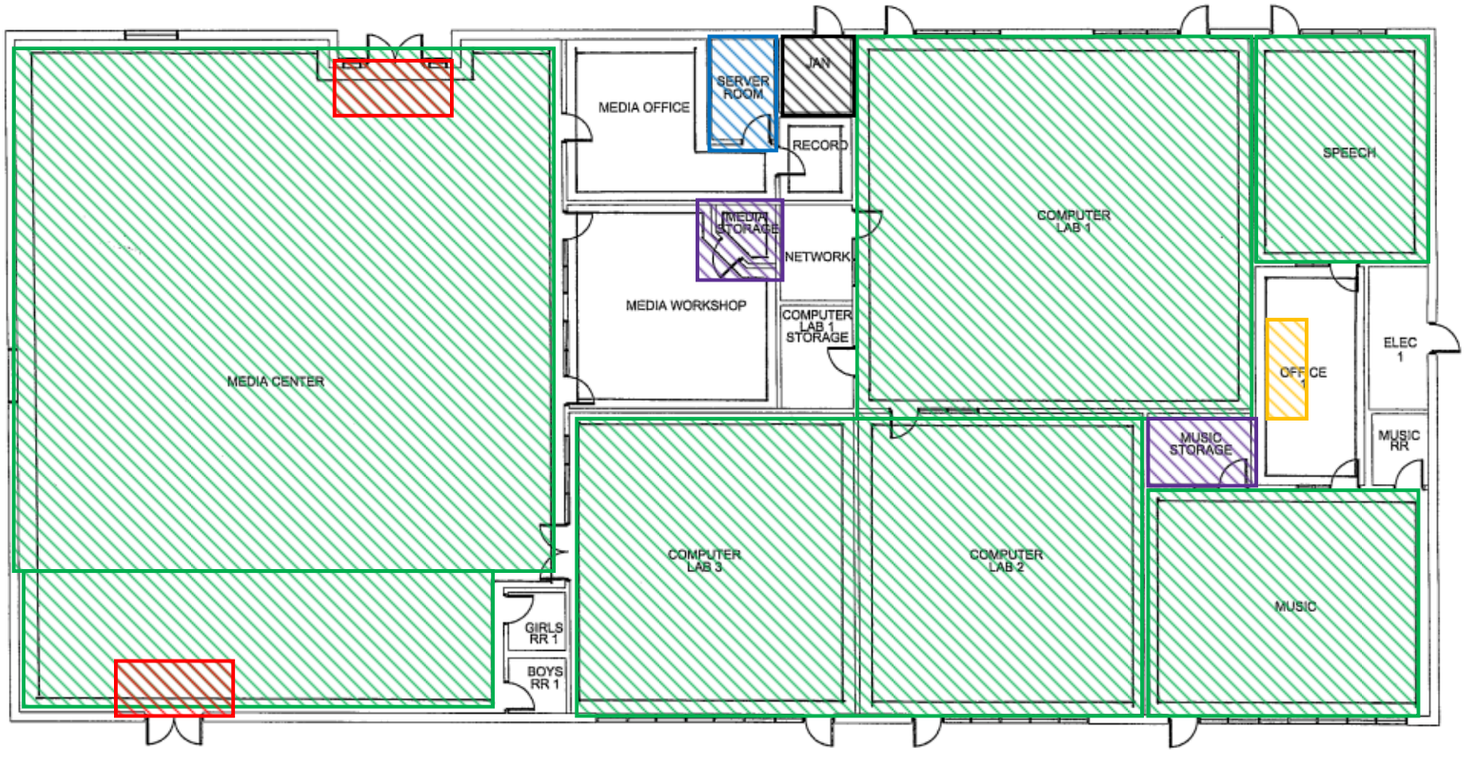
Building F

Assumed Asbestos-Containing
Interior/Exterior Caulking
Black Window Glazing
Brick & Mortar
Expansion Joint
Large Pipe Wrap & Mastic
Small Pipe Wrap & Mastic
Black Pipe Foam Insulation
Silver Box Duct Wrap
Silver Duct Wrap
Silver Flex Duct Wrap
White Duct Tape & Mastic
Unfinished Drywall
Silver Duct Tape
Skylight Insulation Panel

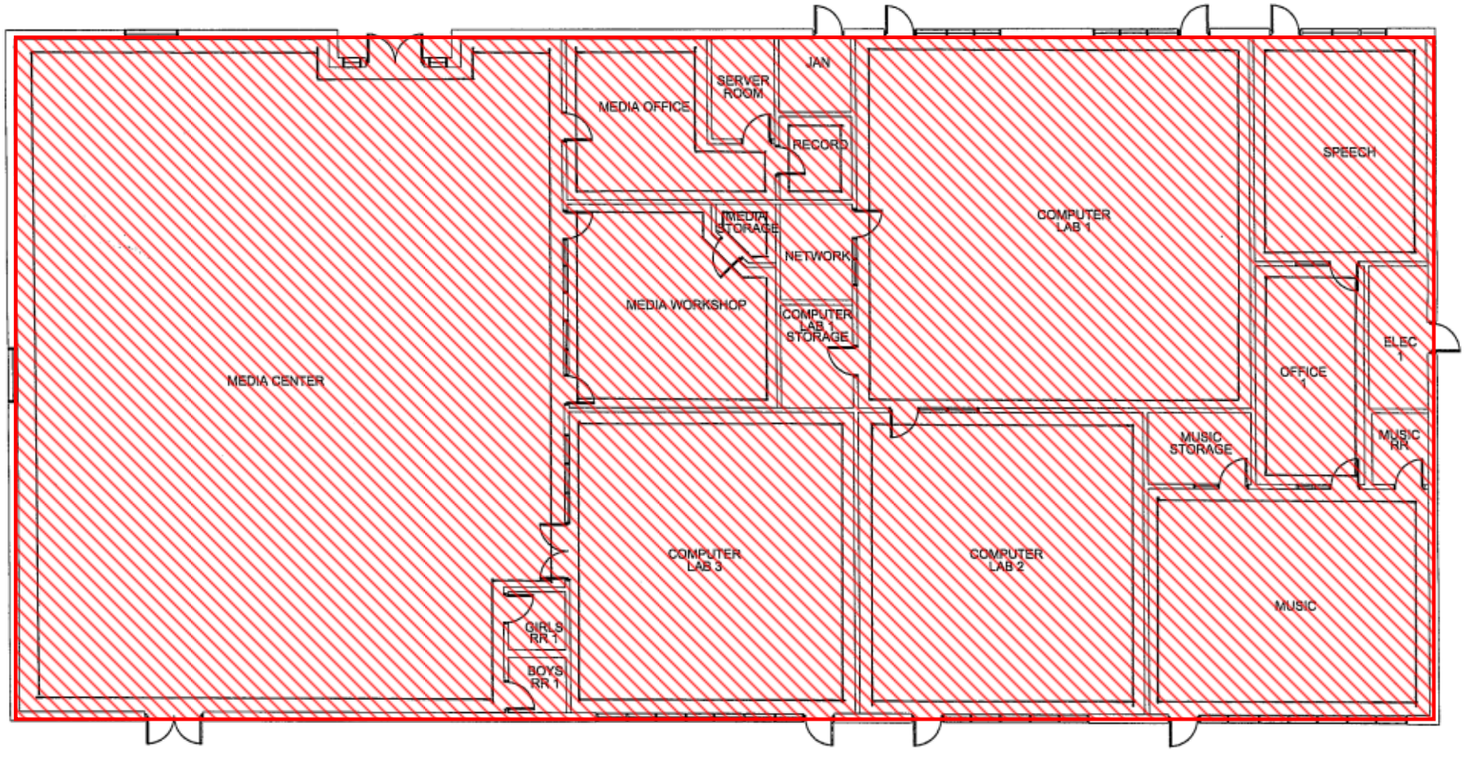
Assumed Asbestos-Containing
White w. Gray 12" x 12" VCT
(Mastic)

Assumed Asbestos-Containing
Gray Wallpaper
Brown Cove Base & Mastic

Assumed Asbestos-Containing
Knockdown Drywall

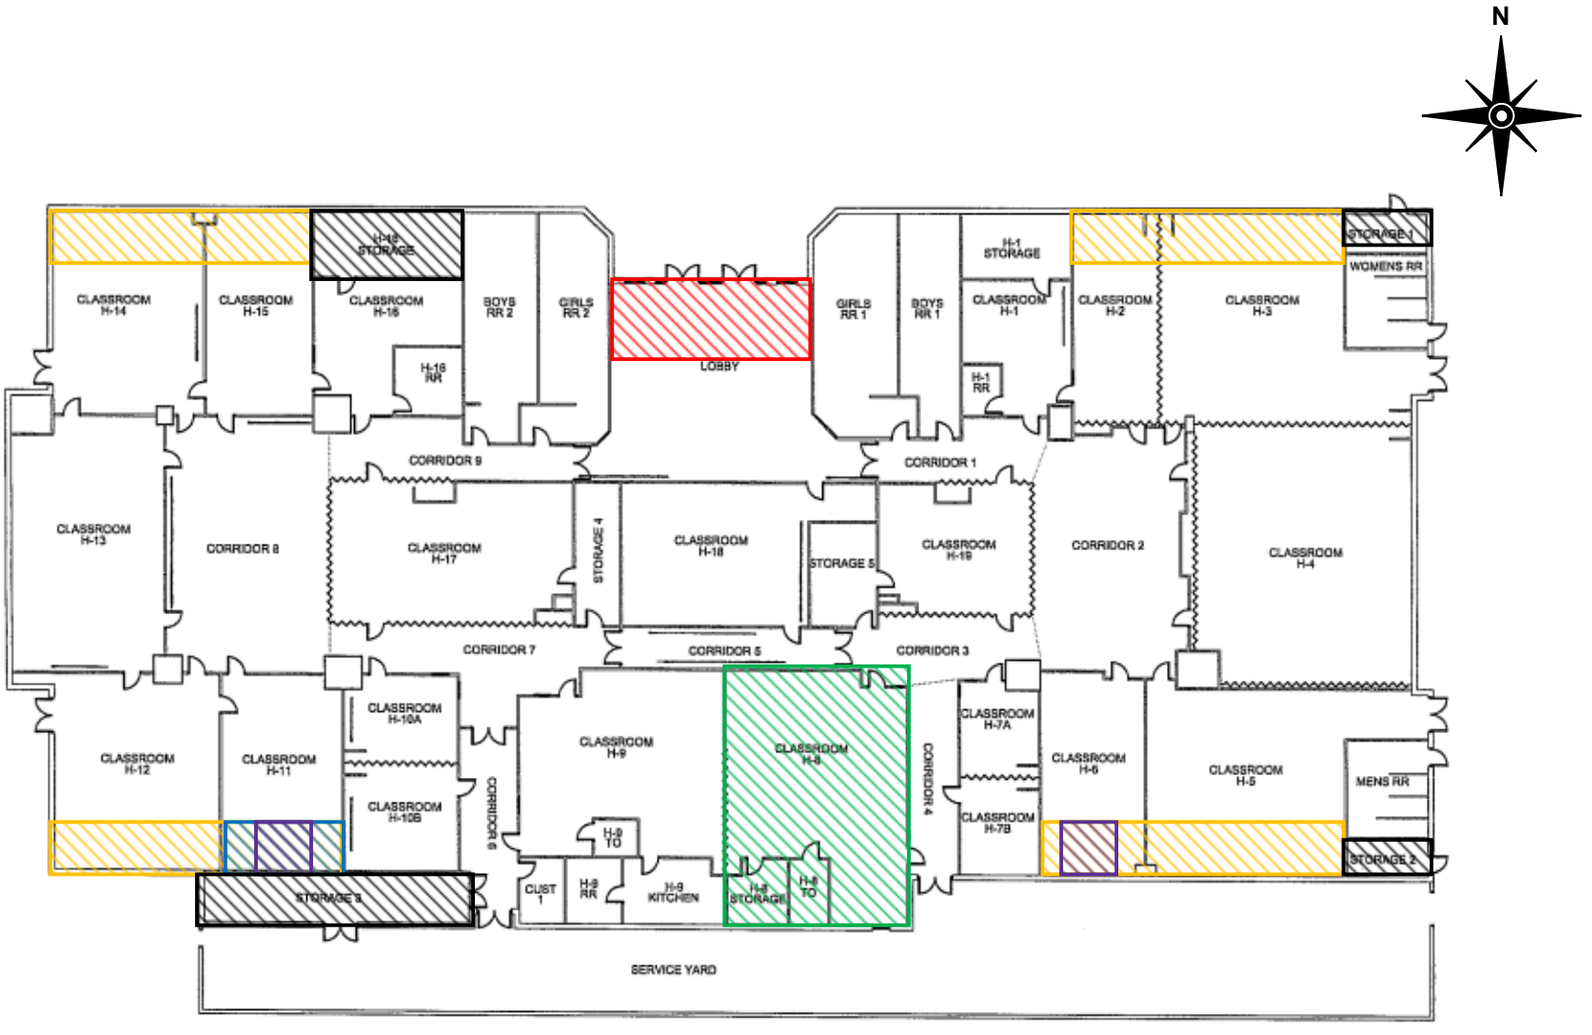
Building G

Assumed Asbestos-Containing Black Entry Carpet & Mastic Glass Block Mortar
