AHERA ASBESTOS MANAGEMENT PLAN

KYRENE CENTENNIAL MIDDLE SCHOOL
13808 SOUTH 36TH STREET
PHOENIX, ARIZONA 85044

Dominion Environmental Consultants, Inc.
20045 North 19th Avenue, Building 7
Phoenix, Arizona 85027
(623) 516-1415

September 12 , 2025

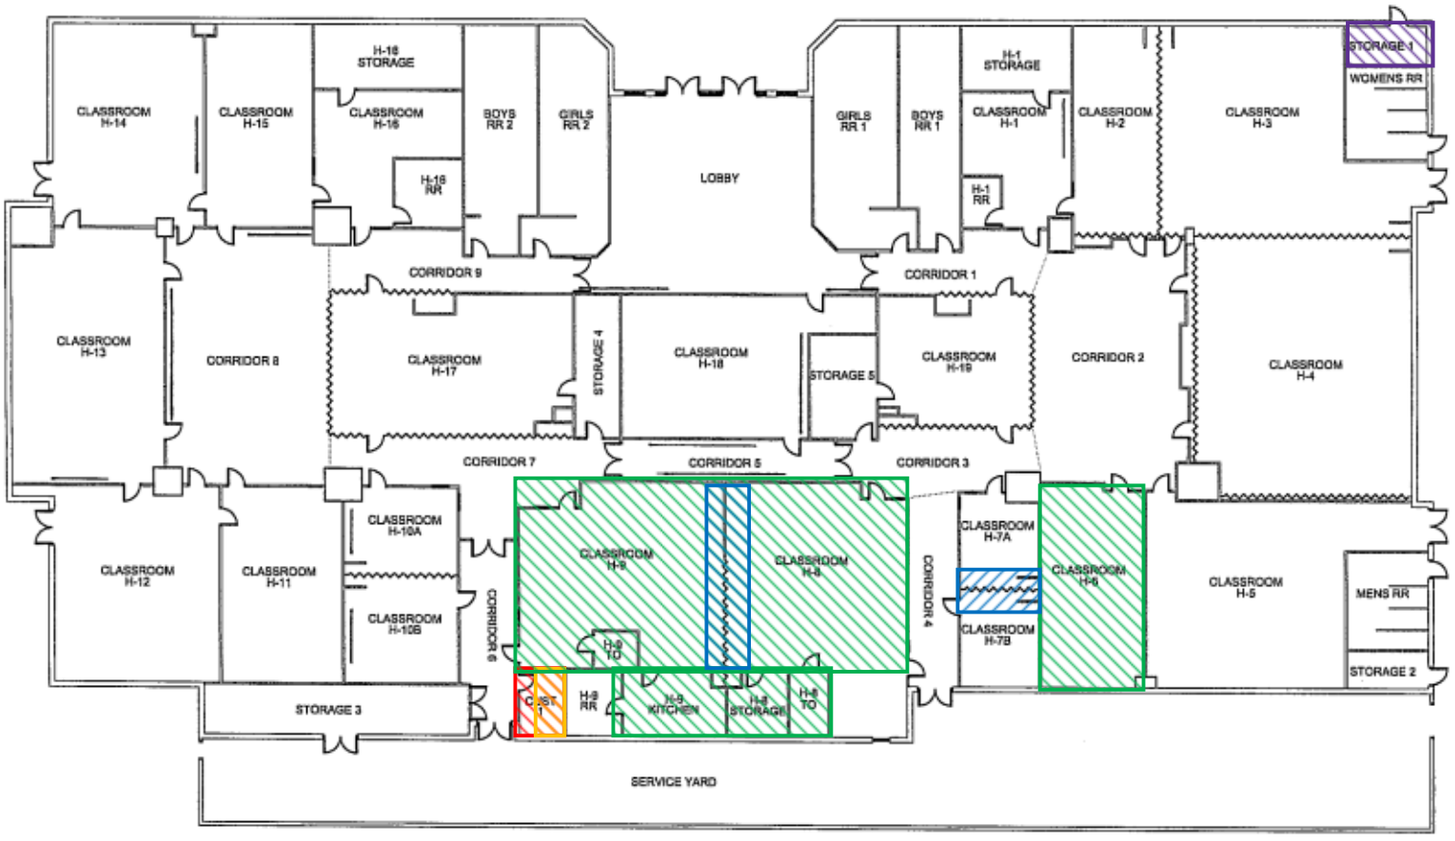
Assumed Asbestos-Containing White Sink Coating

Assumed Asbestos-Containing Fume Hood Panel

Assumed Asbestos-Containing Tan Speckled 12" x 12" VCT (Mastic)

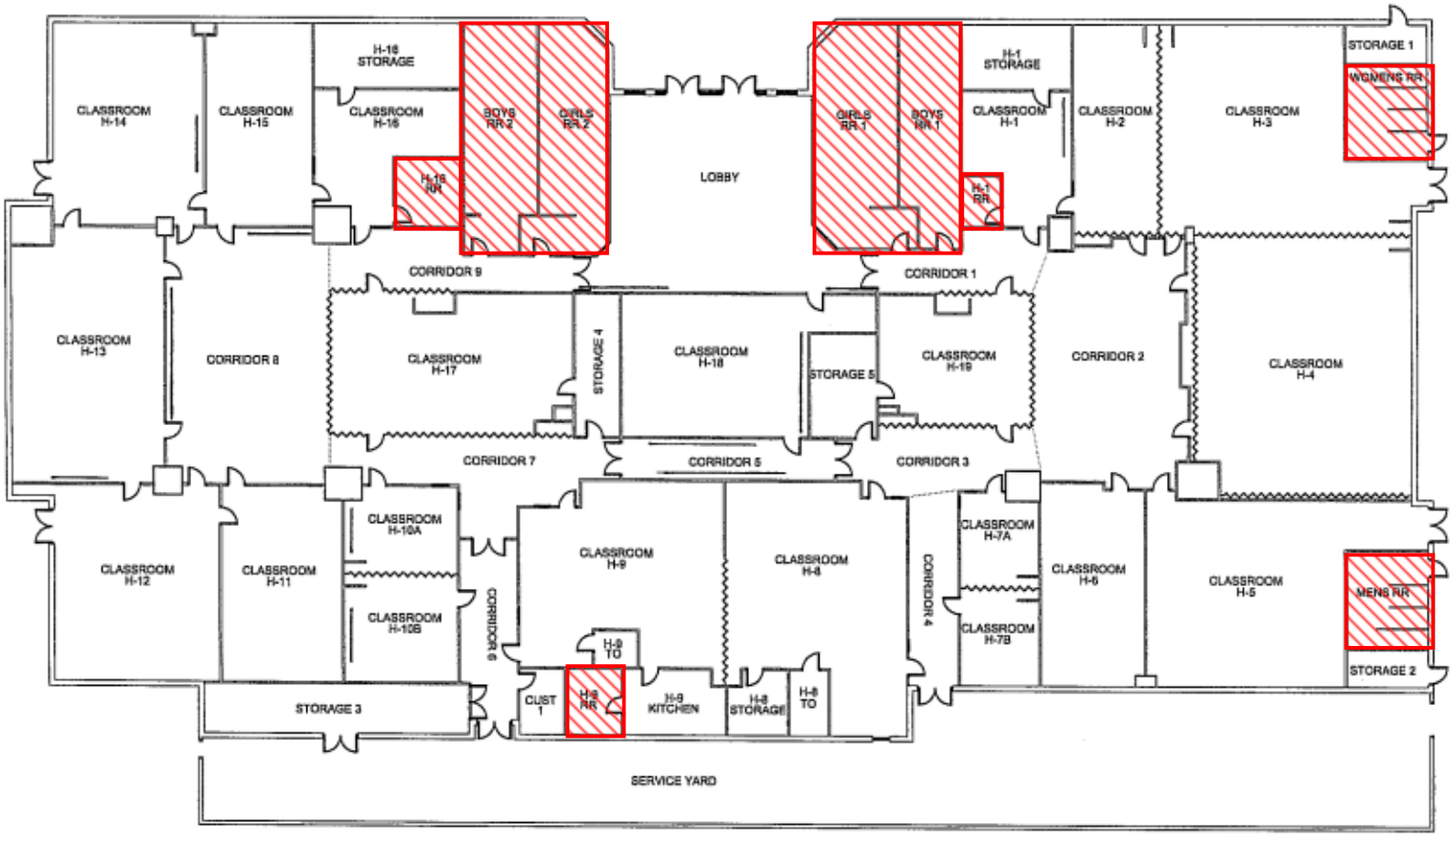
Assumed Asbestos-Containing White w. Gray 12" x 12" VCT (Mastic)

Assumed Asbestos-Containing Divider Wall

Assumed Asbestos-Containing Knockdown Drywall

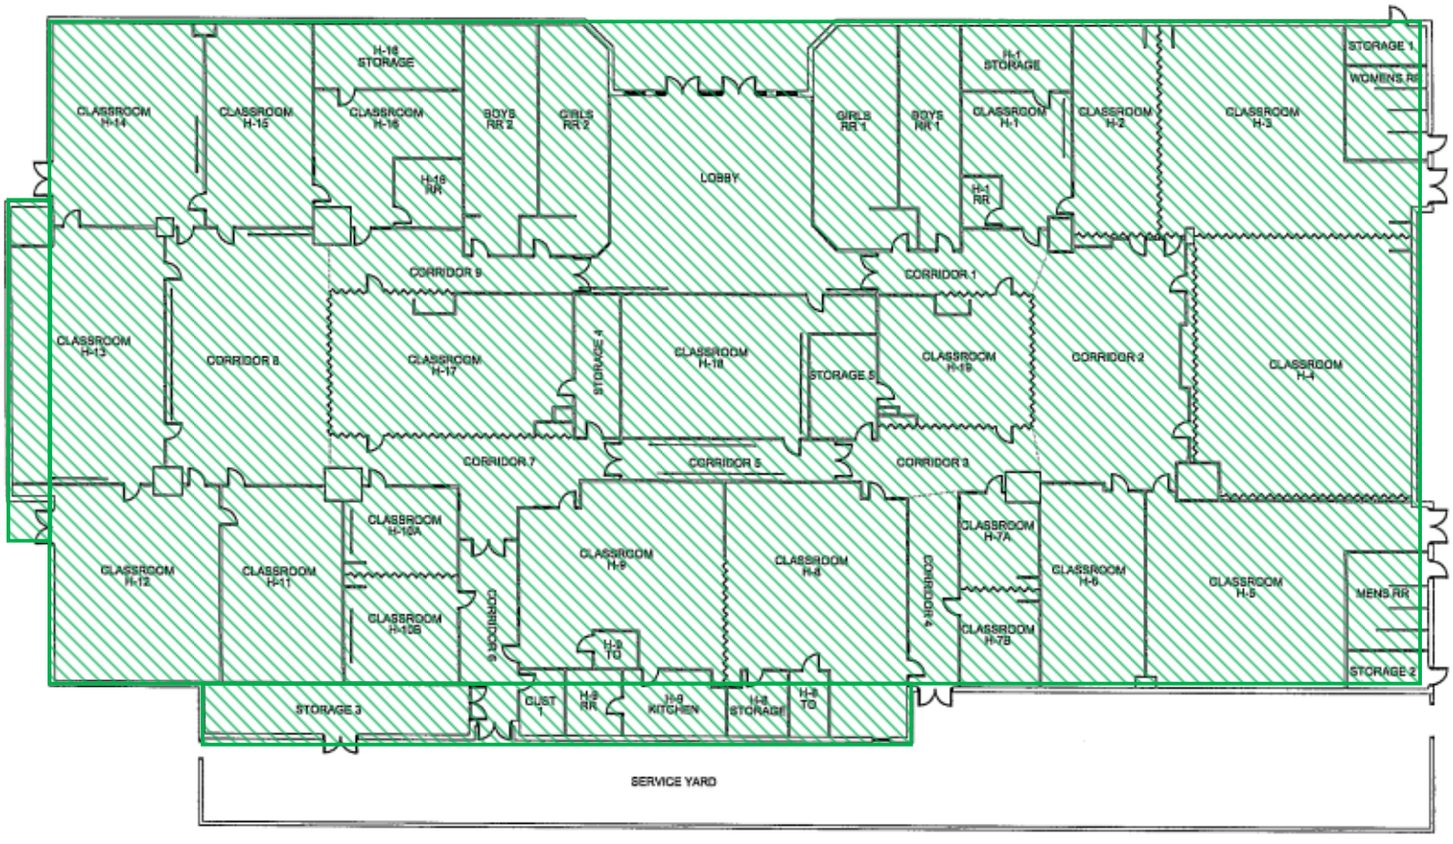
Building H

Assumed Asbestos-Containing
Large Pipe Wrap & Mastic
Small Pipe Wrap & Mastic
Black Pipe Foam Insulation
Silver Box Duct Wrap
Silver Duct Wrap
Silver Flex Duct Wrap
White Duct Tape & Mastic
Unfinished Drywall
Silver Duct Tape
Skylight Insulation Panel
Interior/Exterior Caulking
Block & Mortar
Brick & Mortar
Tacboard & Mastic
