AHERA ASBESTOS INSPECTION REPORT

KYRENE MIDDLE SCHOOL
1050 EAST CARVER ROAD
TEMPE, ARIZONA 85284

Dominion Project Number: AZ1418.57

AHERA Inspection Date: June 11 – June 12, 2025 & June 16, 2025

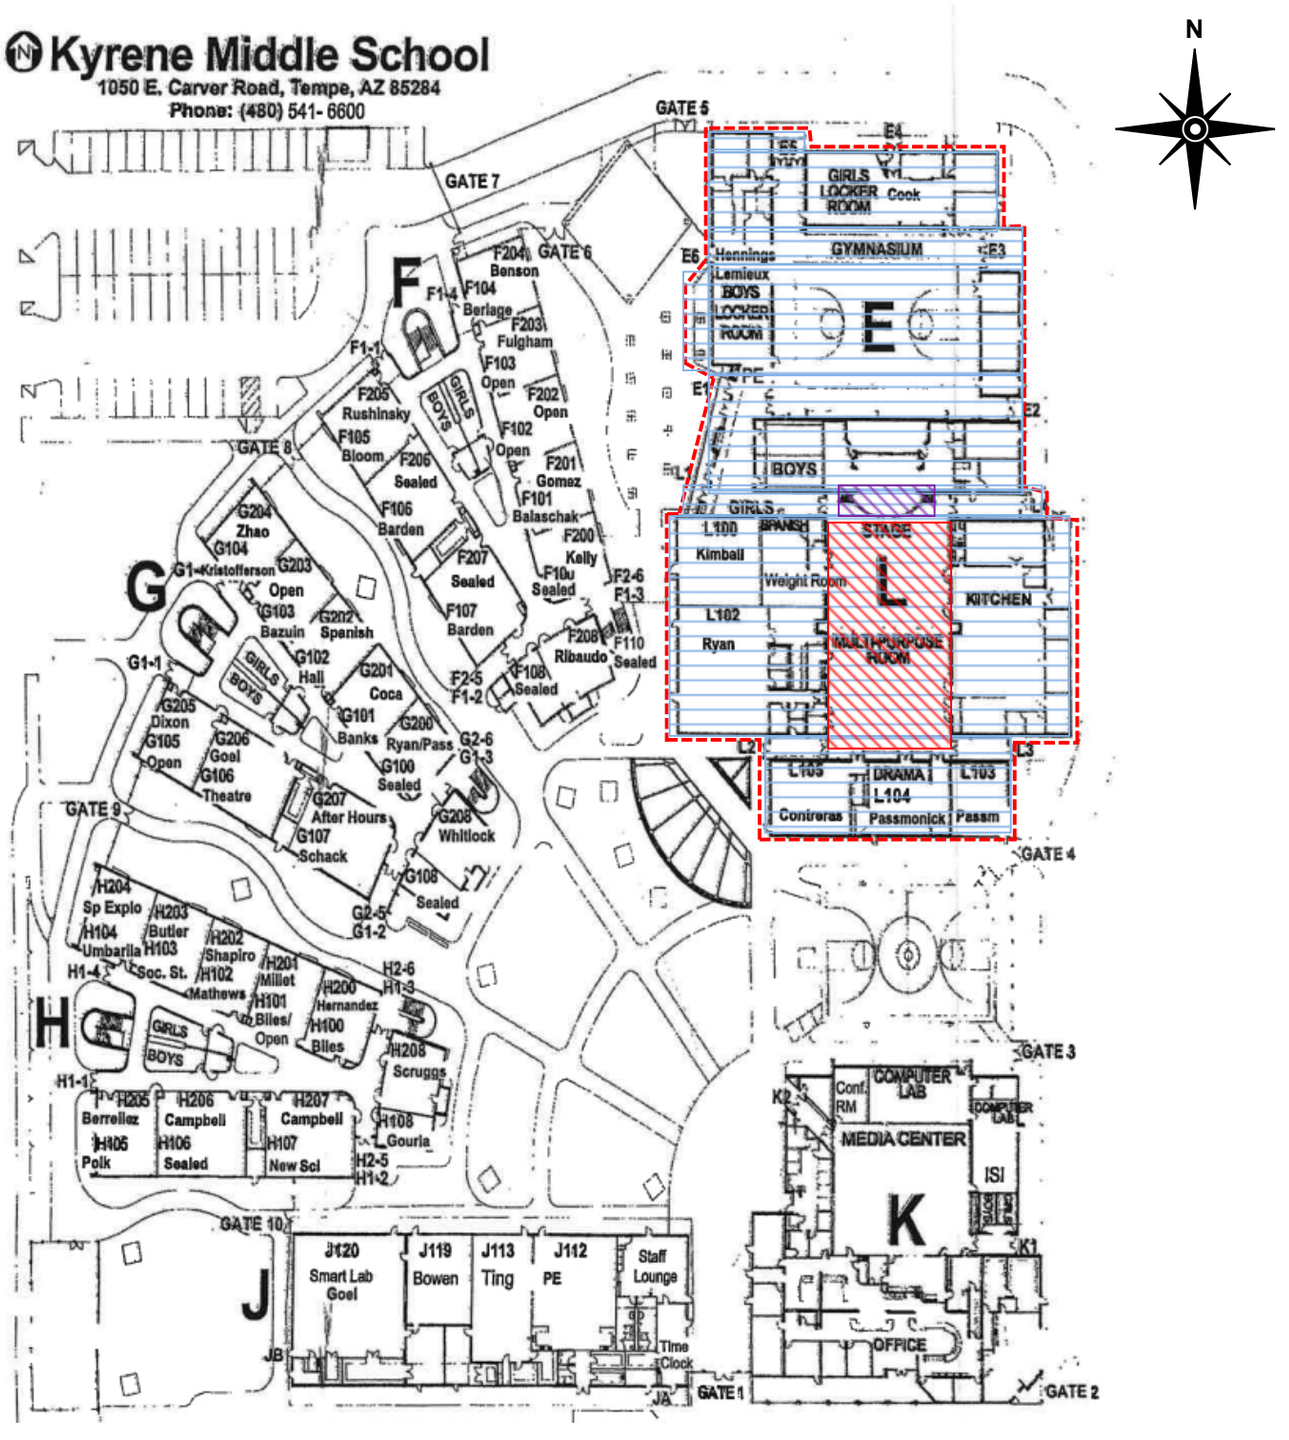
Assumed Asbestos-Containing
Brick & Mortar

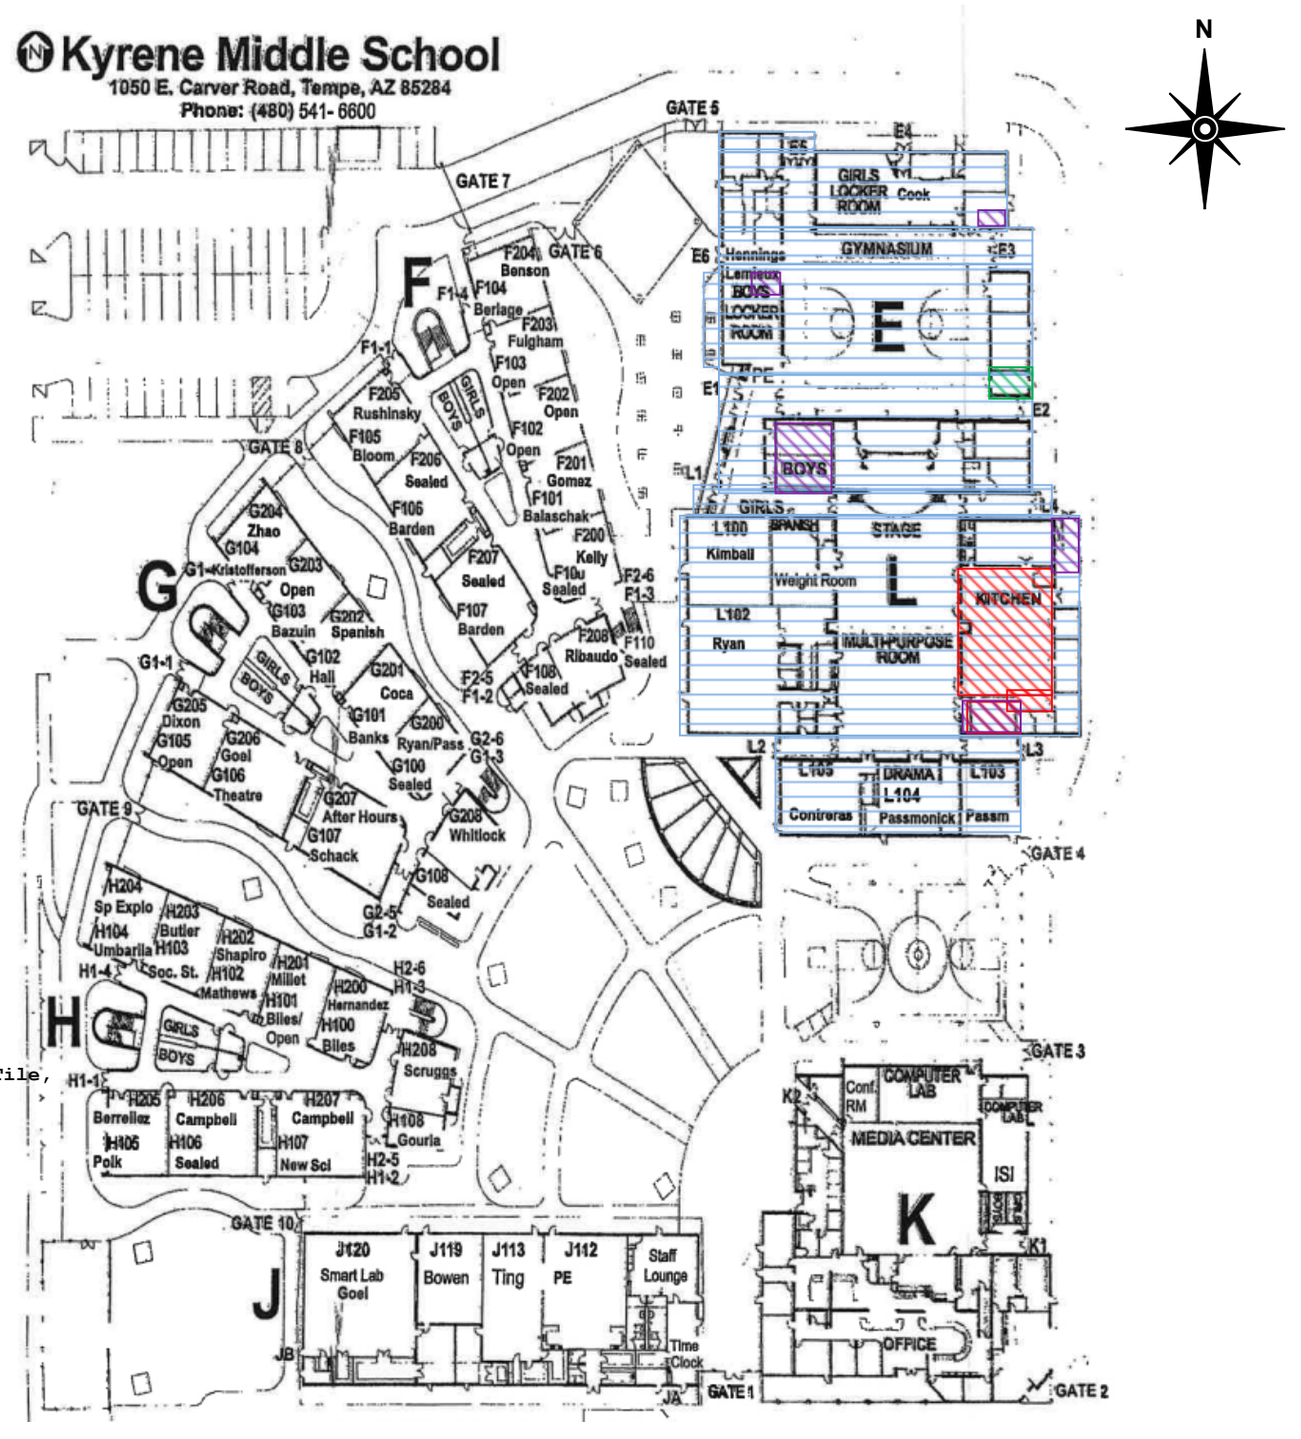
Assumed Asbestos-Containing Material Location Map (1)
Kyrene Middle School
1050 East Carver Road, Tempe, Arizona 85284

Assumed Asbestos-Containing
White w/Black 12" x 12" VCT
& Mastic

Assumed Asbestos-Containing
Black 12" x 12" VCT & Mastic
& Black Stair Tread & Mastic

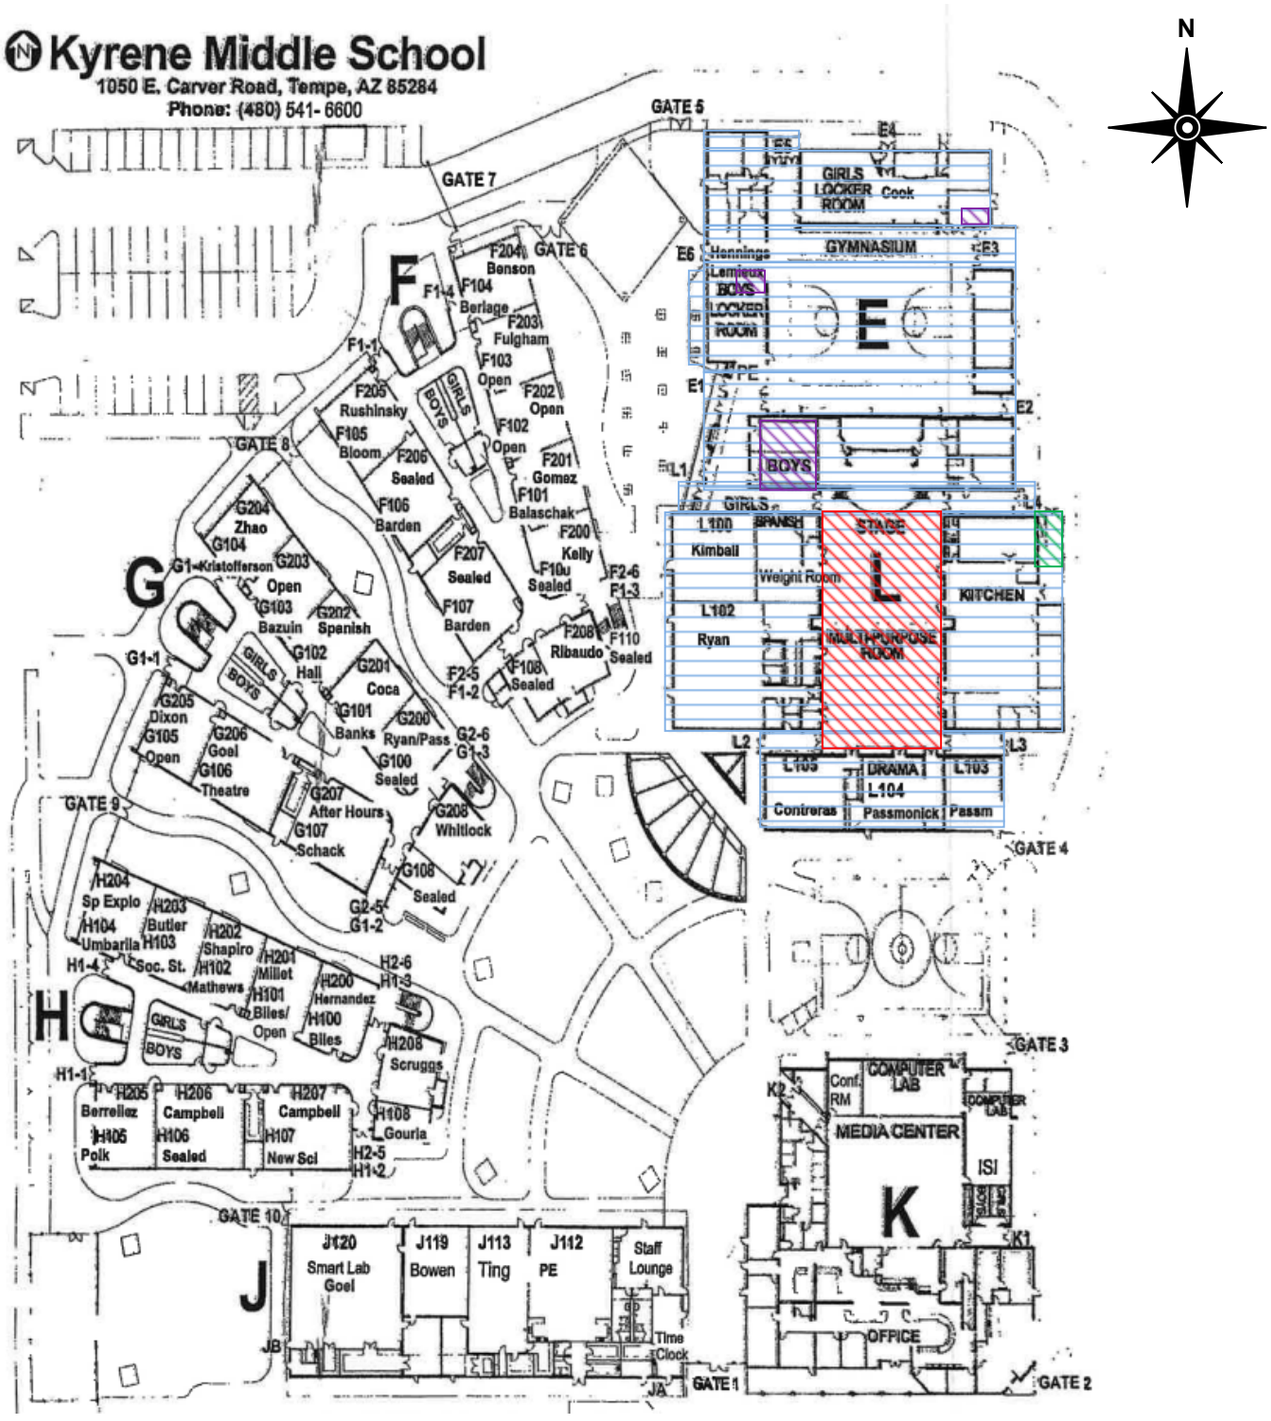
Building E/L

Assumed Asbestos-Containing
Fixture Caulking & Blue
4" x 4" Ceramic
Wall Tile

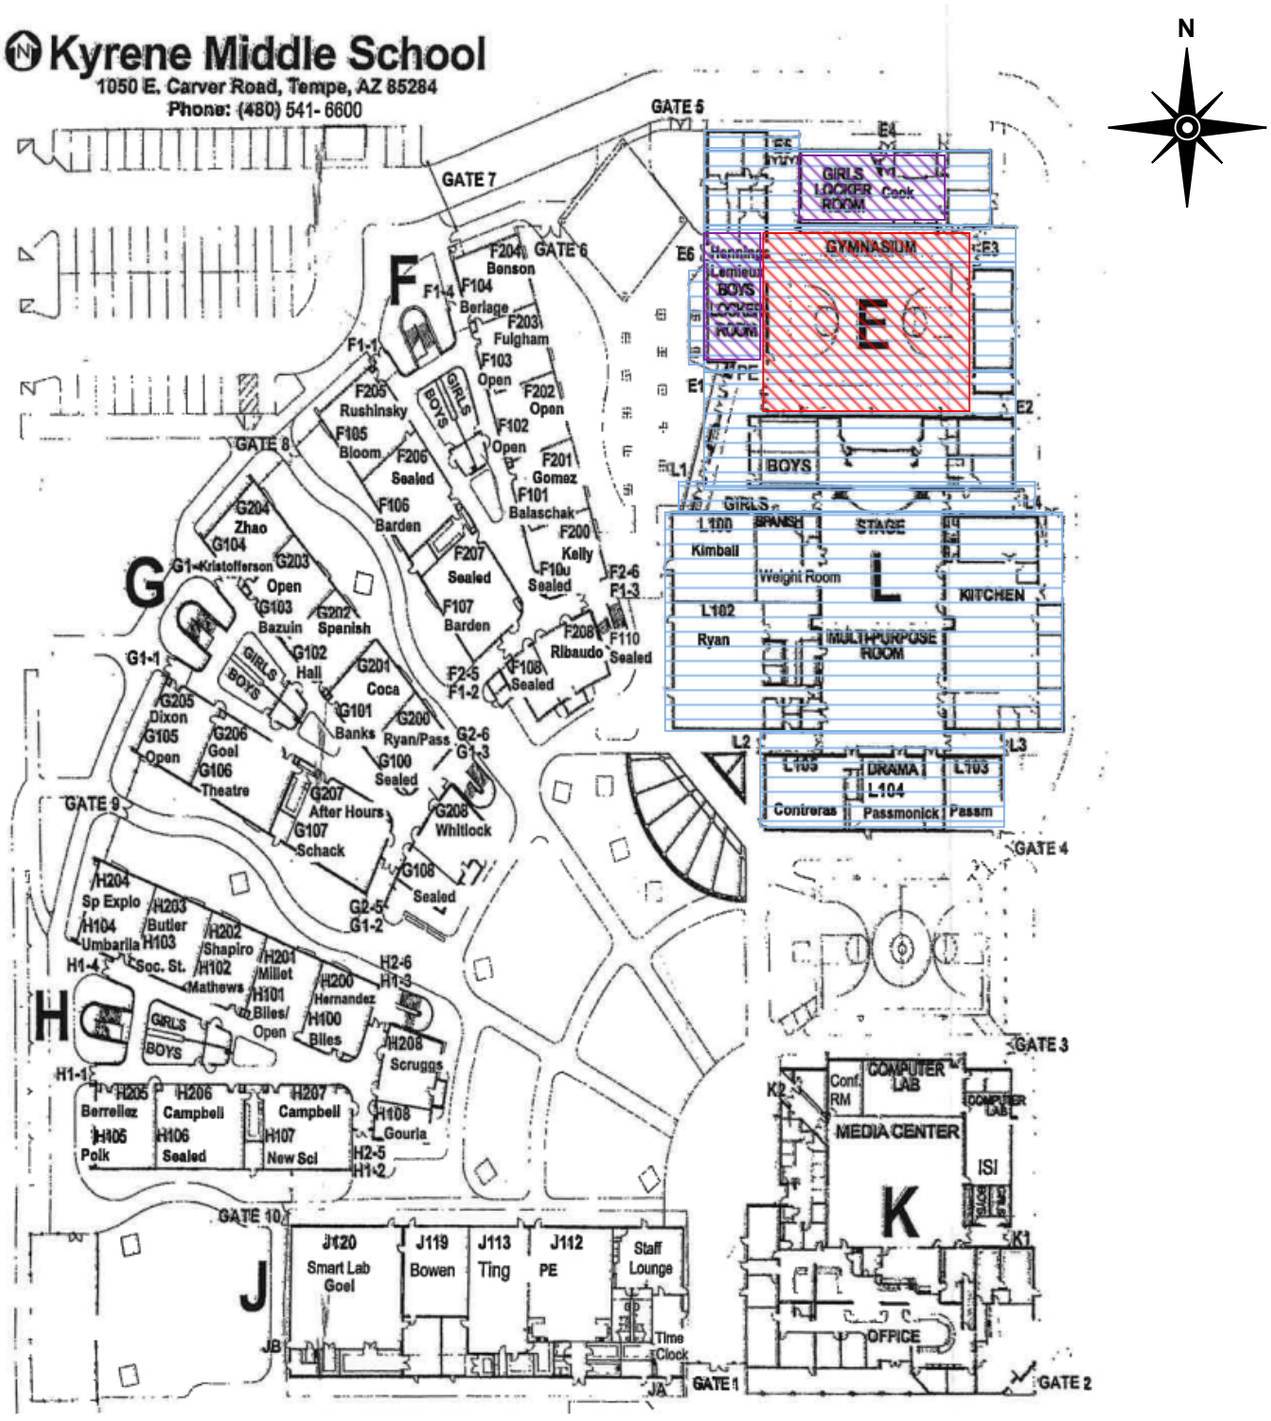
Assumed Asbestos-Containing

Tan 2" x 2" Ceramic Floor Tile,
Grout, & Thinset, Green
2" x 2" Ceramic Floor Tile,
Blue 2" x 2" Ceramic Floor Tile,
& Marble Threshold

Assumed Asbestos-Containing
Divider Wall

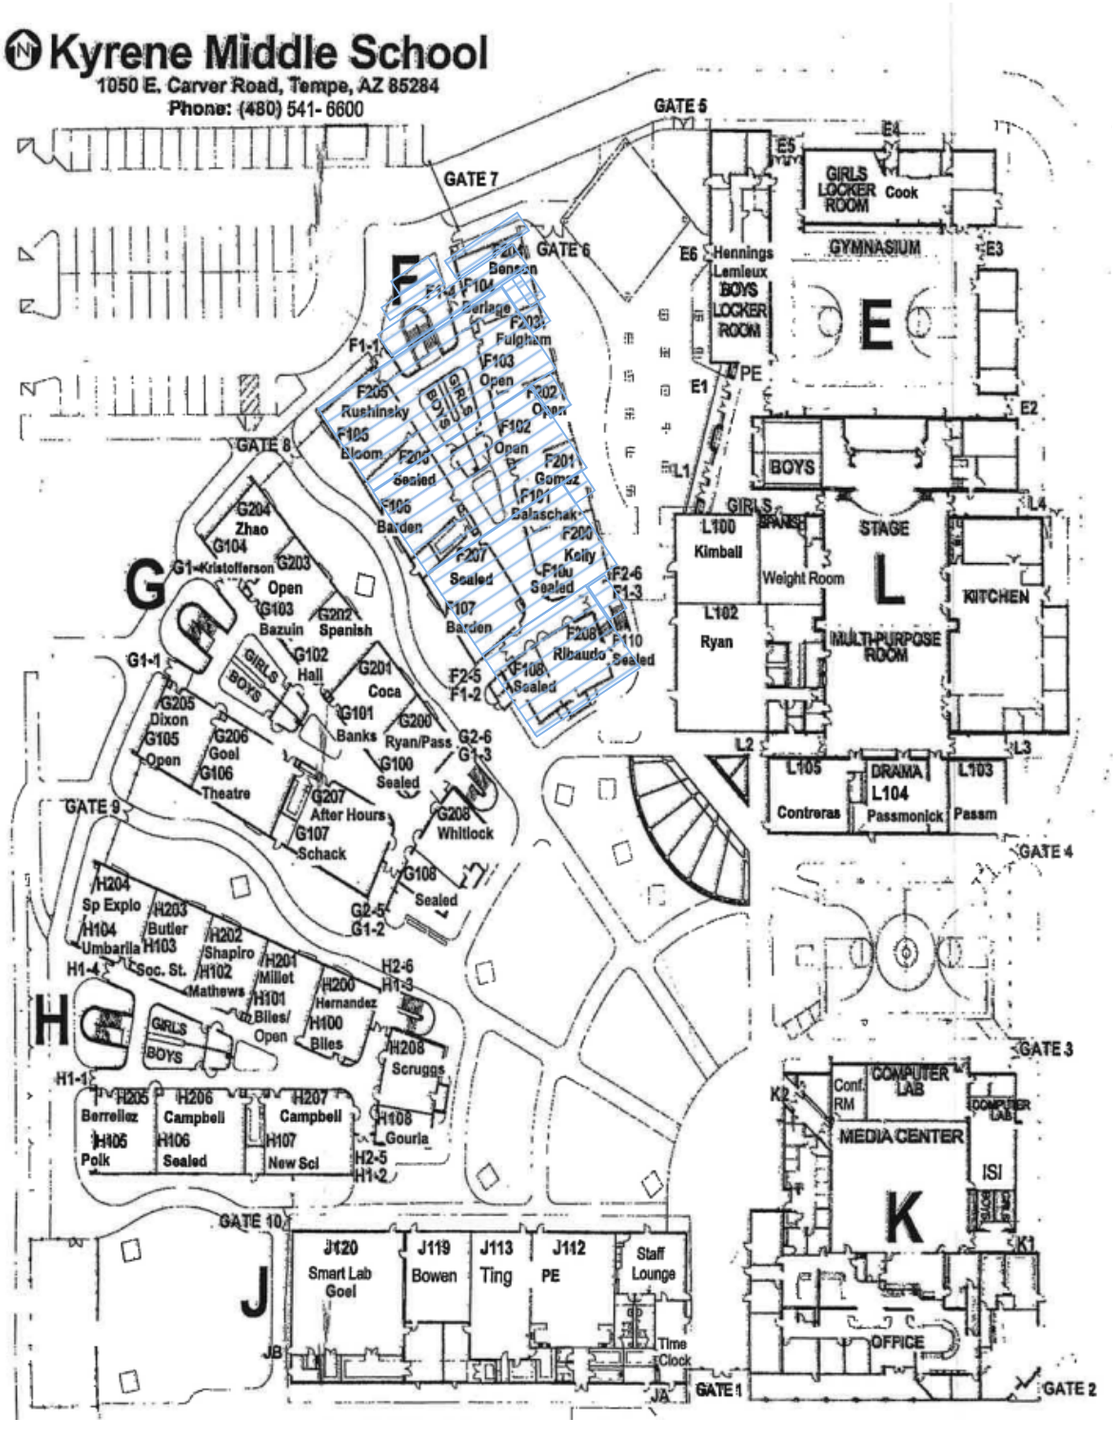
Assumed Asbestos-Containing

Interior Caulking,
Fixture Caulking, FRP & Mastic,
Gray 20 " x 20" Floor Tile &
Mastic, & Knockdown
Drywall System

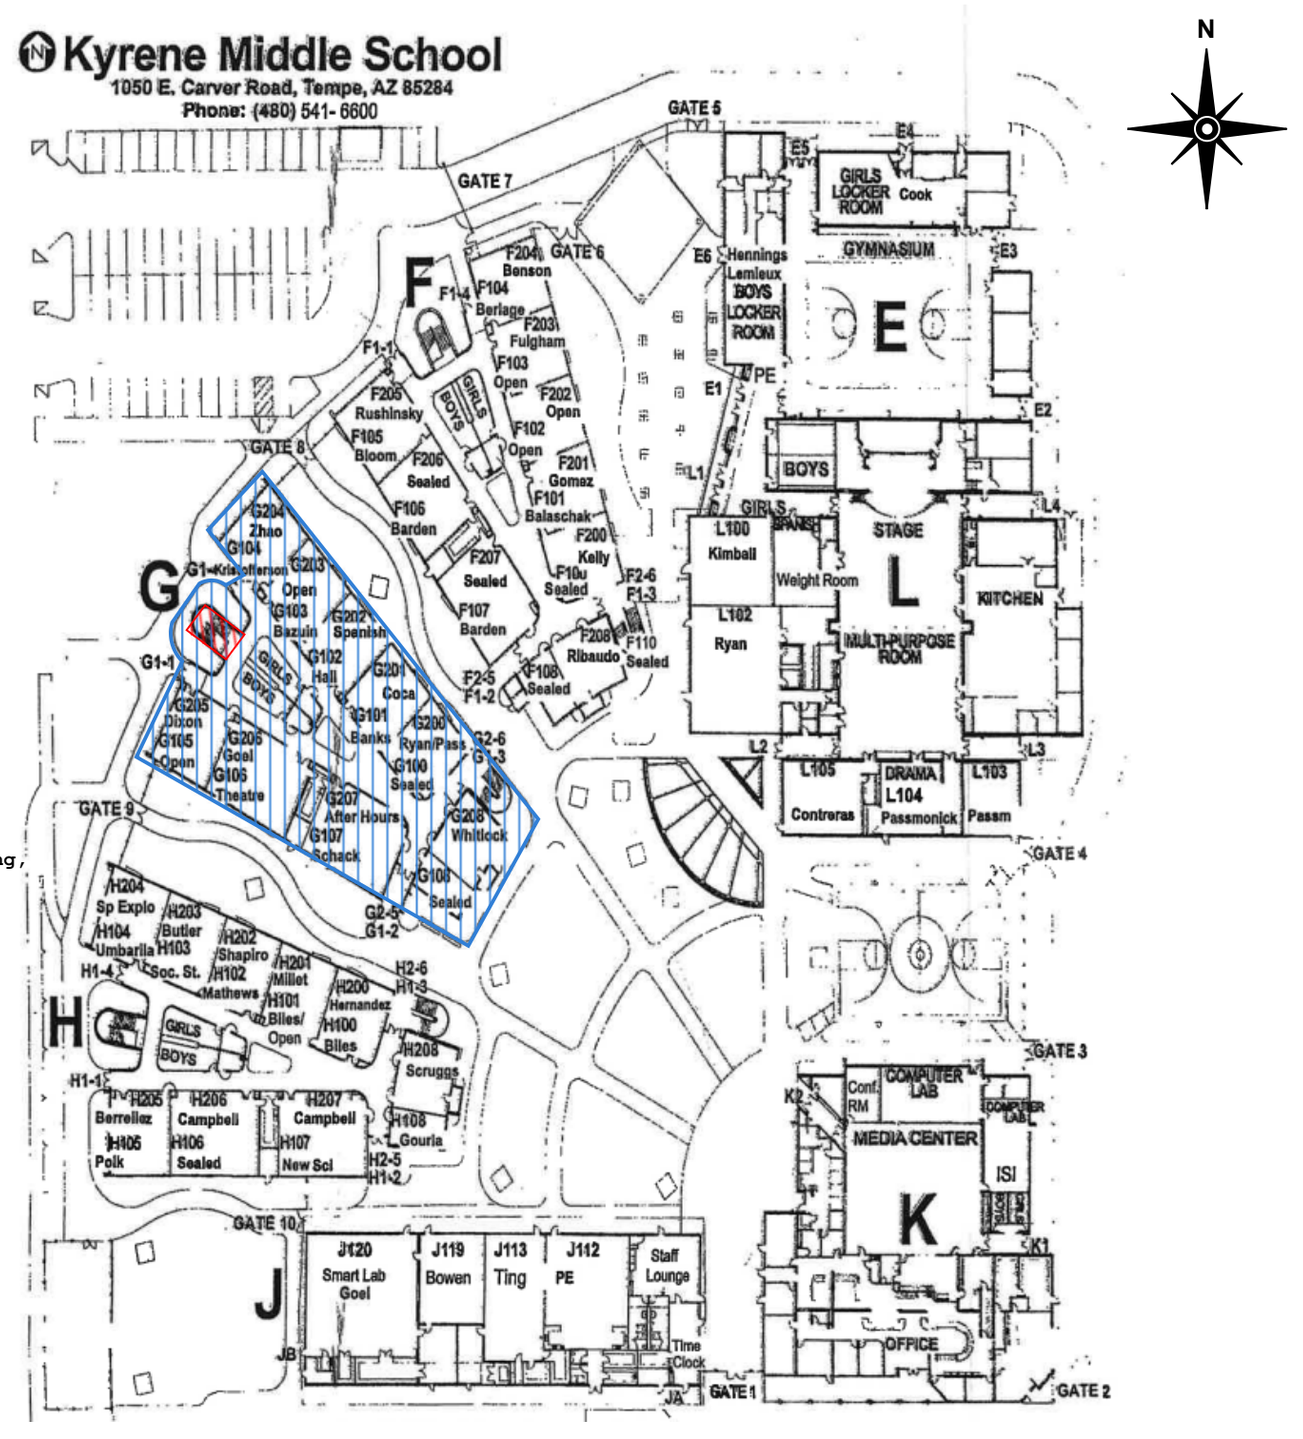
Assumed Asbestos-Containing Material Location Map (1) — Project No. AZ1418.57
Kyrene Middle School
1050 East Carver Road, Tempe, Arizona 85284 — Building G

Assumed Asbestos-Containing

Assumed Asbestos-Containing Exterior Caulking

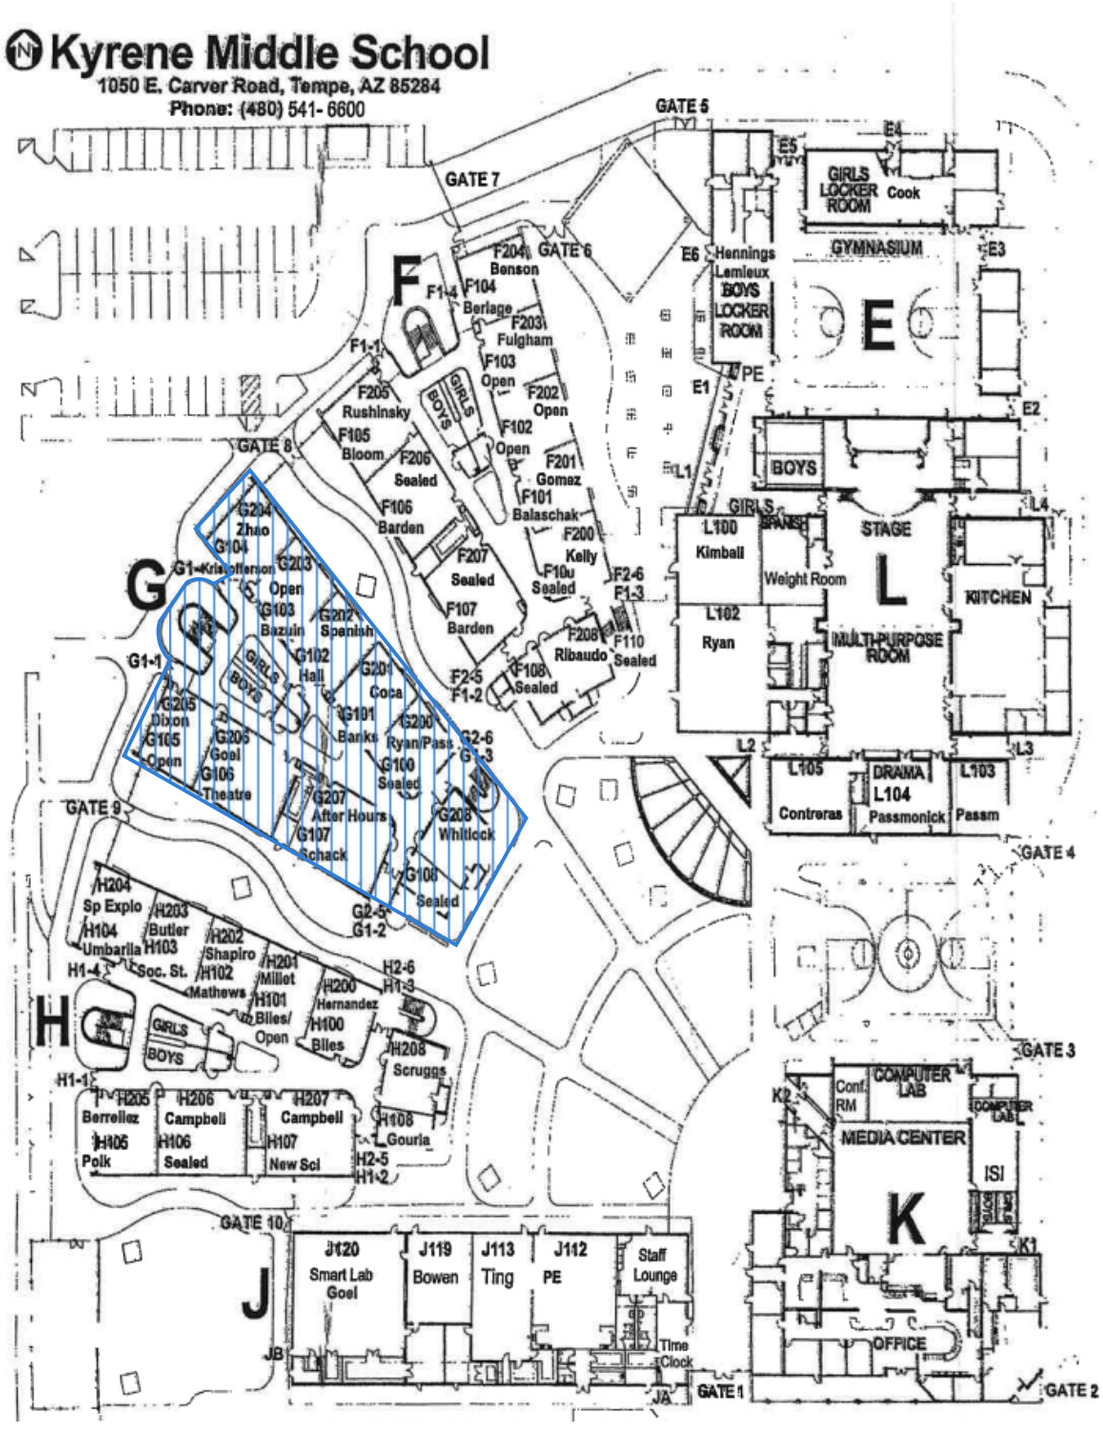
Assumed Asbestos-Containing Material Location Map (2)
Kyrene Middle School
1050 East Carver Road, Tempe, Arizona 85284

Assumed Asbestos-Containing

Tan 2" x 2" Ceramic Floor Tile, Grout, & Thinset, Green 2" x 2" Ceramic Floor Tile, Blue 2" x 2" Ceramic Floor Tile, Marble Threshold, Fixture Caulking, Knockdown Drywall System, Brown FRP & Mastic, Terrazo Mop Sink, & Glass Block Mortar

Assumed Asbestos-Containing Black Stair Tread & Mastic

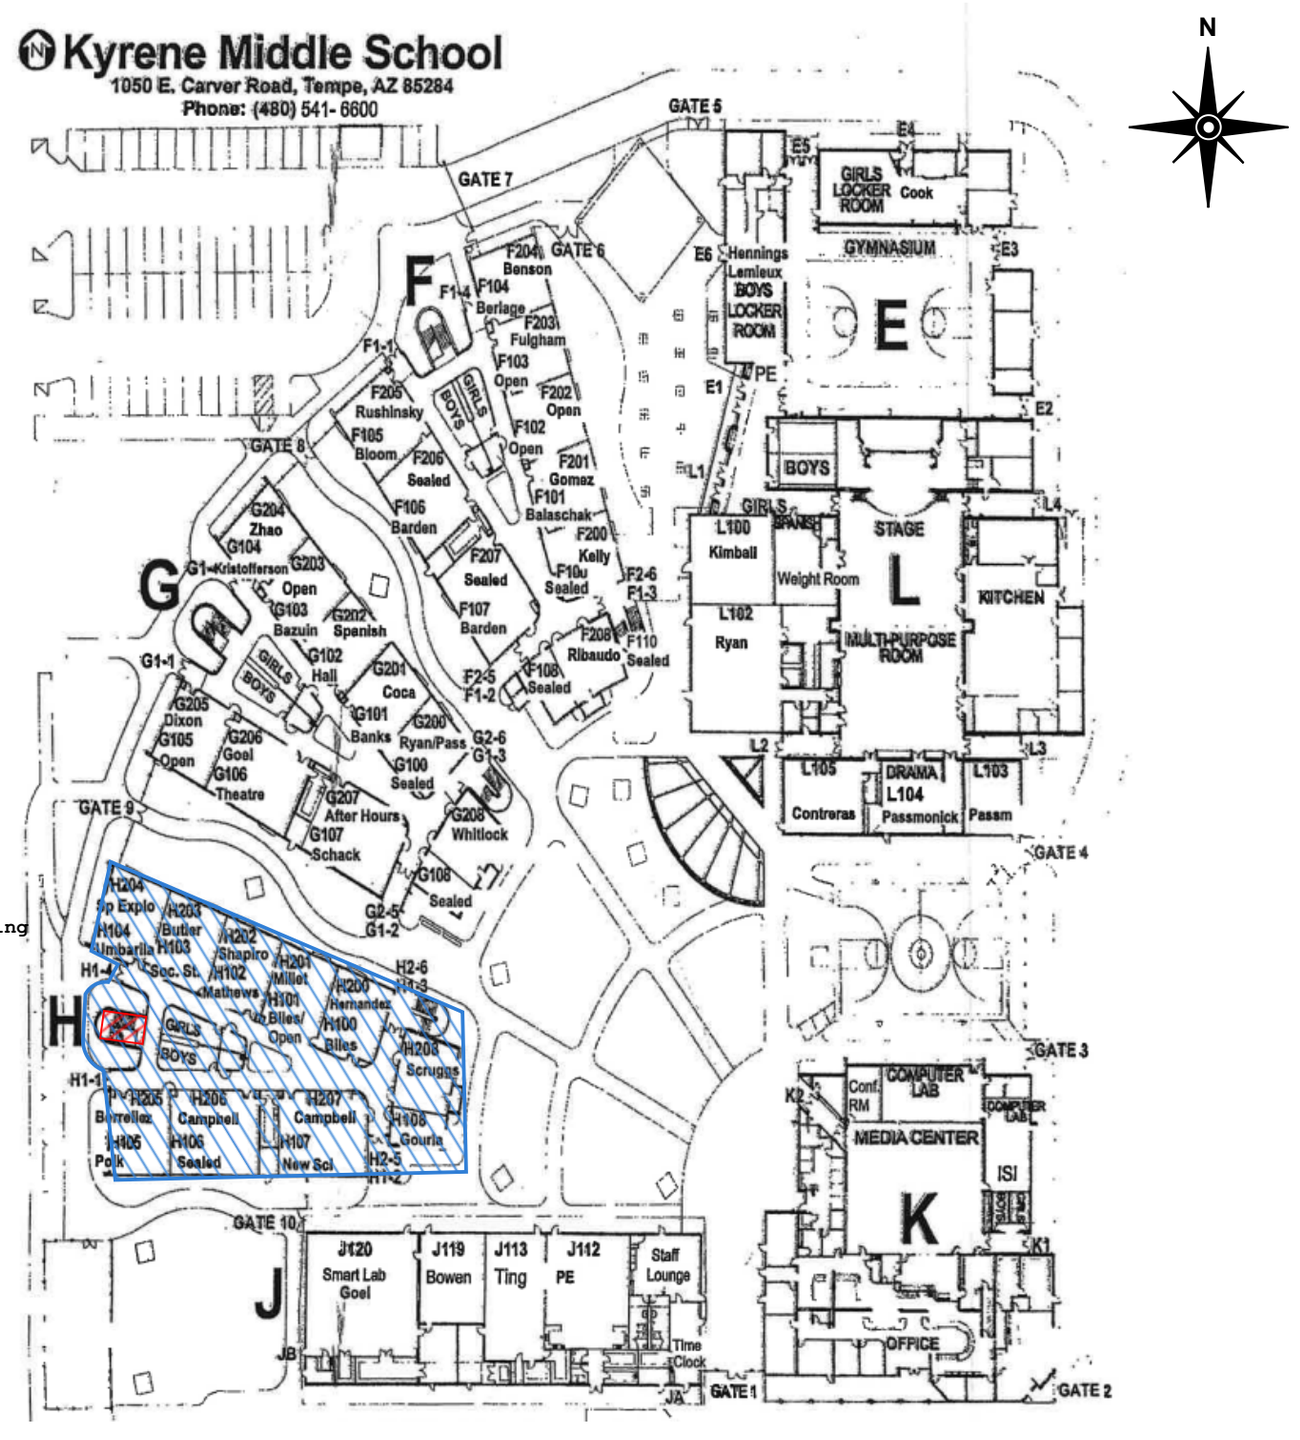
Assumed Asbestos-Containing Material Location Map (3)
Kyrene Middle School
1050 East Carver Road, Tempe, Arizona 85284

Assumed Asbestos-Containing

Skylight Insulation Panel,
Silver Flex Duct Wrap,
Silver Box Duct Wrap,
Gray Duct Mastic,
Unfinished Drywall System,
Black Foam Pipe Insulation,
White Pipe Wrap & Mastic

*Above the Ceiling

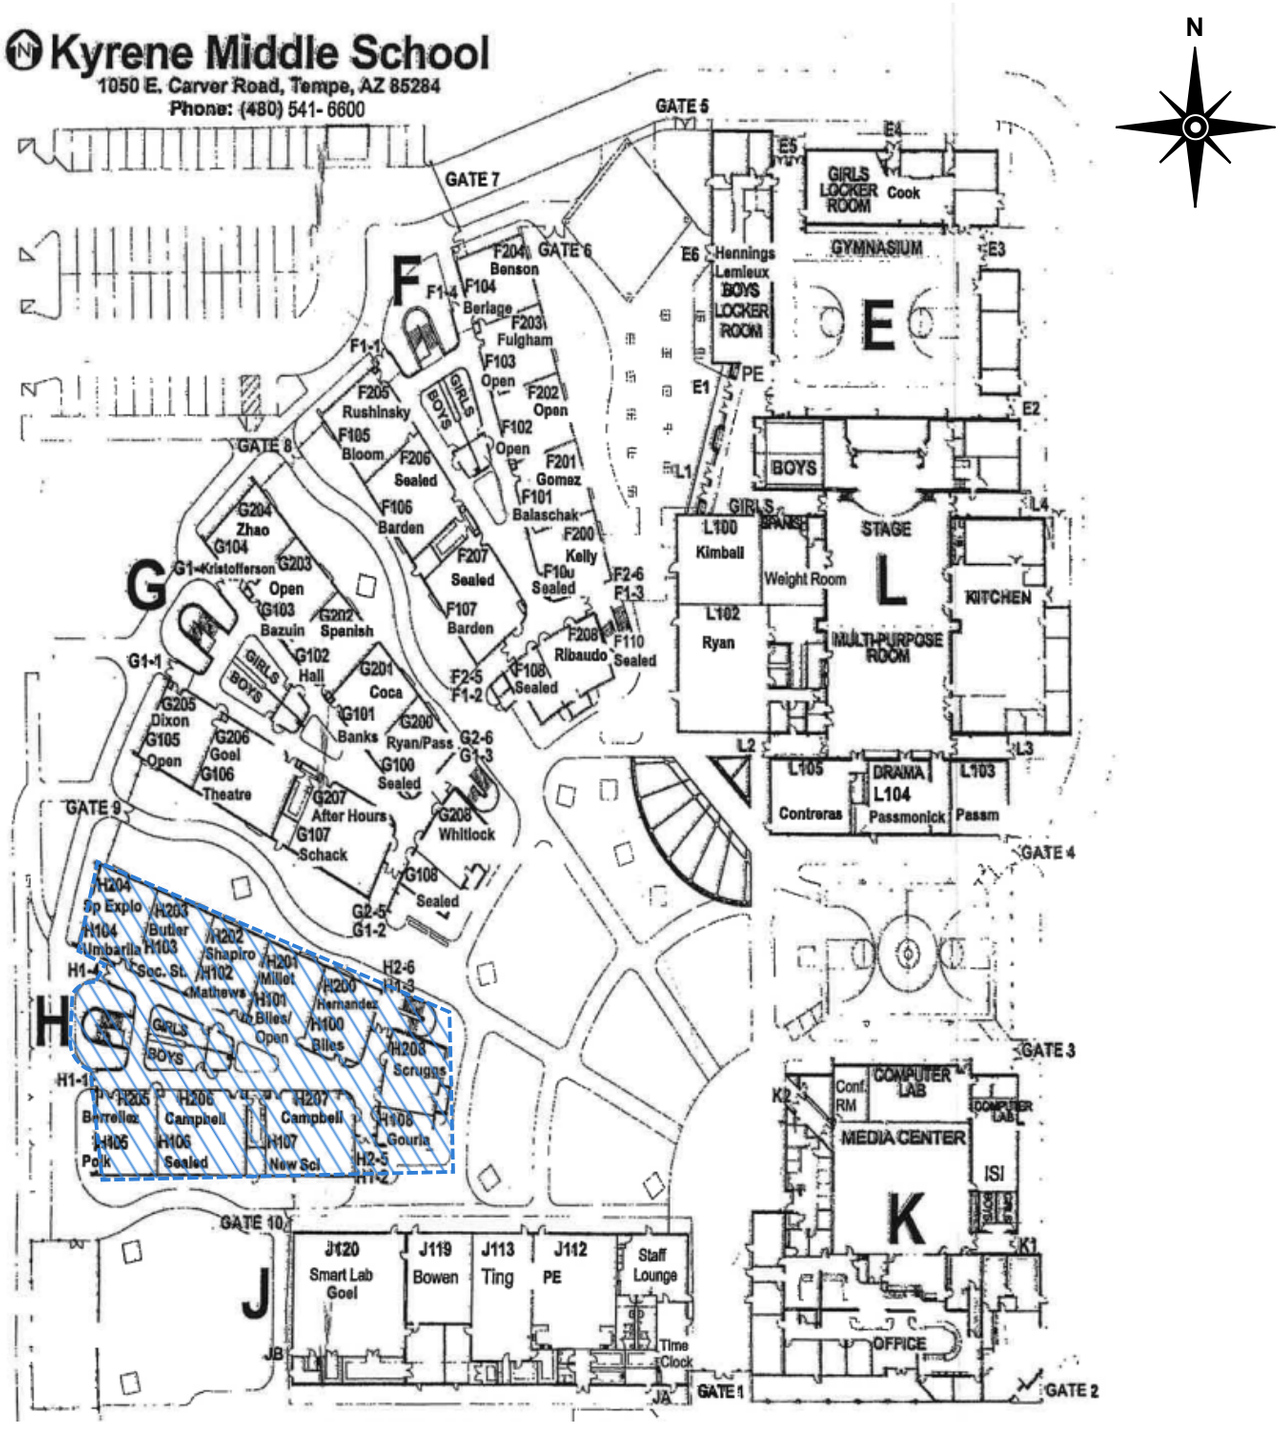
Assumed Asbestos-Containing Material Location Map (1) — Project No. AZ1418.57
Kyrene Middle School
1050 East Carver Road, Tempe, Arizona 85284 — Building H

Assumed Asbestos-Containing
Black Stair Tread & Mastic

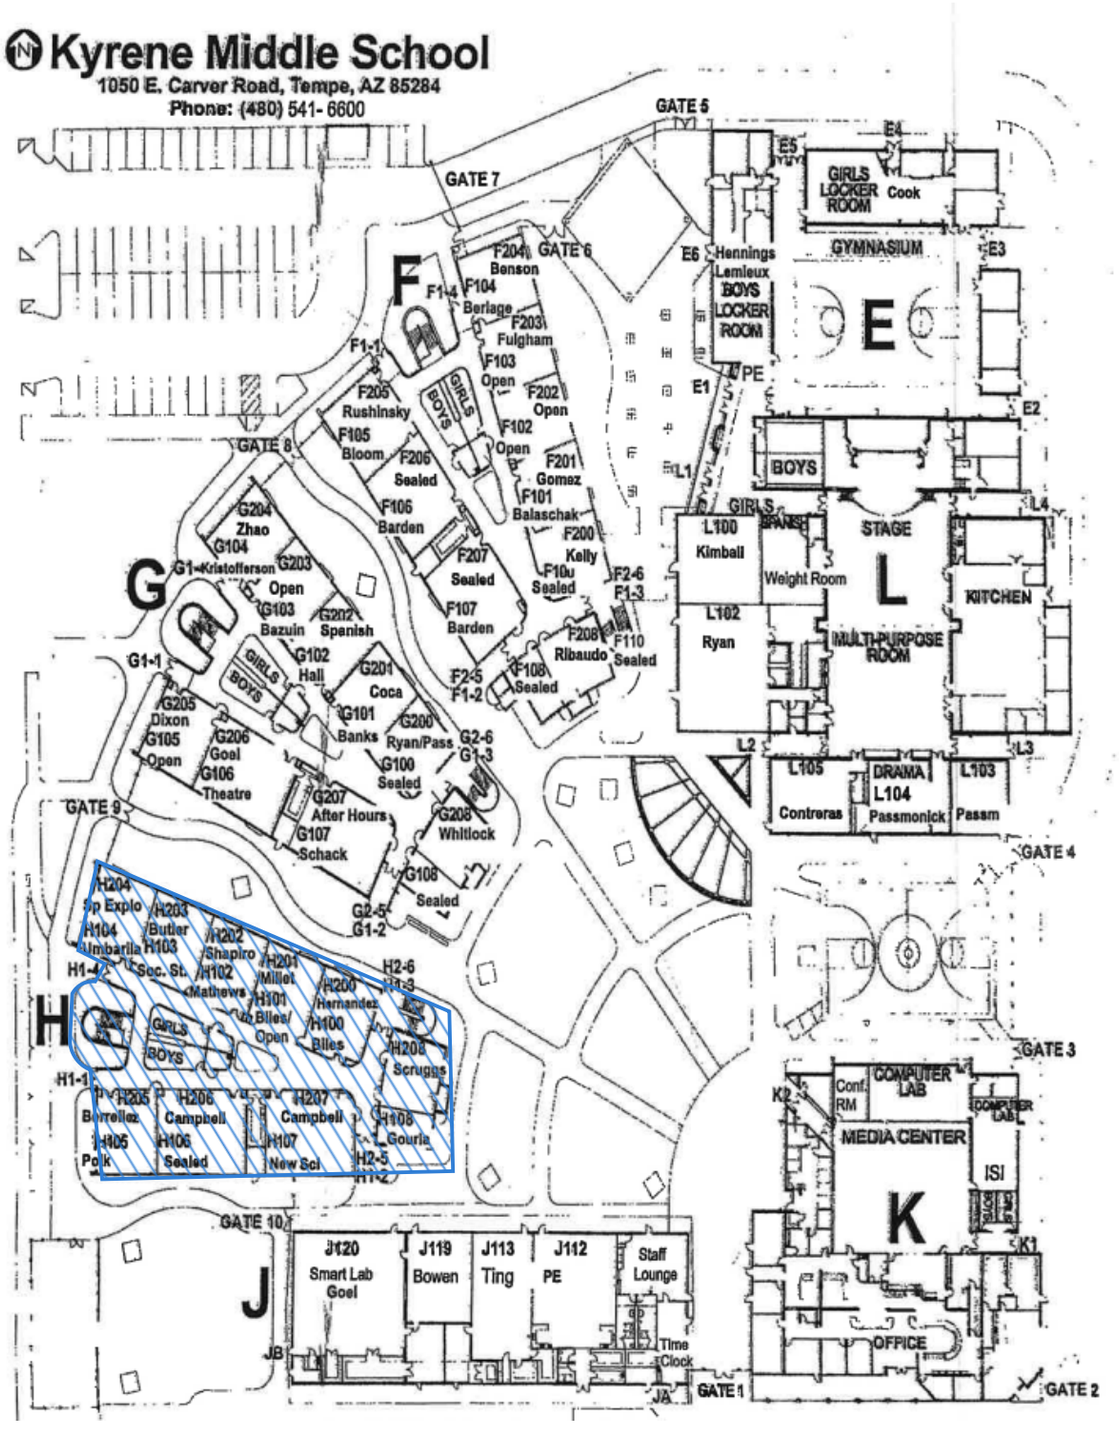
Assumed Asbestos-Containing Material Location Map (2)
Kyrene Middle School
1050 East Carver Road, Tempe, Arizona 85284

Assumed Asbestos-Containing

White w/Black 12" x 12" VCT & Mastic, Interior Caulking, Gray Sink Coating, Divider Wall, Brick & Mortar, Tacboard, Tan 4" x 4" Ceramic Wall Tile, Grout, & Thinset, Green 4" x 4" Ceramic Wall Tile, Blue 4" x 4" Ceramic Wall Tile, Black Cove Base & Mastic, & Black 20" x 20" Floor Tile & Mastic

Assumed Asbestos-Containing Exterior Caulking

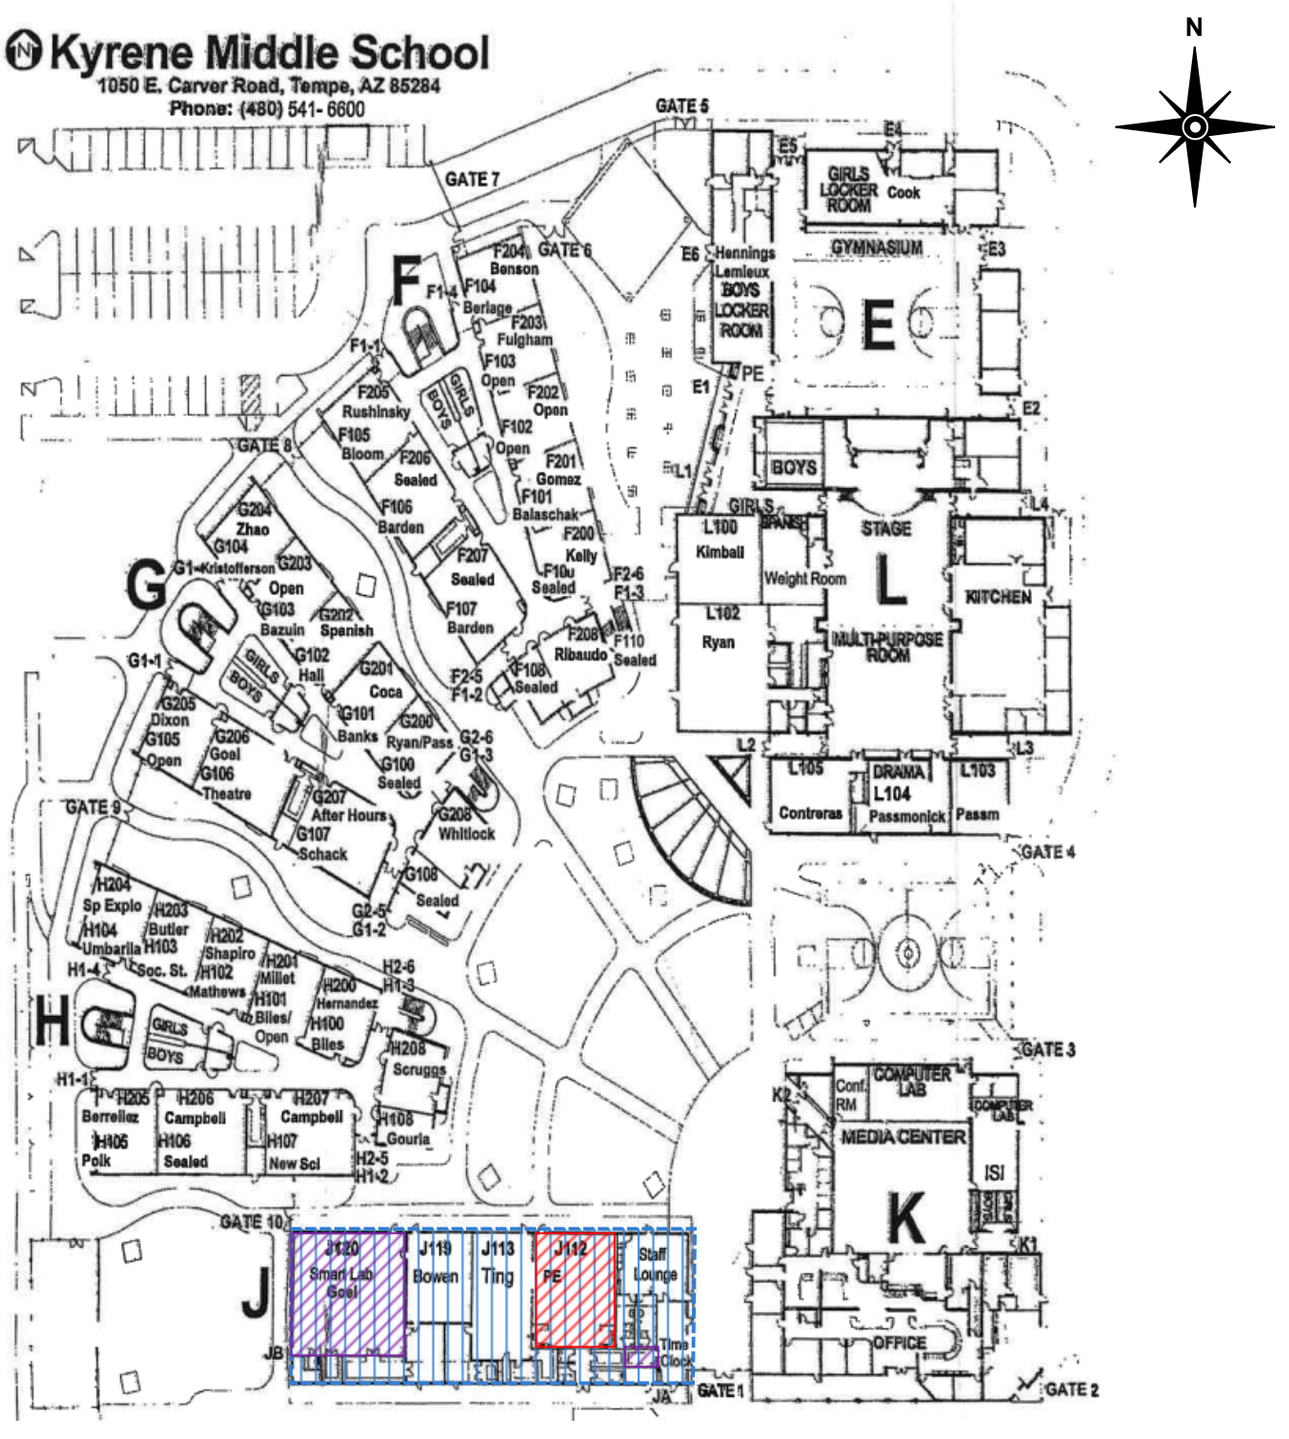
Assumed Asbestos-Containing Material Location Map (1)
Kyrene Middle School
1050 East Carver Road, Tempe, Arizona 85284

Assumed Asbestos-Containing

Tan 2" x 2" Ceramic Floor Tile, Grout, & Thinset, Green 2" x 2" Ceramic Floor Tile, Blue 2" x 2" Ceramic Floor Tile, Fixture Caulking, Marble Threshold, Tacboard, & Brick & Mortar

Assumed Asbestos-Containing
Blue Cove Base & Mastic

Assumed Asbestos-Containing
Knockdown Drywall System

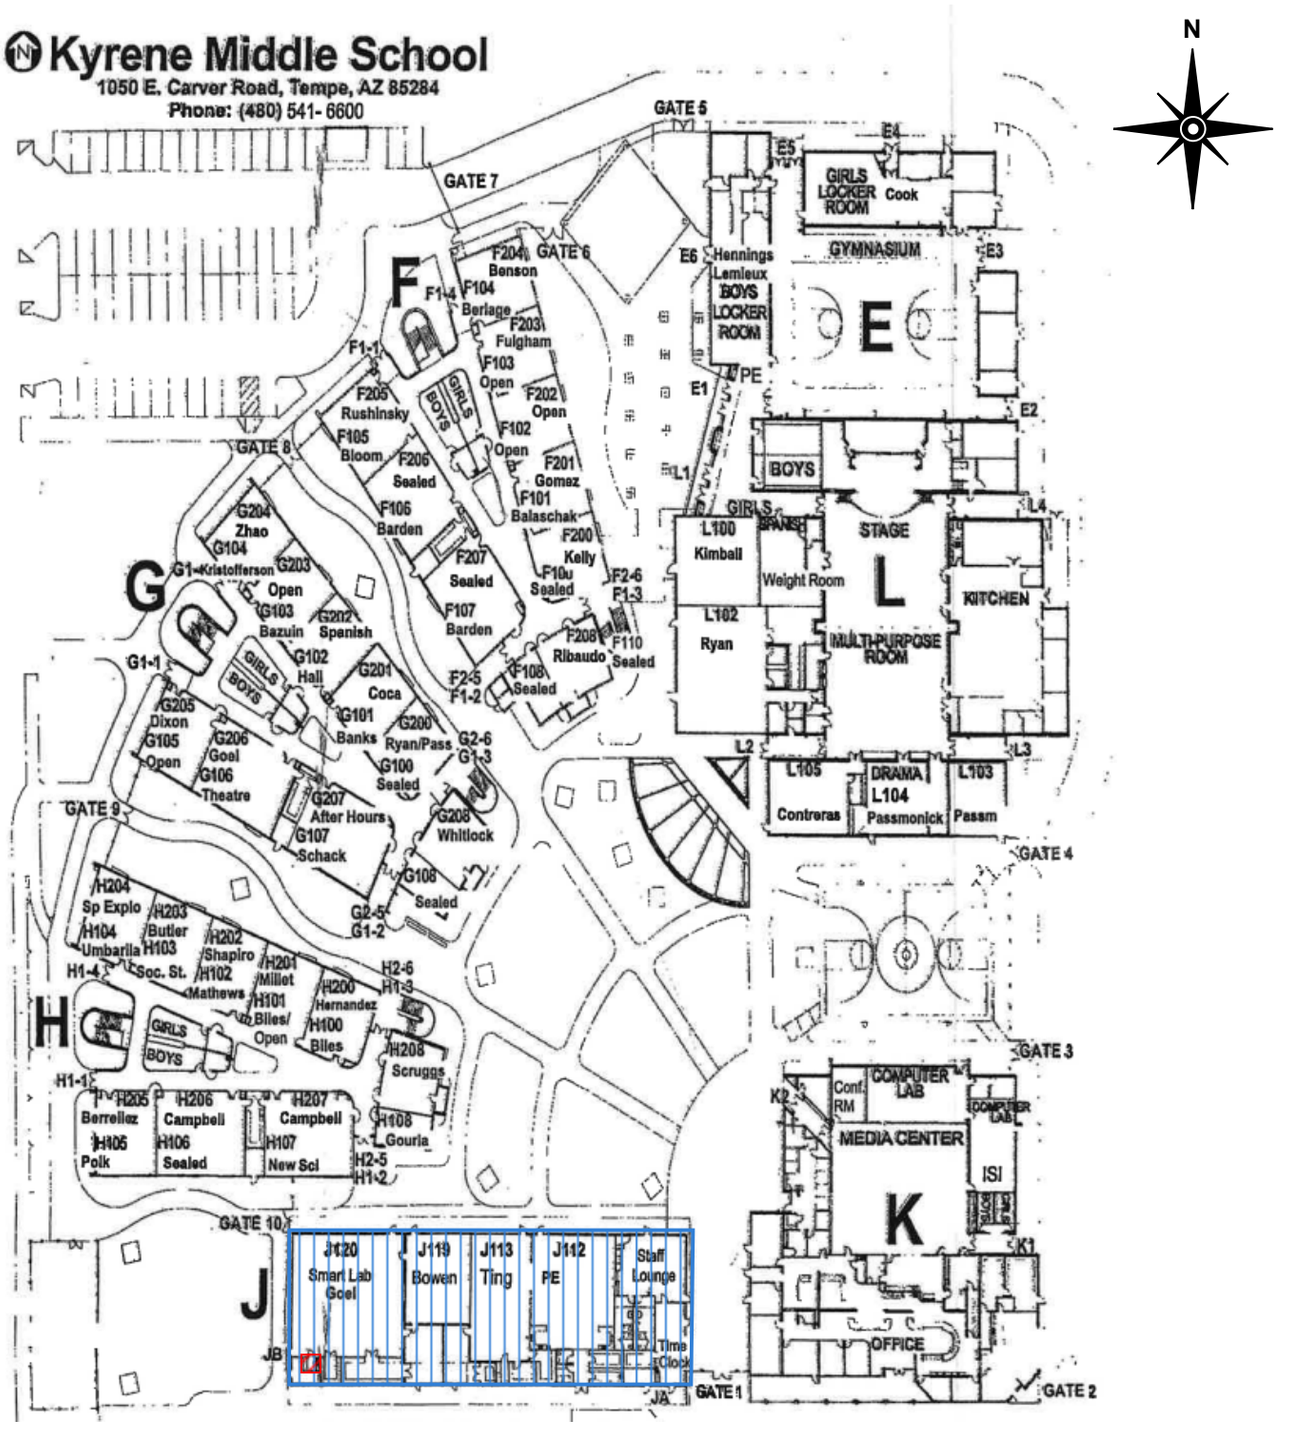
Assumed Asbestos-Containing Material Location Map (2)
Kyrene Middle School
1050 East Carver Road, Tempe, Arizona 85284

FRP & Mastic, Gray Sink Coating,
Interior Caulking,
Tan 4" x 4" Ceramic Wall Tile,
Grout, & Thinset, Green 4" x 4"
Ceramic Wall Tile, & Blue 4" x 4"
Ceramic Wall Tile

Assumed Asbestos-Containing
Gray 12" x 12" VCT & Mastic

Assumed Asbestos-Containing
Tan Multicolored 12" x 12"
VCT & Mastic
