AHERA ASBESTOS INSPECTION REPORT

KYRENE MIDDLE SCHOOL
1050 EAST CARVER ROAD
TEMPE, ARIZONA 85284

Dominion Project Number: AZ1418.57

AHERA Inspection Date: June 11 – June 12, 2025 & June 16, 2025

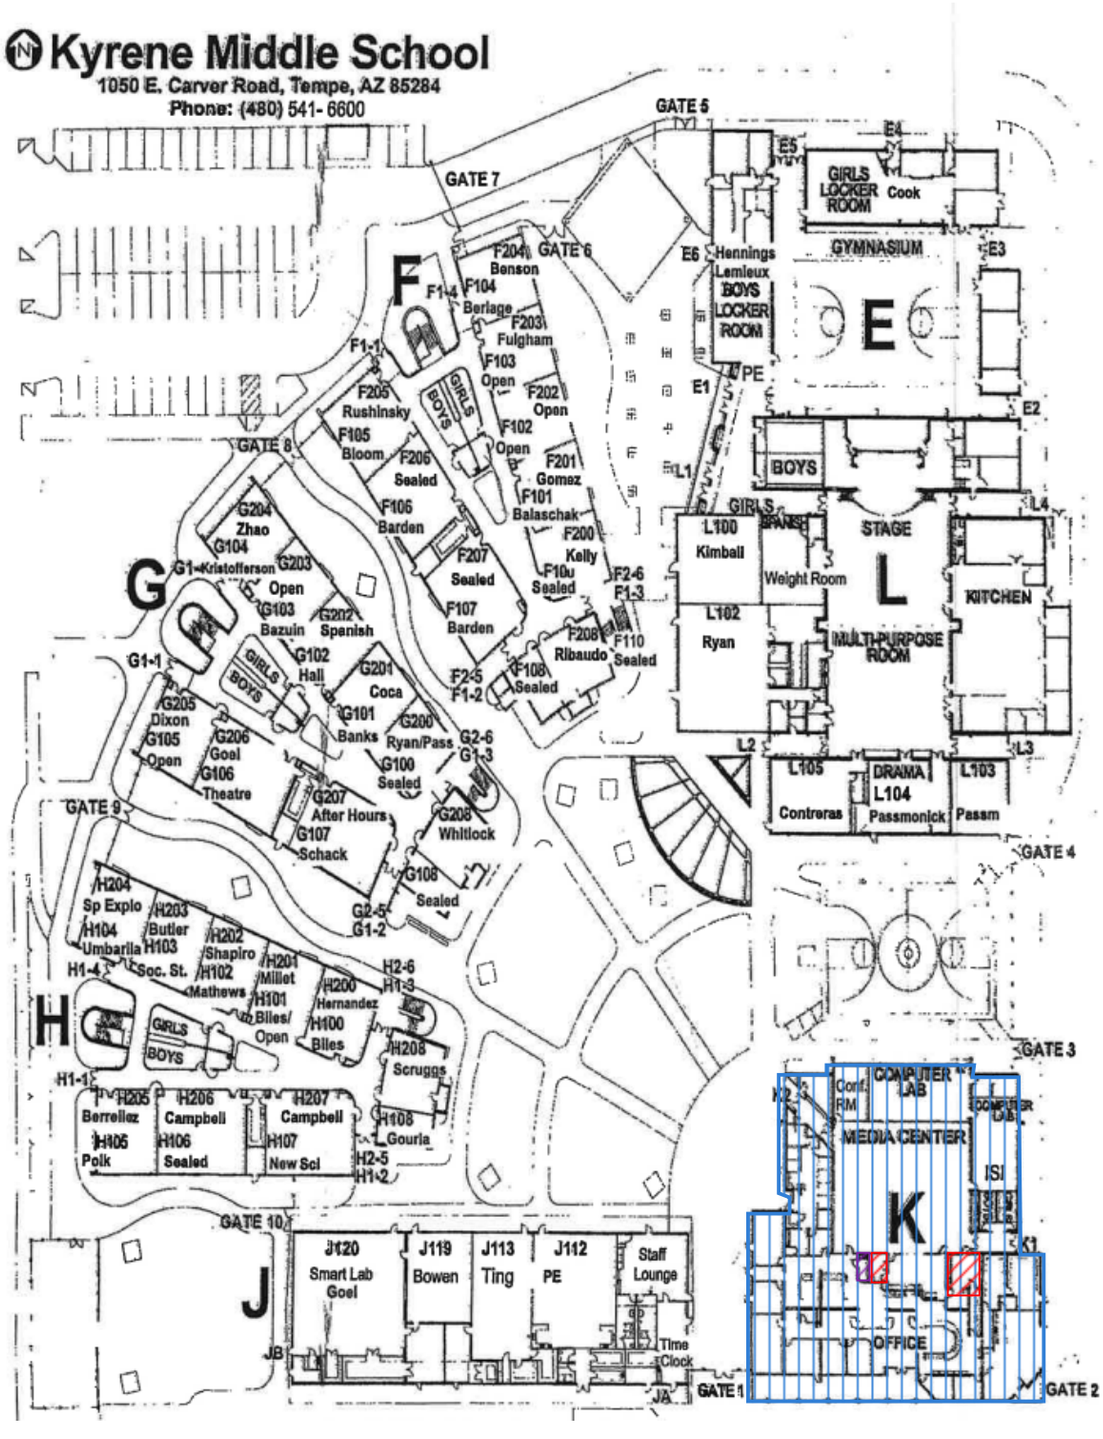
Assumed Asbestos-Containing

Skylight Insulation Panel,
Large Silver Flex Duct Wrap,
Silver Box Duct Wrap,
Gray Duct Mastic,
Unfinished Drywall System,
Black Foam Pipe Insulation,
White Pipe Wrap & Mastic, &
Residual 12" x 12" Ceiling
Tile Mastic

* Above the Ceiling

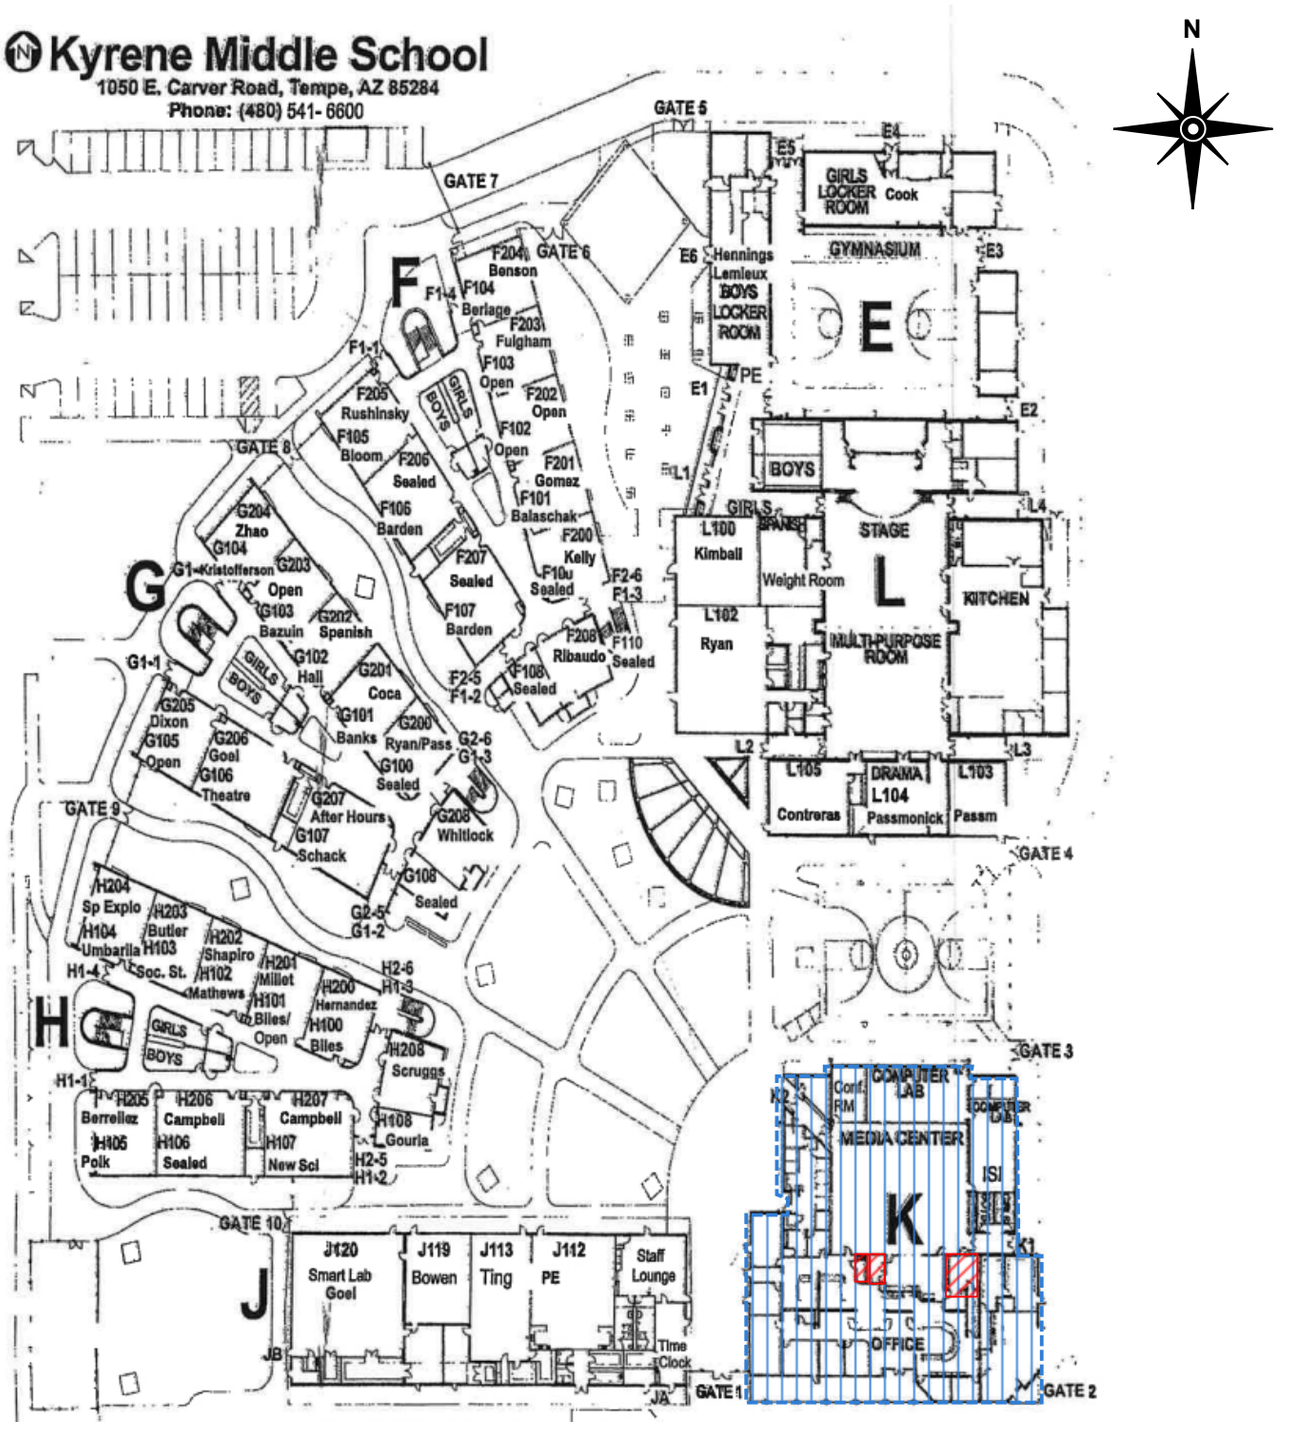
Assumed Asbestos-Containing Material Location Map (1)
Kyrene Middle School
1050 East Carver Road, Tempe, Arizona 85284

Tan 2" x 2" Ceramic Floor Tile, Grout, & Thinset, Green 2" x 2" Ceramic Floor Tile, Blue 2" x 2" Ceramic Floor Tile, Marble Threshold, Wallpaper, Brick & Mortar, White w/Black 12" x 12" VCT & Mortar, & Interior Caulking

Assumed Asbestos-Containing Gray Carpet Square & Mastic

Assumed Asbestos-Containing Beige Multicolored 12" x 12" VCT & Mastic

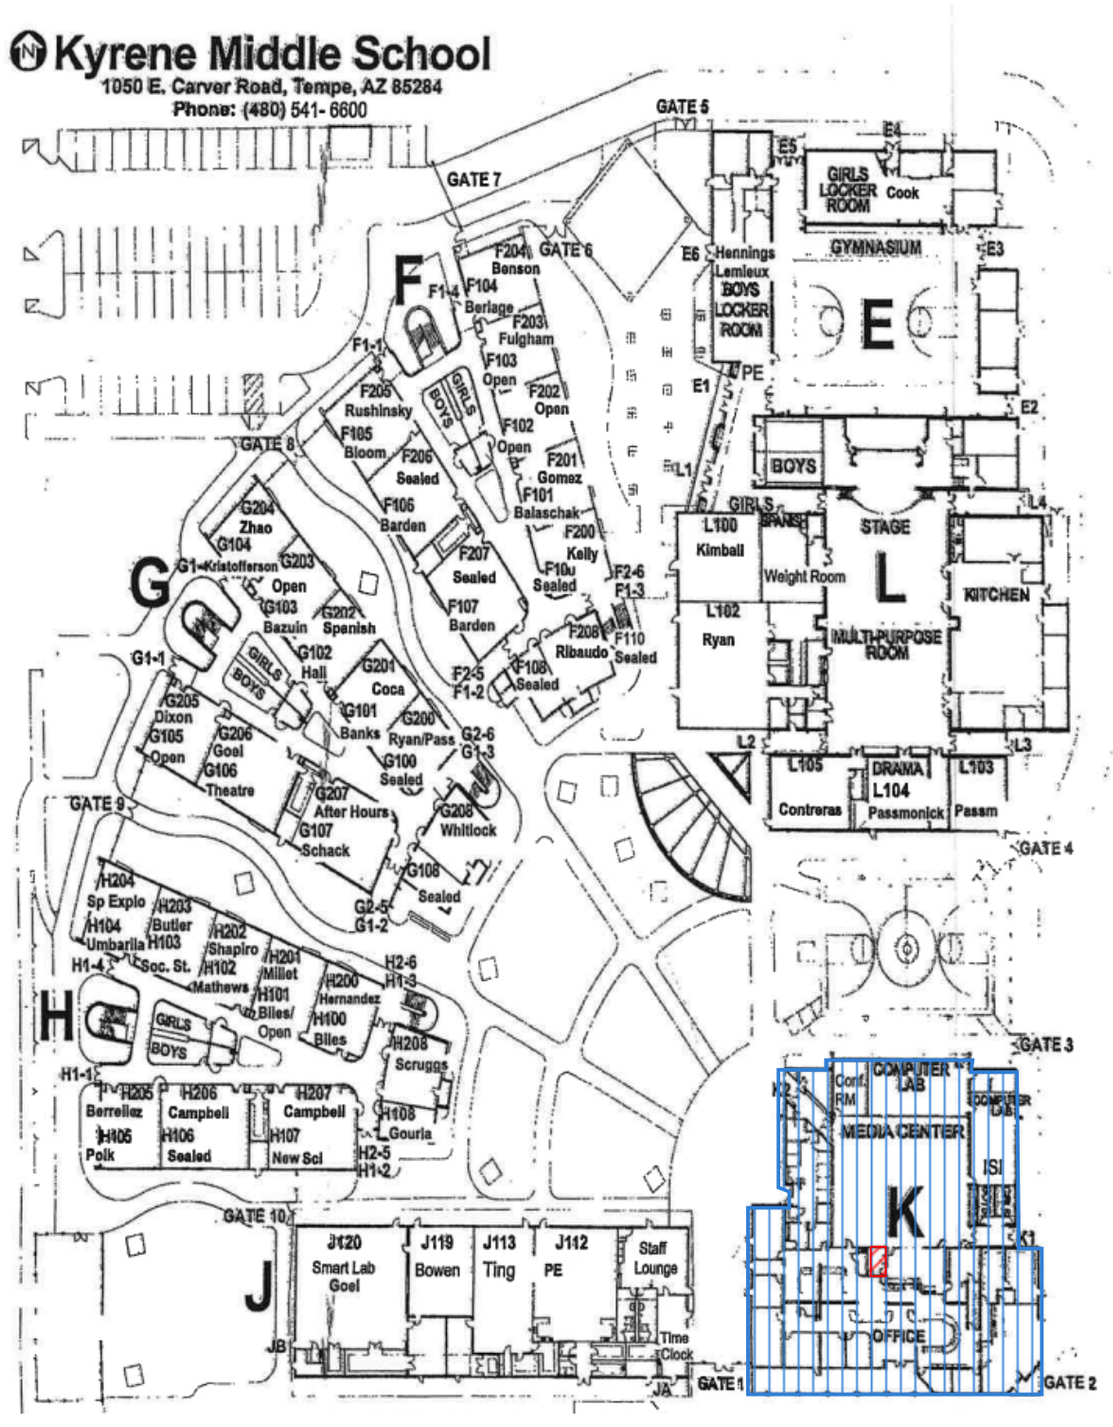
Assumed Asbestos-Containing

Black Carpet Square & Mastic,
Tan 4" x 4" Ceramic Floor Tile,
Grout, & Thinset,
Gray Sink Coating,
FRP & Mastic, &
Terrazo Mop Sink
