December 8, 2025

Regarding: Short Term Radon Testing
Hosford Middle School
2303 SE 28th Place
Portland, Oregon 97214

RADON MONITORING REPORT

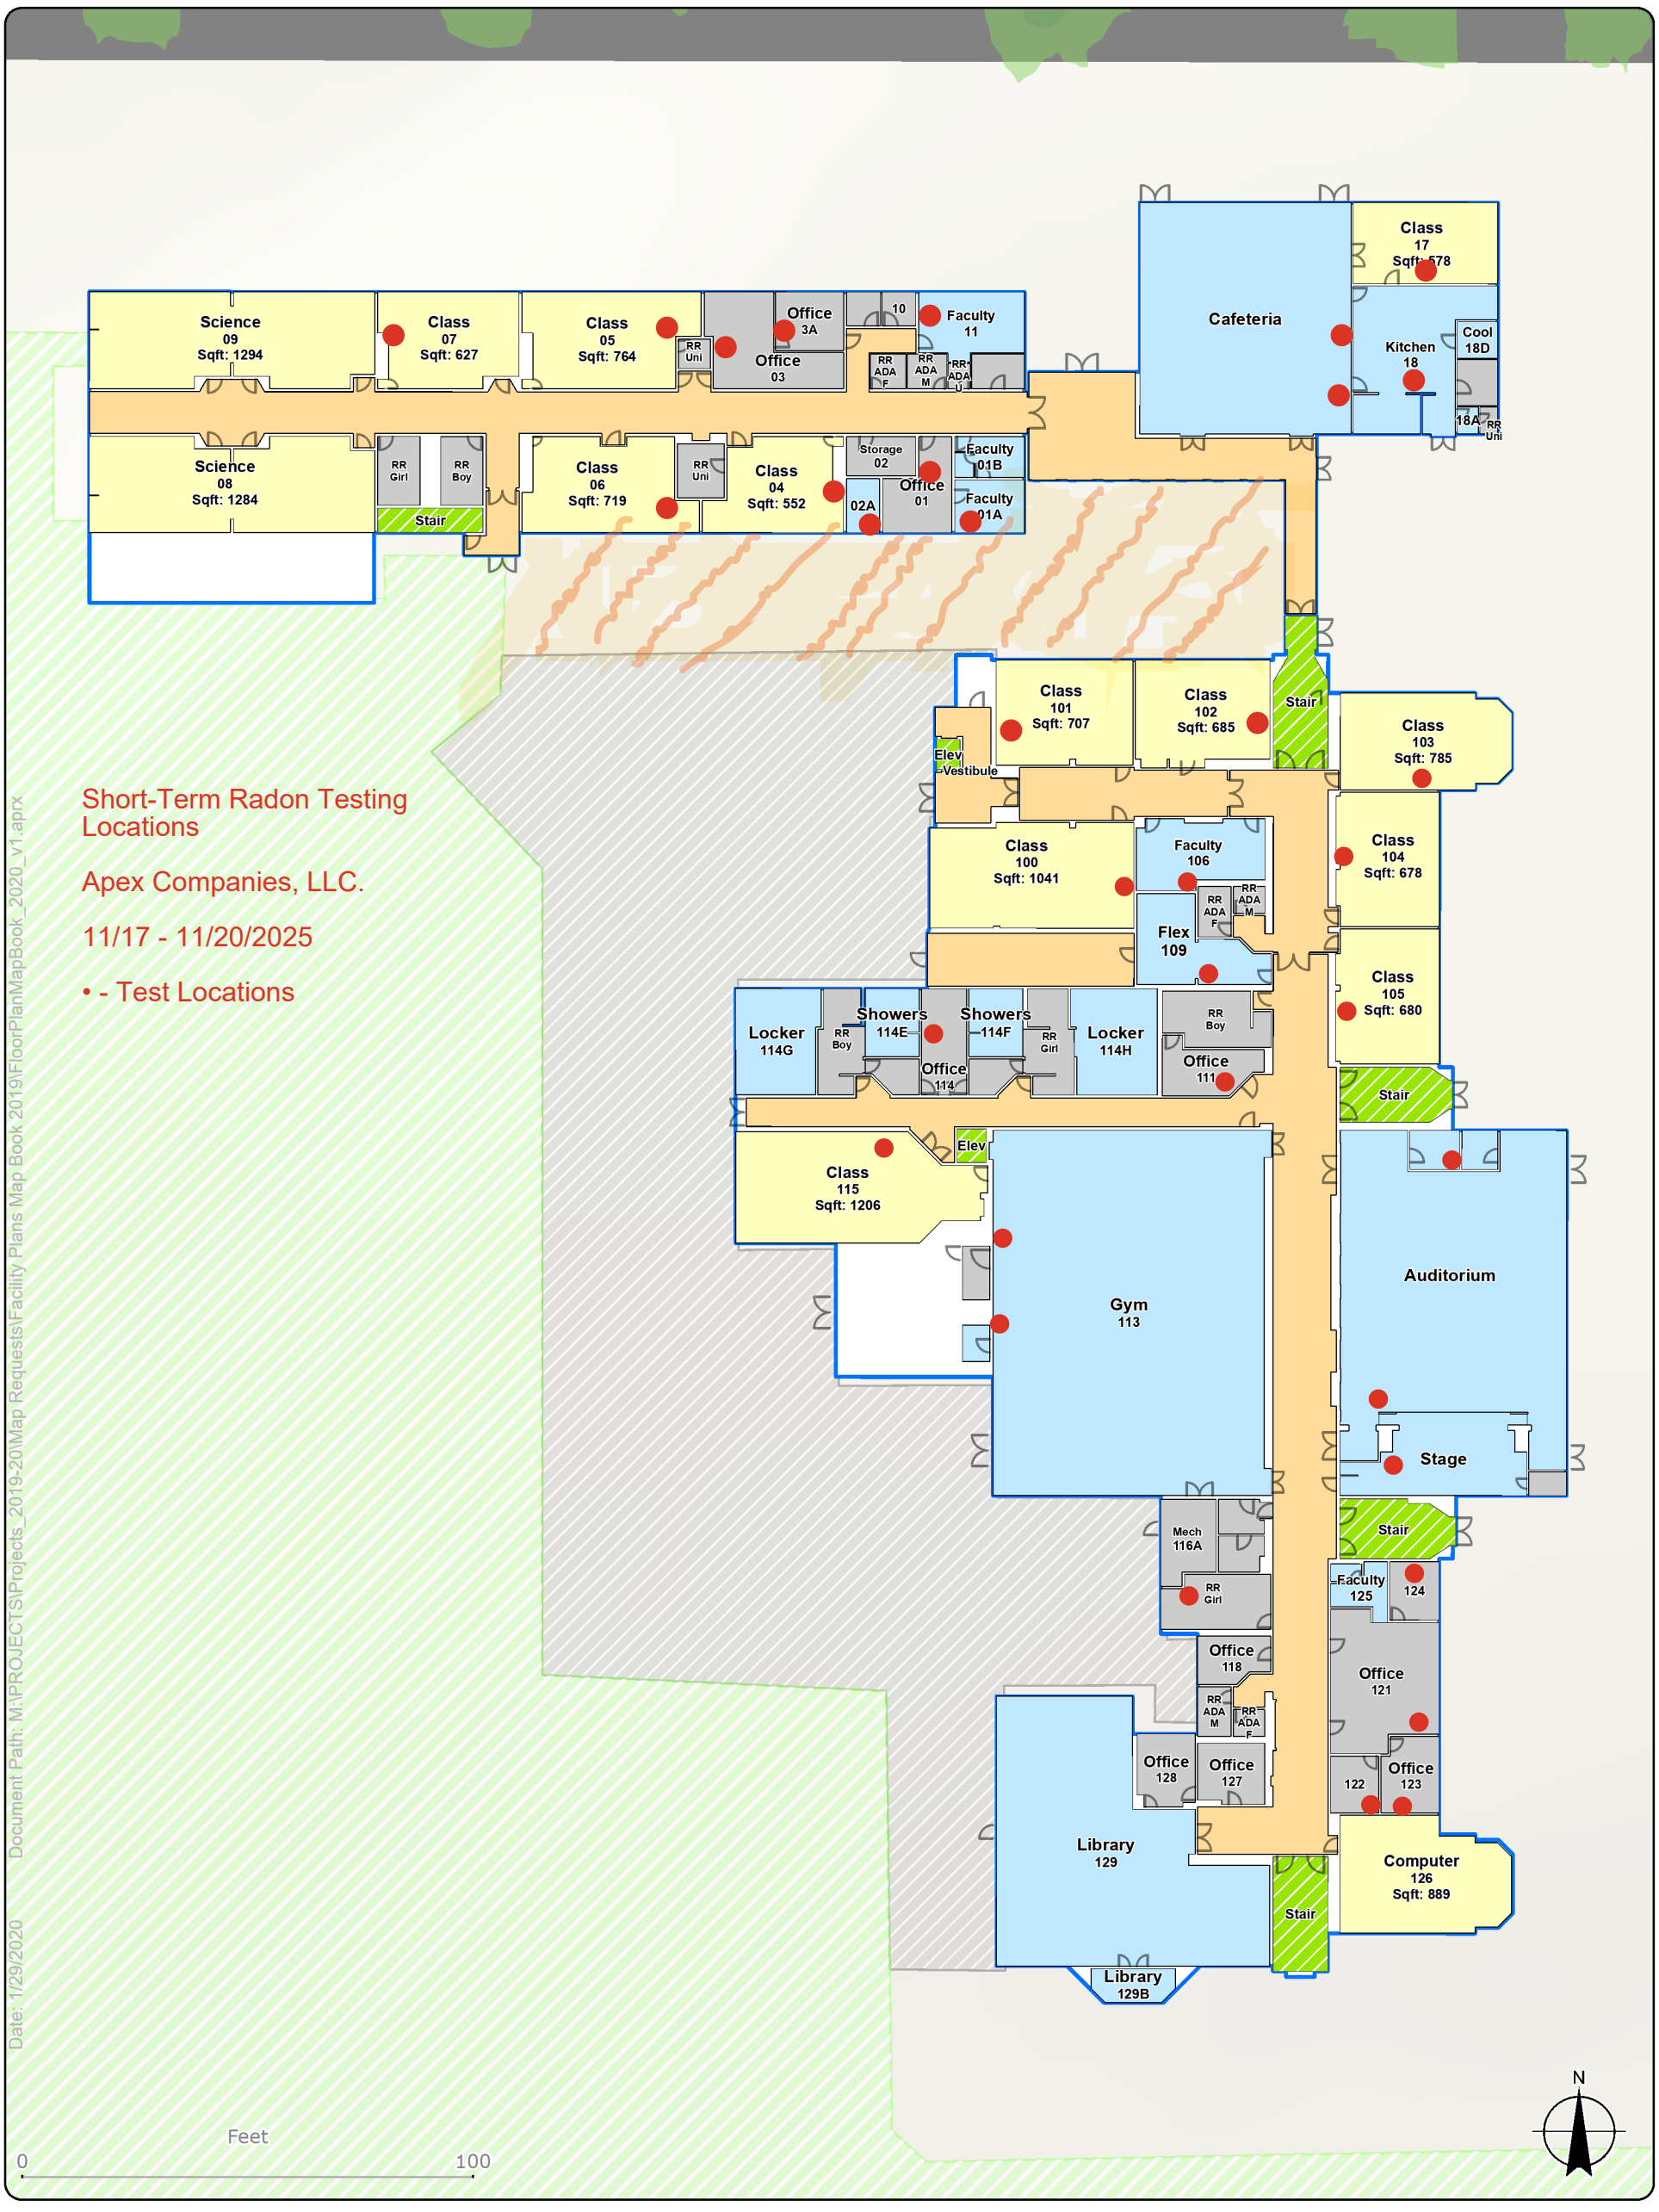
HOSFORD: First Floor

Laboratory results found concentrations below the EPA action level in all tested locations in the building. See the attached laboratory analysis report for more details and the attached informal sample location map for approximate locations of where samples were collected.
