ADDENDUM TO THE BID DOCUMENTS	Page: 1	Total Pages: 509
Addendum No: **# 1**	Date this Addendum Issued: **February 9, 2026**	
Issuing Office: Matanuska-Susitna Borough School District (MSBSD) Purchasing Department 690 Cope Industrial Way Palmer, Alaska 99645 Phone: (907) 861-5120 Facsimile: (907) 861-5184	Previous Addenda Issued: None _____ _____ _____ _____ _____ _____ _____ _____ _____ _____	
Return Acknowledgment To: **Issuing Department** Bid Title: **Testing Services for the MSBSD** Bid No: **B26-02**	Date and Hour of Bid Due Date: **February 20, 2026 at 2:00 P.M.** As Advertised (Frontiersman): **January 28 and 30, 2026** As Advertised (ADN): **January 25 and 28, 2026**

ATTACHMENT A:
REVISED SCOPE OF SERVICES

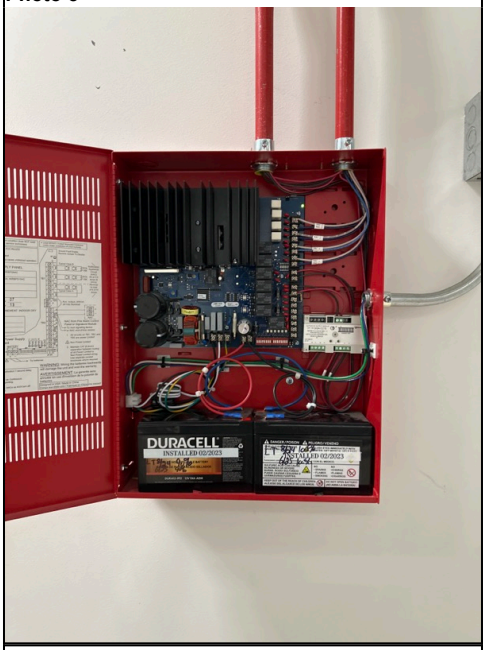
Photo 5 Description
BOOSTER PANEL IN GYM FAN ROOM

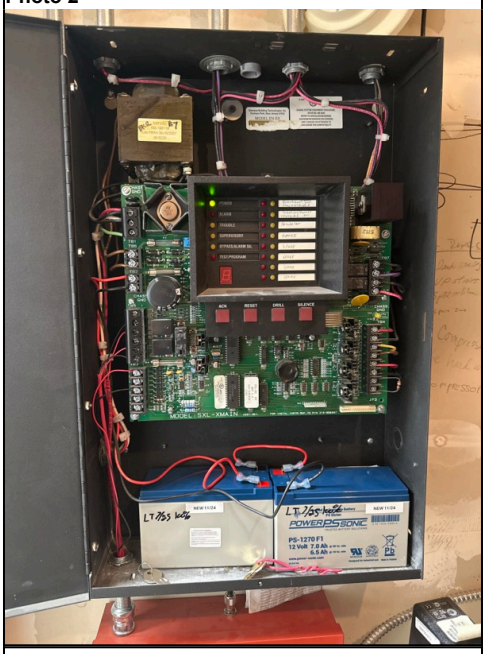
Photo 2 Description
PANEL SCHEMATICS

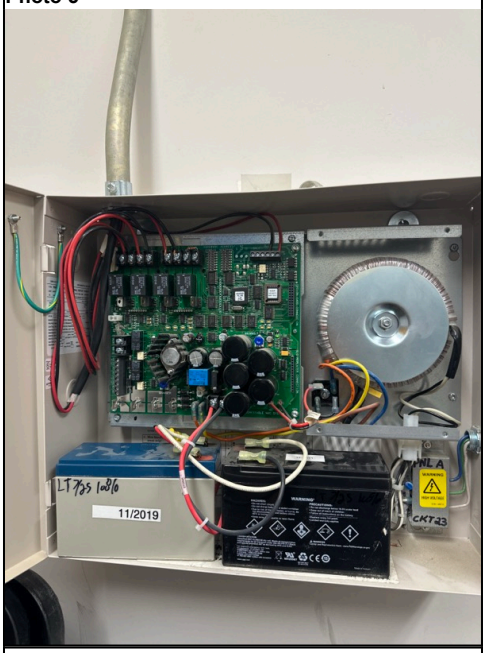
Photo 5 Description
BOOSTER OANEL IN 1ST FLOOR BUILDING STORAGE ROOM

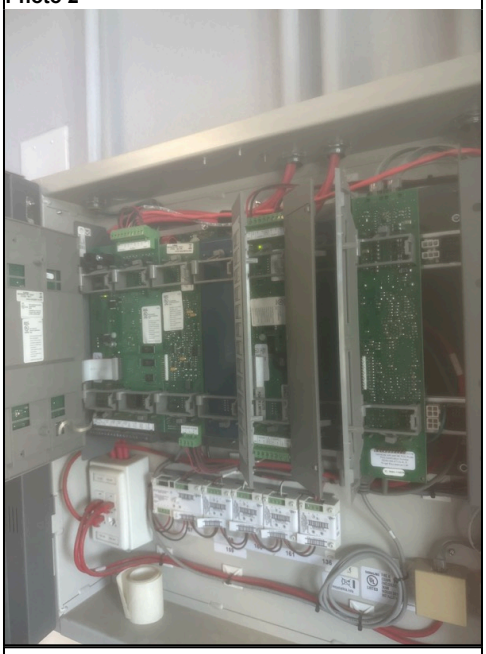
Photo 2 Description
PANEL SCHEMATICS

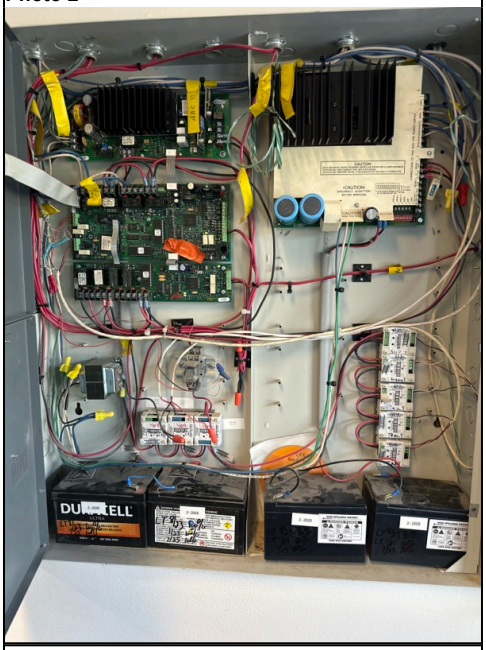
Photo 2 Description
PANEL SCHEMATICS

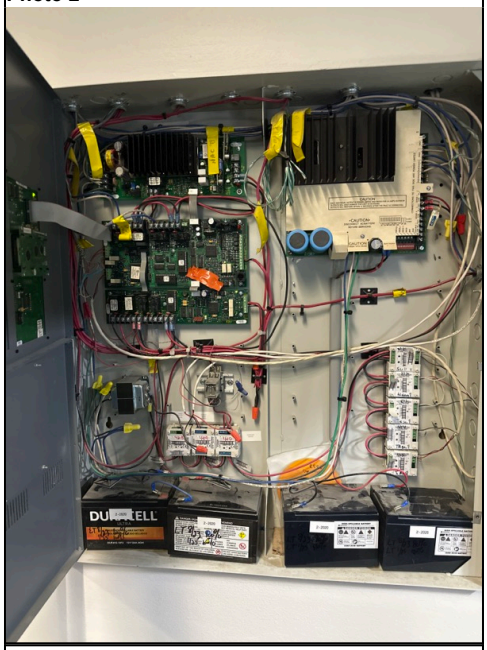
Photo 2 Description
PANEL SCHEMATICS

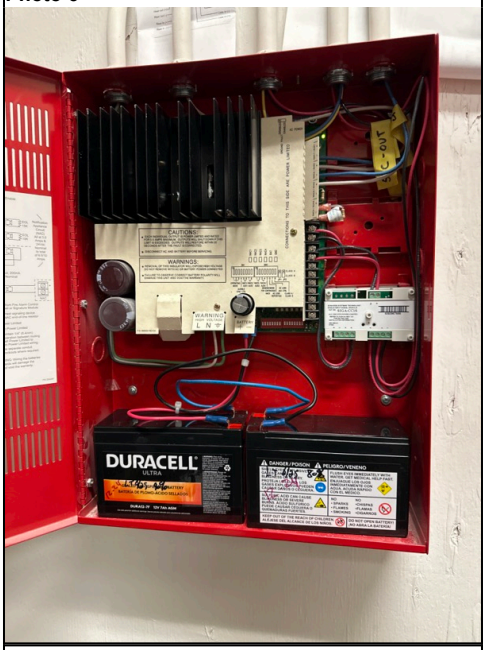
Photo 6 Description
BOOSTER IN IT/DATA ROOM 223

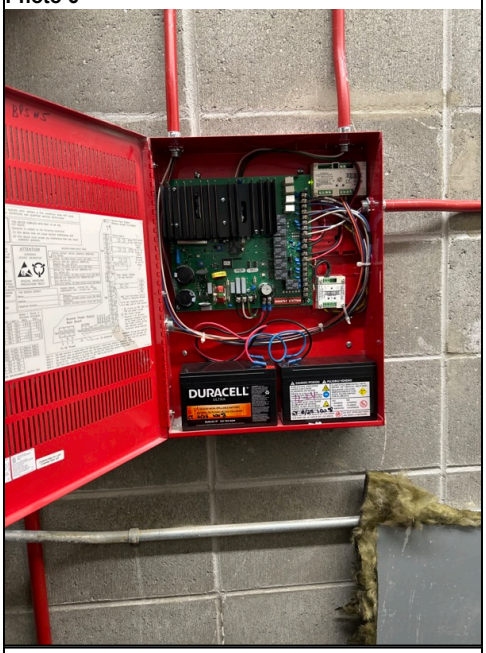
Photo 6 Description
BOOSTER IN FAN ROOM 3

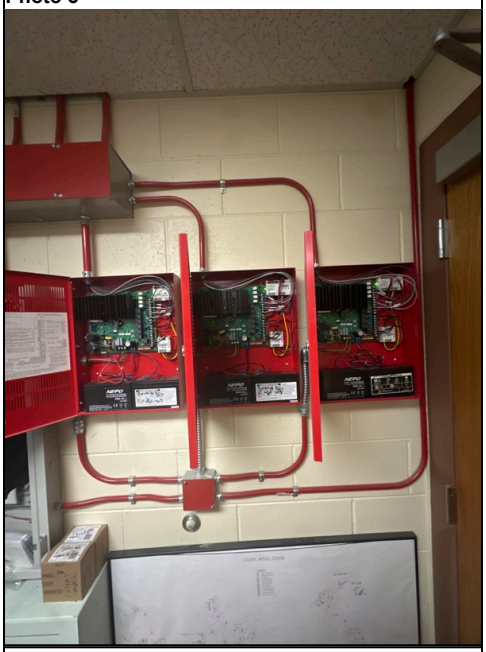
Photo 3 Description
BOOSTER PANELS BY FACP

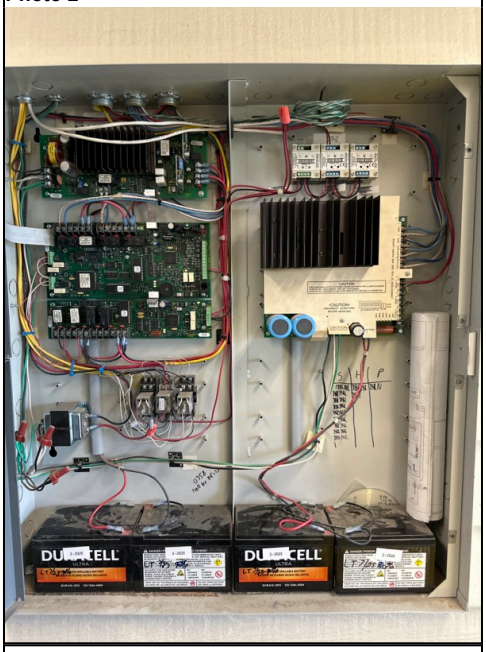
Photo 2 Description
PANEL SCHEMATICS AND BOOSTER PANEL IN FACP CABINET

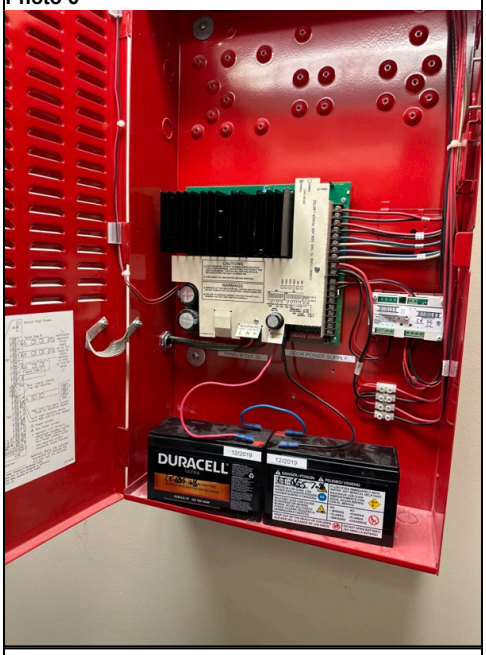
Photo 6 Description
BOOSTER PANEL IN 1ST FLOOR COMM ROOM

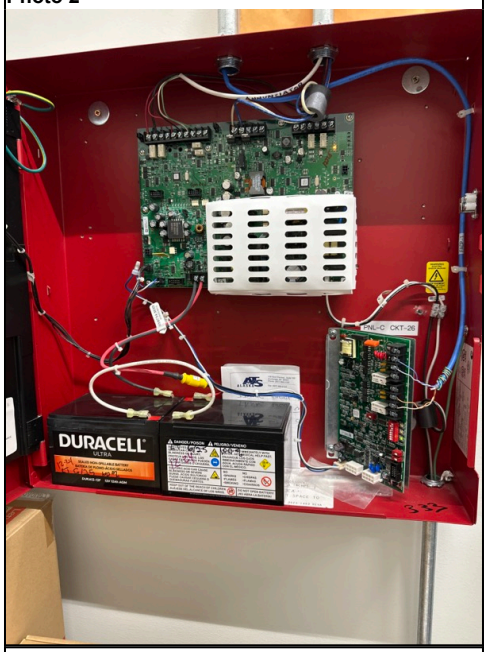
Photo 2 Description
PANEL SCHEMATICS

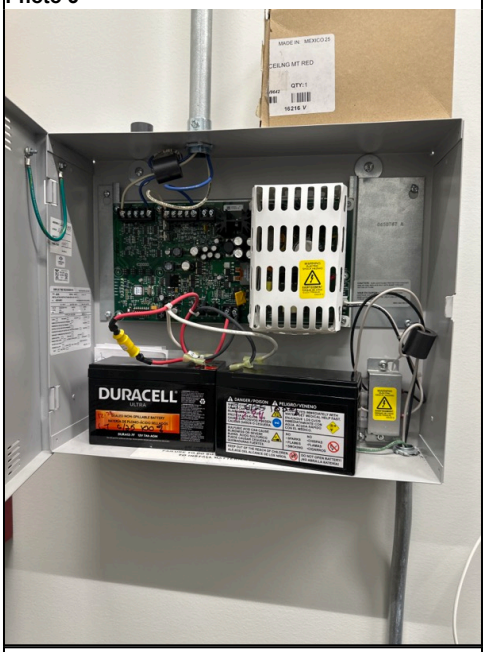
Photo 3 Description
BOOSTER PANEL BY FACP

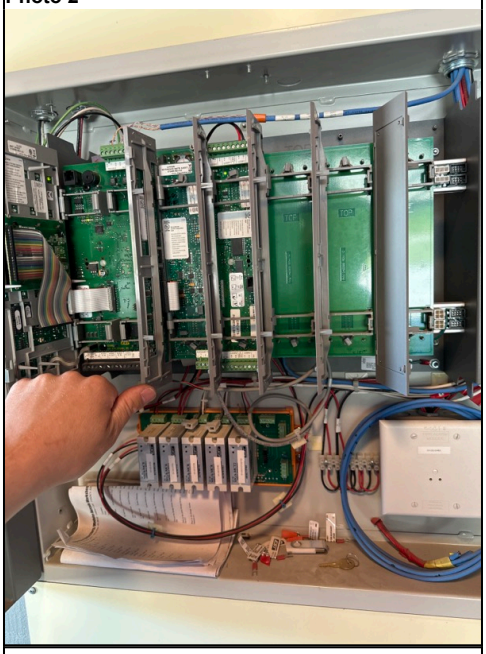
Photo 2 Description
PANEL SCHEMATICS

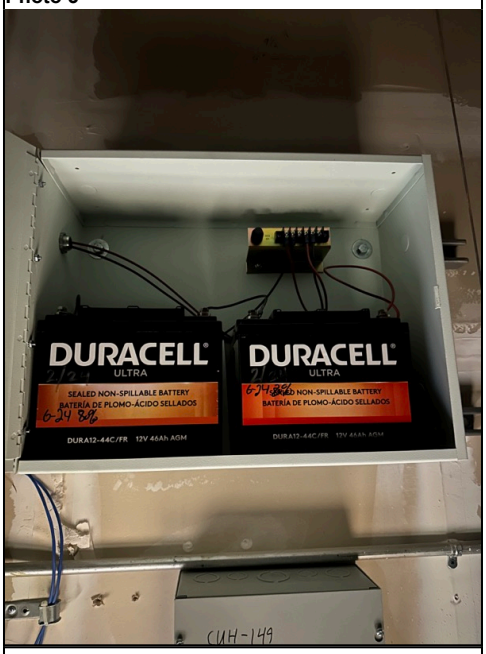
Photo 3 Description
PANEL BATTERIES

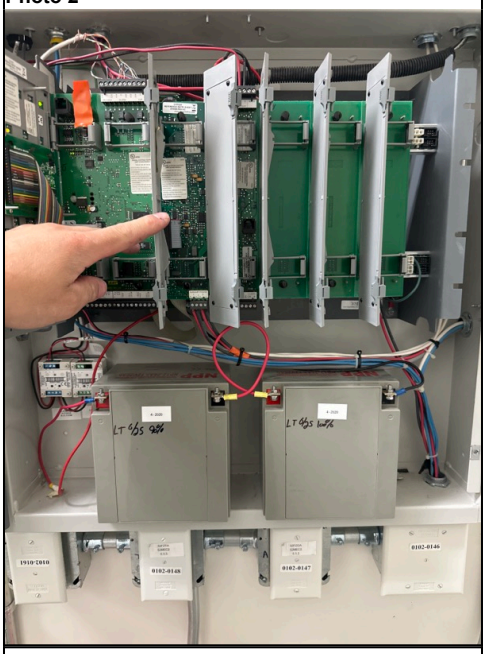
Photo 2 Description
PANEL SCHEMATICS

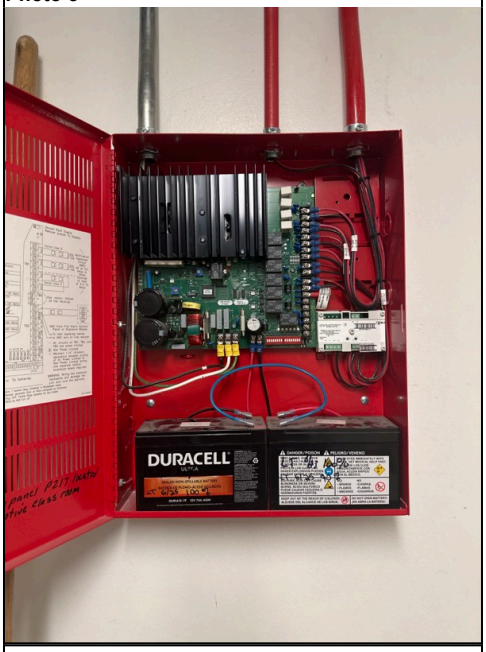
Photo 5 Description
BOOSTER IN 2ND FLOOR JANITOR ROOM 1541

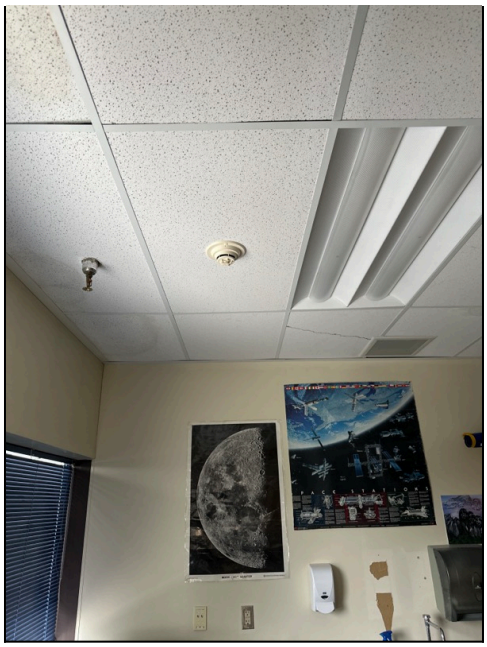
Photo 8 Description
SMOKE DETECTOR FROM PRIOR SYSTEM IN STORAGE ROOM 2033B

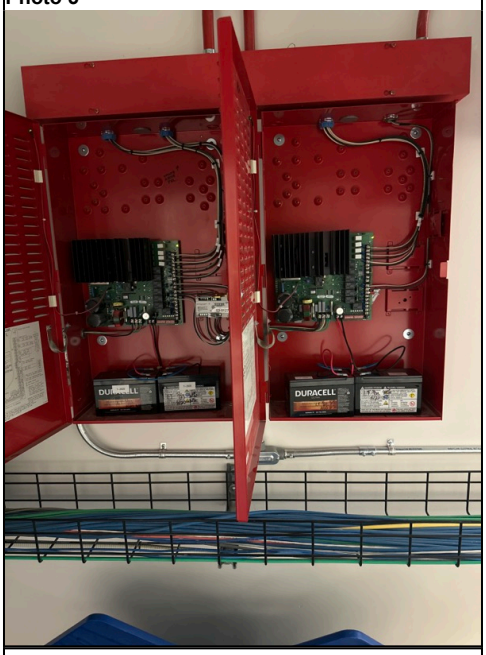
Photo 5 Description
BOOSTER PANELS IN GYM MEZZANINE

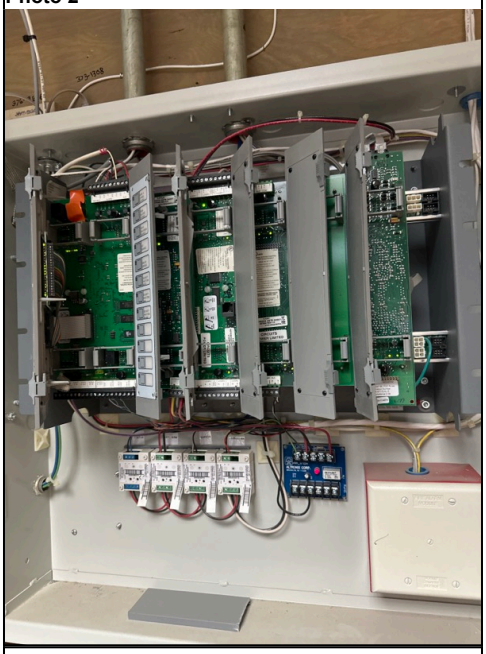
Photo 2 Description
PANEL SCHEMATICS

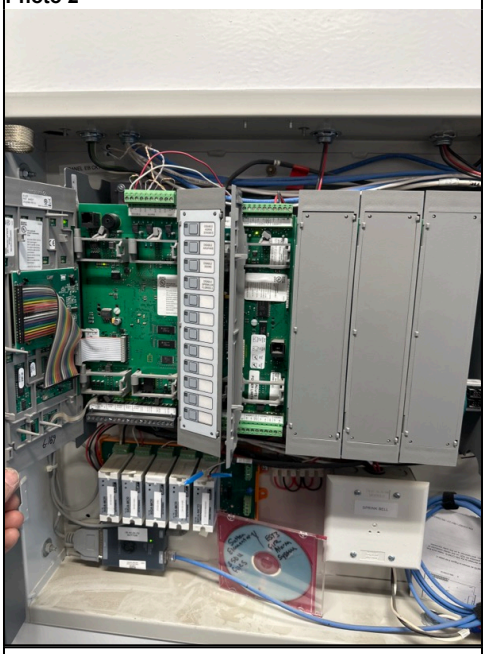
Photo 2 Description
PANEL SCHEMATICS

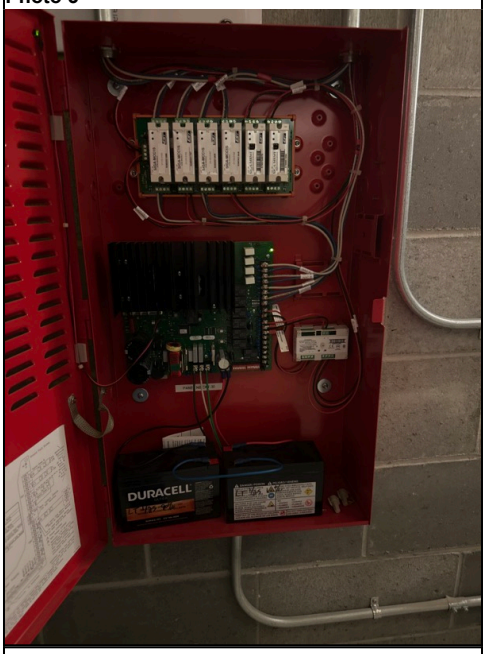
Photo 3 Description
BOOSTER IN FAN ROOM ABOVE JANITORIAL ROOM

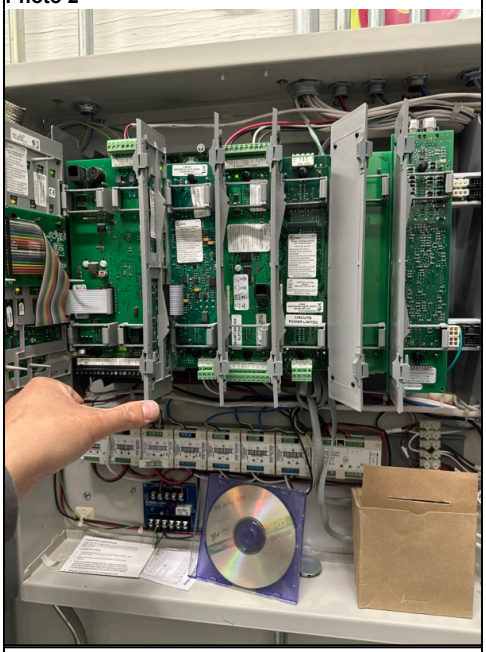
Photo 2 Description
PANEL SCHEMATICS

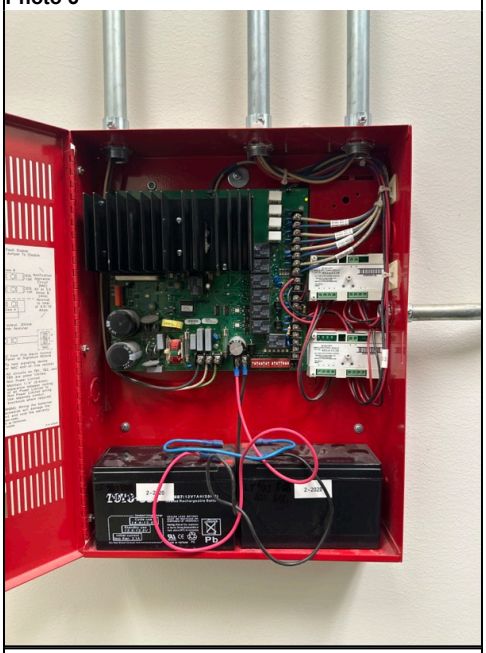
Photo 5 Description
BOOSTER PANEL IN IDF ROOM 141

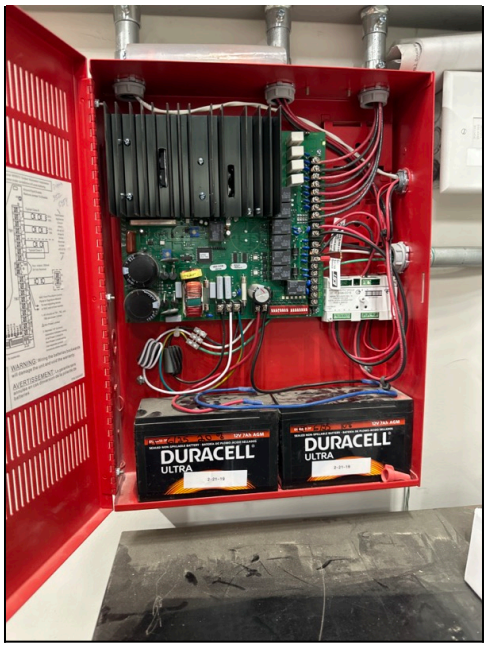
Photo 8 Description
BOOSTER IN POOL BOILER ROOM

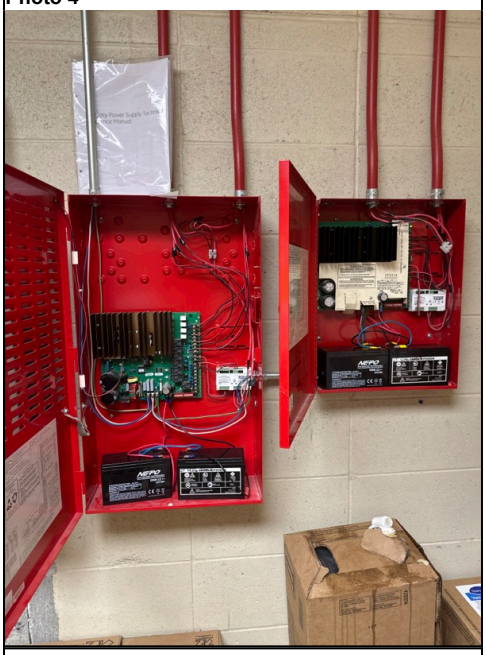
Photo 4 Description
BOOSTERS IN STORAGE ROOM 109
