CONFIDENTIAL AND PRIVILEGED
COMPREHENSIVE ASBESTOS MATERIAL SURVEY

15151 Columbia Ln
Huntington Beach, California 92647

Westminster School District
14121 Cedarwood Ave
Westminster, CA 92683
Attn: Brad Seaver

Date: March 27, 2026

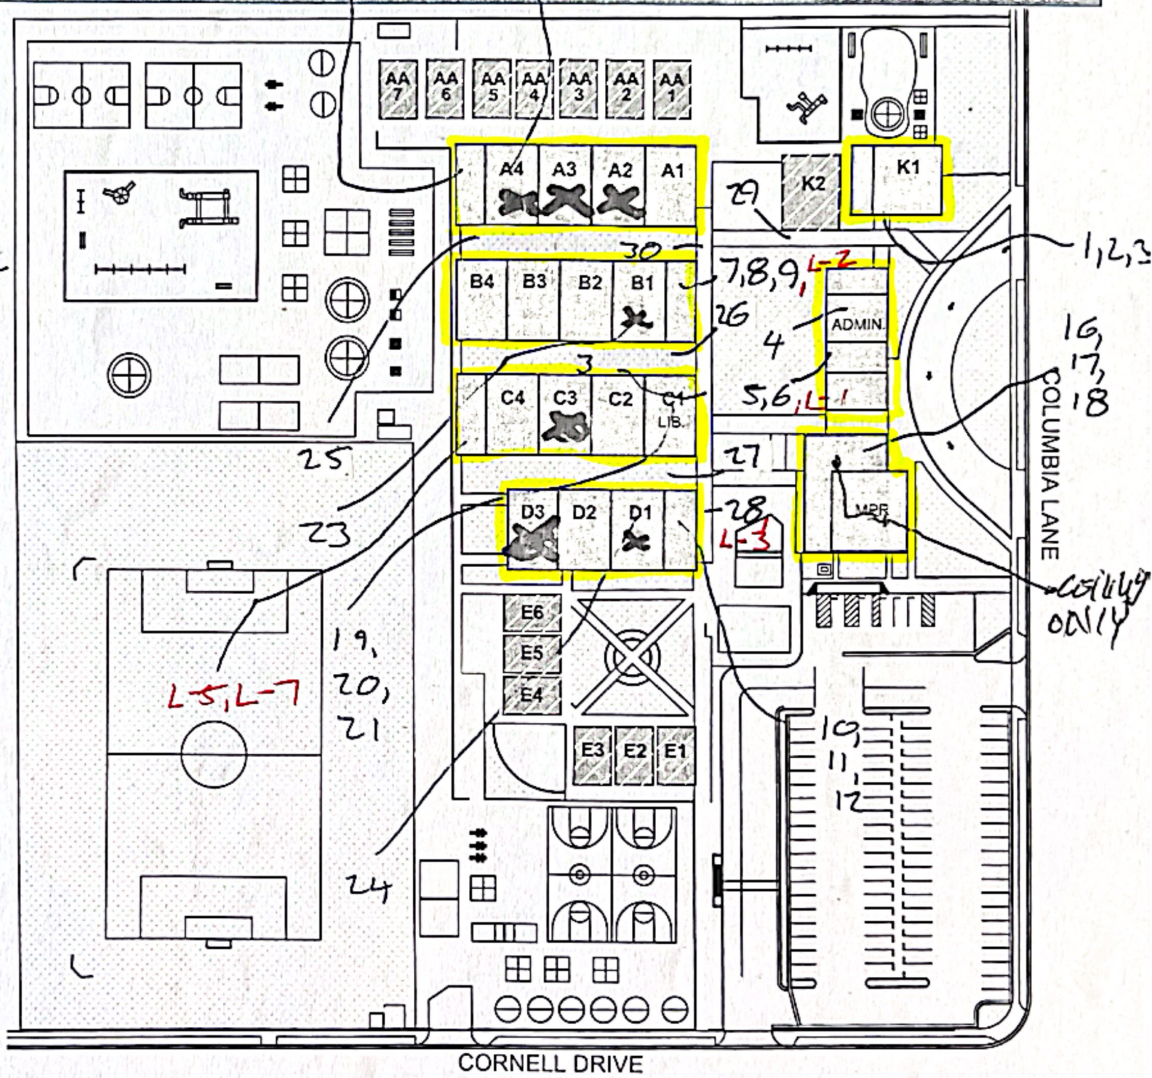
SITE DRAWING WITH SAMPLE LOCATION

Material	Sample Number	Asbestos Content	Square Footage	Location of Material	Friable	Damage
Under Carpet Vinyl Foor Tile and Black Mastic	22-24	5% Chrysotile (Black Mastic)	2700 SF	A4, B1, D1 Floors	No	No

X FLOOR TILE UNDER CARPET
