Attn:	MG Remediation
Site:	211 Swett Rd. Woodside, CA 94062
Service:	Mold – Screening
Location:	Specified Areas
Date:	February 17th, 2026
Project #:	2602-02M
Prepared For:	Peter Mandel

Site: 211 Swett Rd. Woodside, CA 94062
Service: Mold Screening
Location: Specified Areas
Date: February 17th, 2026
#: 2602-02M

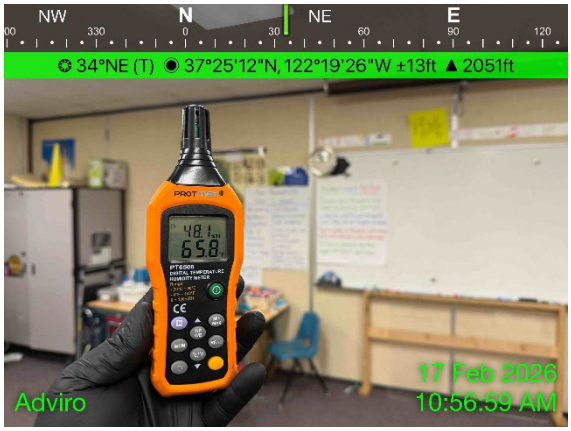
Humidity & Temperature Readings:

ENVIRONMENT READINGS		
LOCATION	TEMPERATURE	HUMIDITY
4th/5th Grade Classroom	62.4 °F	56.7%
Staff Room	66 °F	51.3%
Front Office	67.6 °F	46.5%
Classroom 1	65.8 °F	47.9%
Classroom 2	69.4 °F	44.6%
Classroom 3	65.8 °F	48.1%
Classroom 4	65.8 °F	46.8%
Cafeteria	64.2 °F	50.3%
Library	65.1 °F	48.8%
Outdoor 2	42.9 °F	92.5%
Outdoors 1	42.8 °F	92.3%

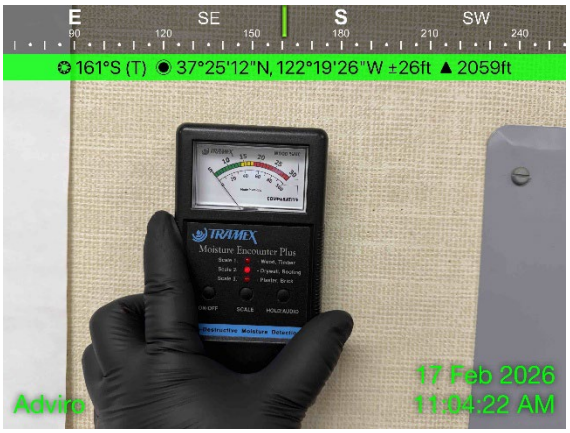
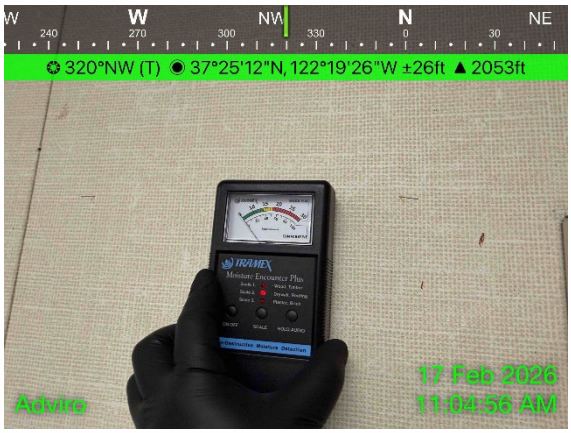
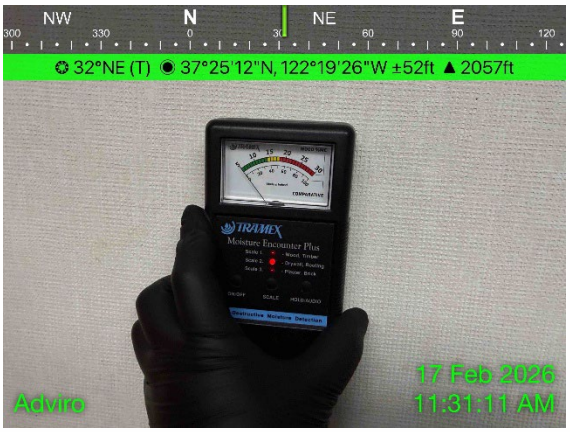
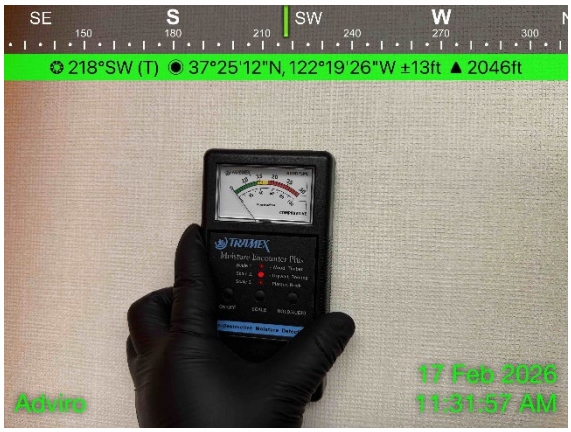
Moisture Meter Readings:

MOISTURE READINGS		
LOCATION	SPECIFIC SECTIONS	MOISTURE LEVEL
4th / 5th Grade Classroom	*Refer to map*	Normal
Staff Room	*Refer to map*	Normal
Front Office	*Refer to map*	Normal
Classroom 1	*Refer to map*	Normal
Classroom 2	*Refer to map*	Normal
Classroom 3	*Refer to map*	Normal
Classroom 4	*Refer to map*	Normal
Cafeteria	*Refer to map*	Normal
Library	*Refer to map*	Normal
