FULLERTON SCHOOL DISTRICT

FACILITIES 2026 MASTER PLAN

FEBRUARY 25, 2026

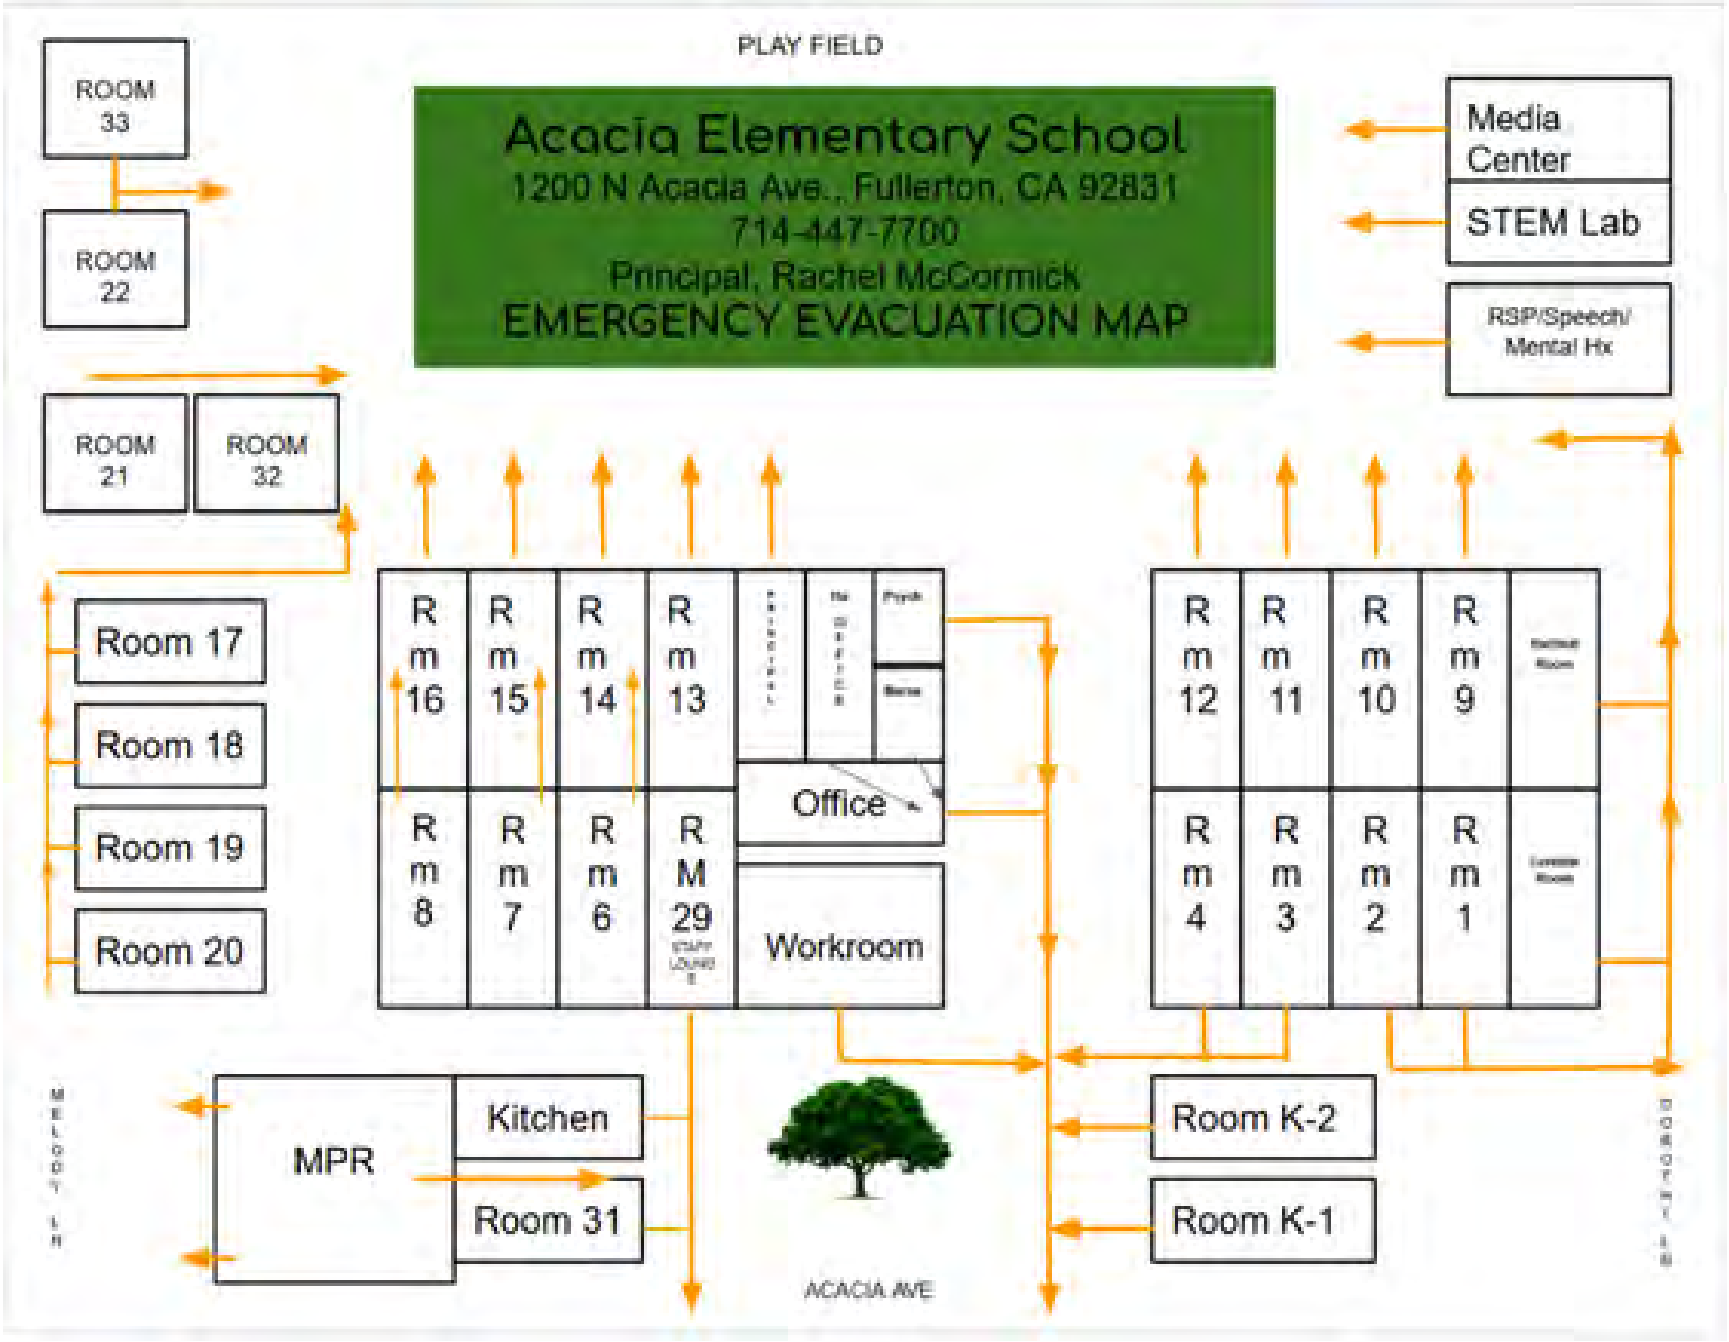
IMPROVEMENTS SITE PLAN

1. INCREASE EXTERIOR LIGHTING
2. REPAIR CONCRETE SIDEWALK
3. UPGRADE ASPHALT PAVING
4. REPLACE NON-ADA DRINKING FOUNTAINS

5. IMPROVEMENTS
   - ADD SOUND AMPLICATION SYSTEM
   - IMPROVE LIGHTING
   - REPLACE CASEWORK
   - REPLACE/ADD WINDOW COVERING
   - UPGRADE FINISHES AND FURNITURE

10. REPLACE ROOFING/HVAC/ PLUMBING AS NEEDED

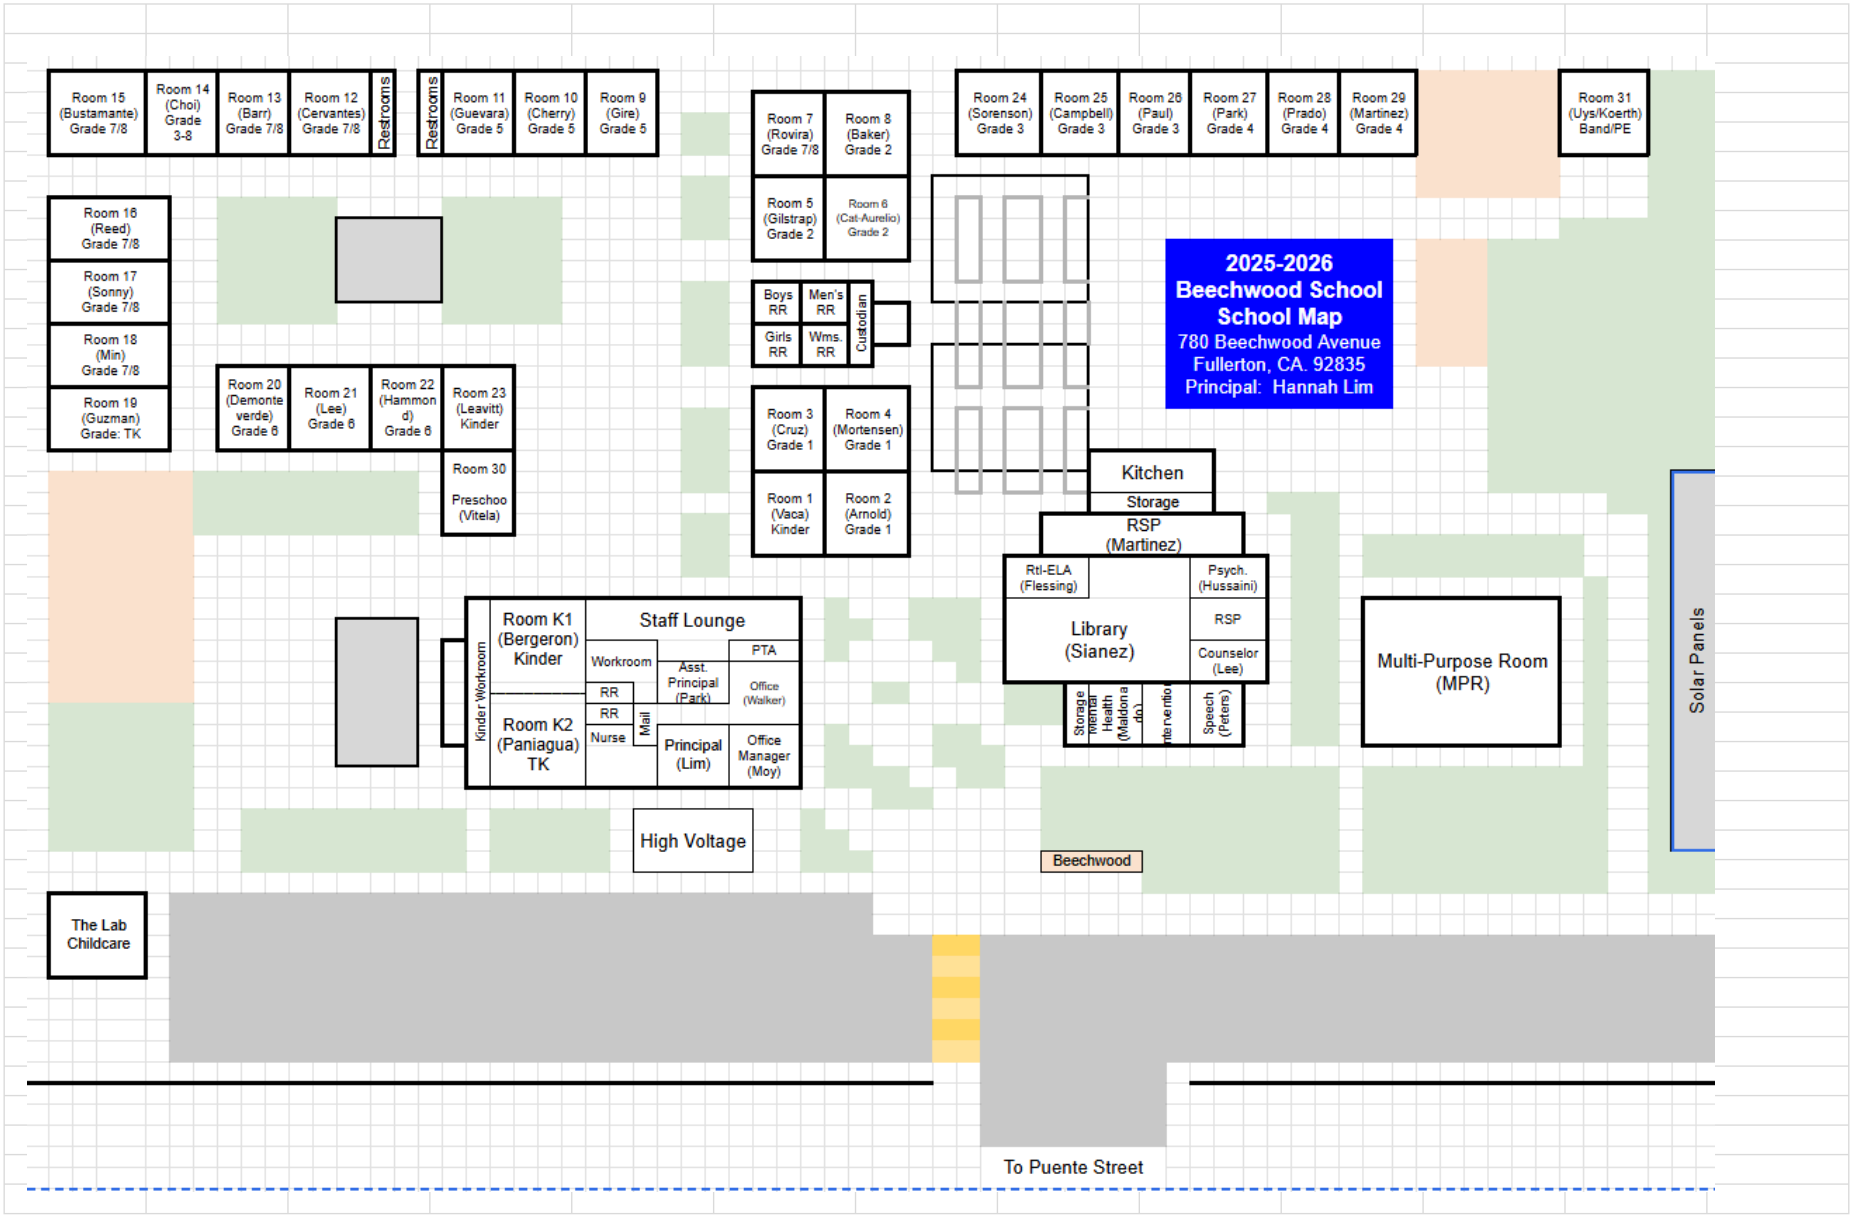
IMPROVEMENTS SITE PLAN

1. INCREASE EXTERIOR LIGHTING
2. REPAIR CONCRETE SIDEWALK
3. UPGRADE KINDERGARTEN TOILETS
4. UPGRADE ASPHALT PAVING
5. REPLACE LUNCH SHELTER

6. IMPROVEMENTS
   - ADD SOUND AMPLICATION SYSTEM
   - IMPROVE LIGHTING
   - REPLACE CASEWORK
   - REPLACE/ADD WINDOW COVERINGS
   - UPGRADE FINISHES AND FURNITURE

7. ADD ELECTRONIC MARQUEE SIGN
8. ADD STEM/STEAM LAB
9. IMPROVE LIBRARY
10. NEW 2-STORY BUILDING TO REPLACE ALL 22 RELOCATABLE CLASSROOMS

12. REPLACE ROOFING/HVAC/ PLUMBING AS NEEDED

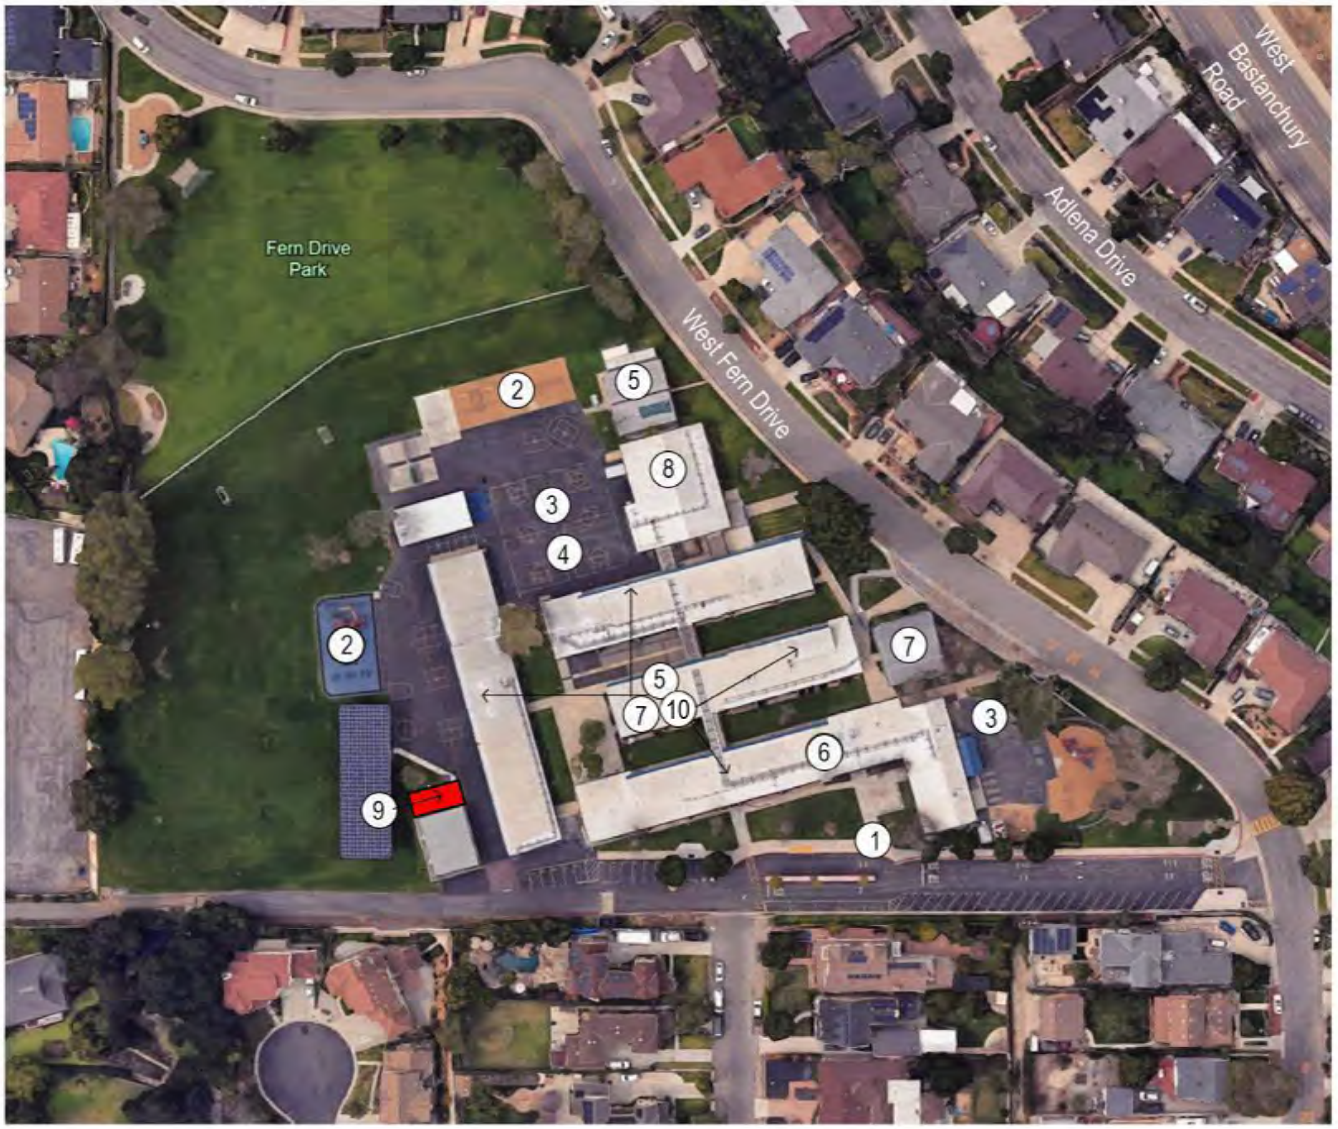
1. INCREASE EXTERIOR LIGHTING
2. NEW RUBBER SURFACE & PLAY EQUIPMENT
3. UPGRADE ASPHALT PAVING
4. REPAIR CONCRETE SIDEWALK

UPGRADE ALL CLASSROOMS

5. IMPROVEMENTS
   - ADD SOUND AMPLICATION SYSTEM
   - IMPROVE LIGHTING
   - REPLACE CASEWORK
   - REPLACE/ADD WINDOW COVERING
   - UPGRADE FINISHES AND FURNITURE

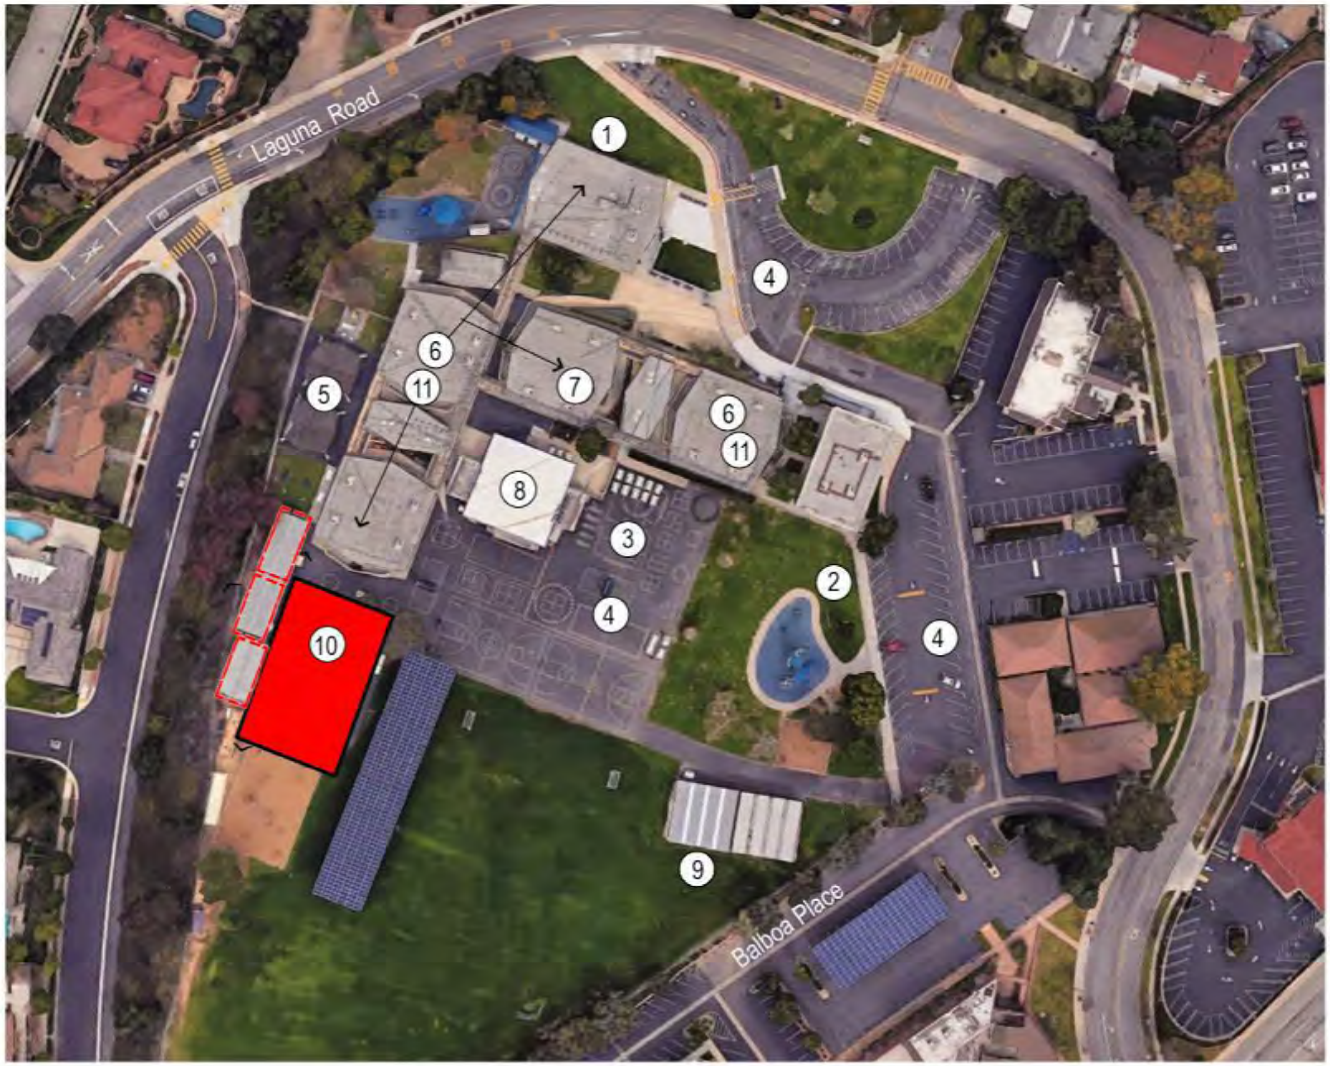
1. REPLACE NON-ADA DRINKING FOUNTAINS
2. INCREASE EXTERIOR LIGHTING
3. REPAIR CONCRETE SIDEWALK
4. UPGRADE ASPHALT PAVING
5. REPLACE LUNCH SHELTER

UPGRADE ALL CLASSROOMS

6. IMPROVEMENTS
   - ADD SOUND AMPLICATION SYSTEM
   - IMPROVE LIGHTING
   - REPLACE CASEWORK
   - REPLACE/ADD WINDOW COVERING
   - UPGRADE FINISHES AND FURNITURE

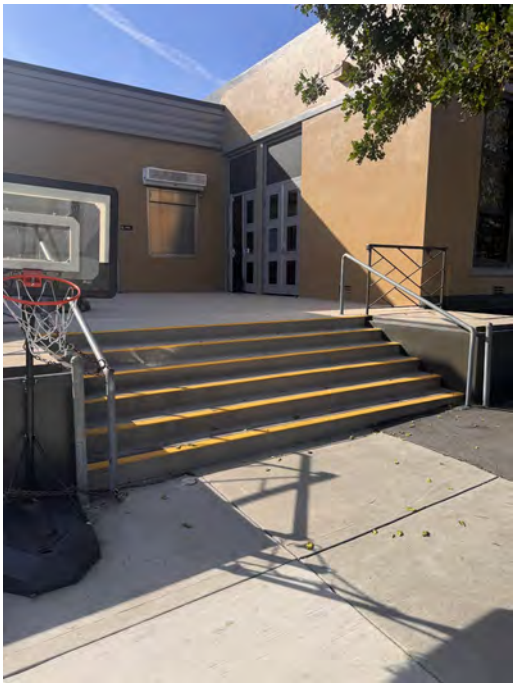
MAPLE ELEMENTARY SCHOOL

REPLACE ASPHALT PAVING

REPLACE BALL WALL WITH CMU

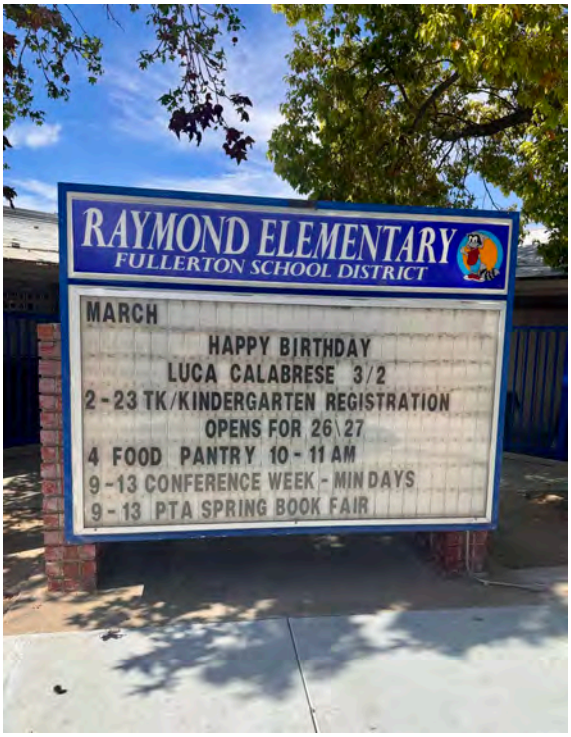
RAYMOND ELEMENTARY SCHOOL

REPLACE ASPHALT PAVING

MODERNIZE ALL CLASSROOMS

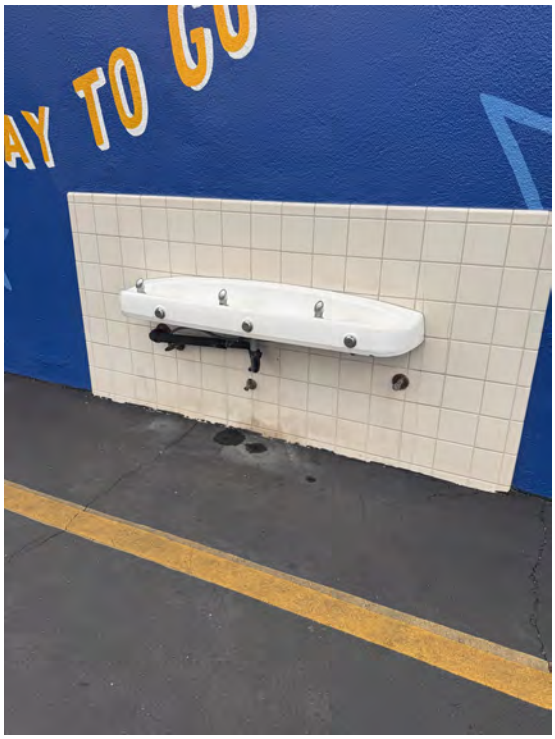
RICHMOND ELEMENTARY SCHOOL

REPLACE ASPHALT PAVING

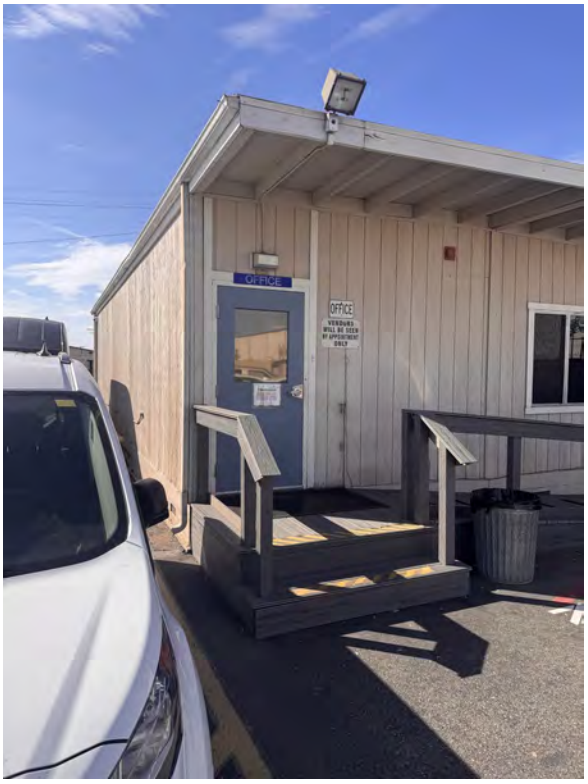
REPLACE OFFICE

ENLARGE WAREHOUSE

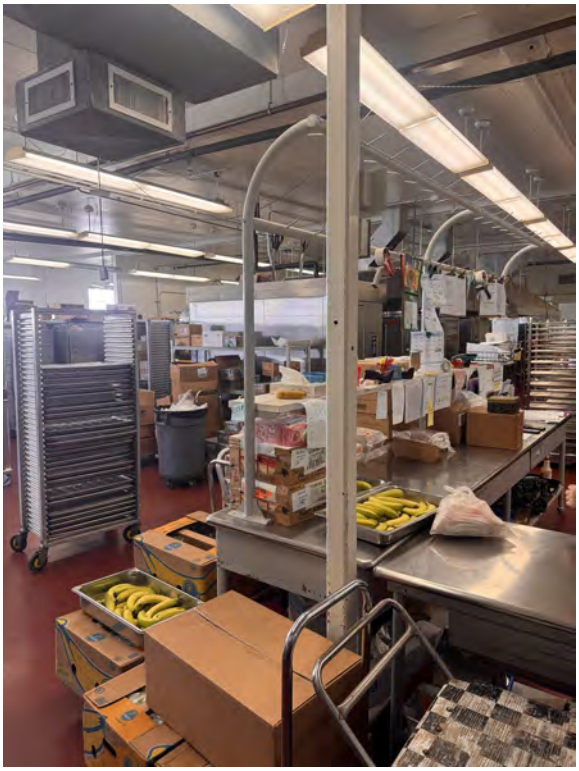
UPGRADE RESTROOM

MODERNIZE KITCHEN
