Indoor Testing Report

Altadena Arts Magnet School
743 East Calaveras Street
Altadena, CA 91001

Verdantas Inc. Project No: 036.0000035210

May 21, 2026

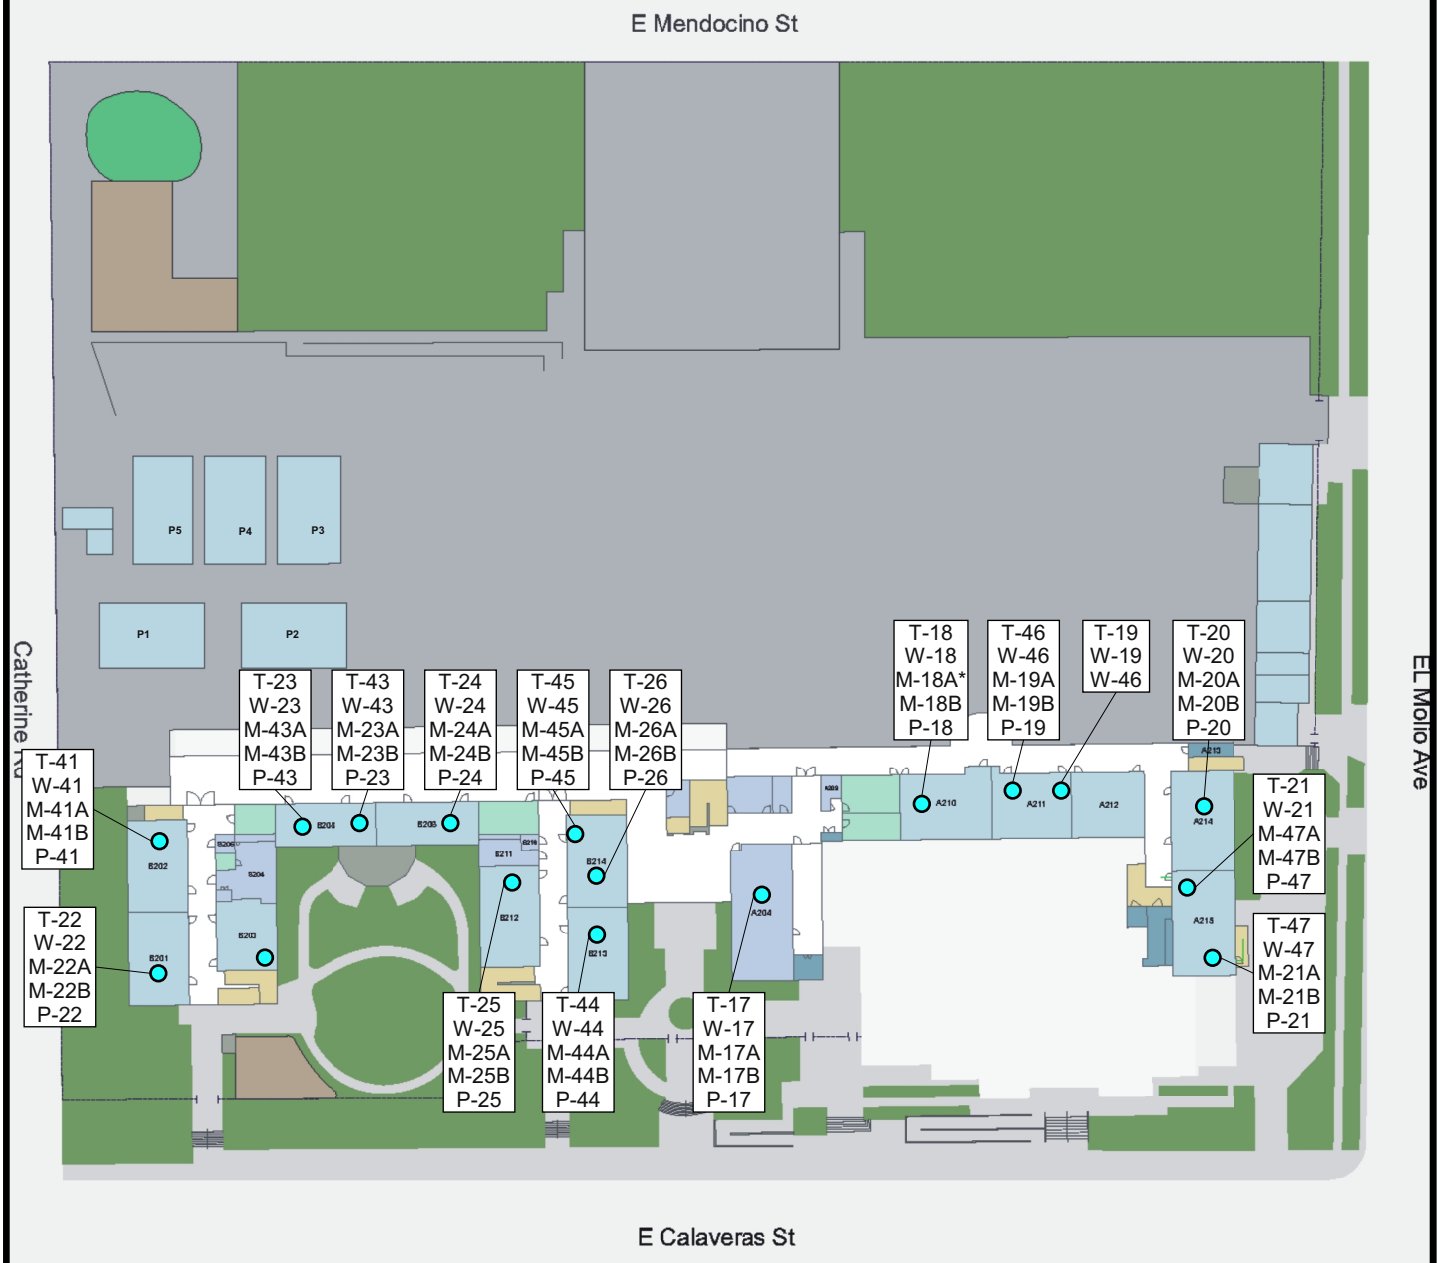
FIGURE 2A

The only further action warranted is for the CAM-17 metal arsenic identified in sample M-06A collected from a hard surface floor located in room A112A. The findings indicate limited exposure potential for students, faculty, and staff, with no evidence of widespread or systemic indoor contamination associated with wildfire impacts.

reporting limit during this investigation was in sample M-06A (46.5 µg/ft²). In addition to arsenic, lead, barium, chromium, copper, nickel, vanadium, and zinc were also detected above the reporting limit in sample M-06A. Sample M-06A was separated from outdoor areas by a single doorway, and the results at this location may be explained by outdoor contributions of dirt and dust that remained for months following the wildfire event. The co-occurrence of elevated metals at this location similar to those observed to be elevated in surface soil sample ALTA-S-013, collected outside in close proximity to the classroom doorway, combined with generally low concentrations reported as less than the reporting limit elsewhere, supports that the observed condition is localized and influenced by proximity to outdoor particulate sources, rather than indicative of a uniform or systemic indoor metals condition.

Based on these results, no broad correction or remedial actions are warranted. Targeted cleaning (e.g., HEPA vacuuming, mopping, and damp wiping) and use of entryway controls to minimize tracking of outdoor dust is recommended in one localized area (room A112A) where elevated arsenic was observed. No correction action is recommended for other metals, PAHs, or asbestos. Continued routine maintenance and observation are recommended, consistent with AIHA wildfire guidance and in the absence of widespread contamination conditions.

Based on the analytical results, the only further action warranted is for the CAM-17 metal arsenic identified in sample M-06A collected from a hard surface floor located in room A112A. No concerning PAHs or asbestos test results were identified during this investigation. Recommended next steps include targeted cleaning (room A112A) and continued routine maintenance and observation, consistent with AIHA wildfire guidance and in the absence of widespread contamination conditions. Since the analytical results are based on a single sampling event, it should be noted that conditions may change over time.

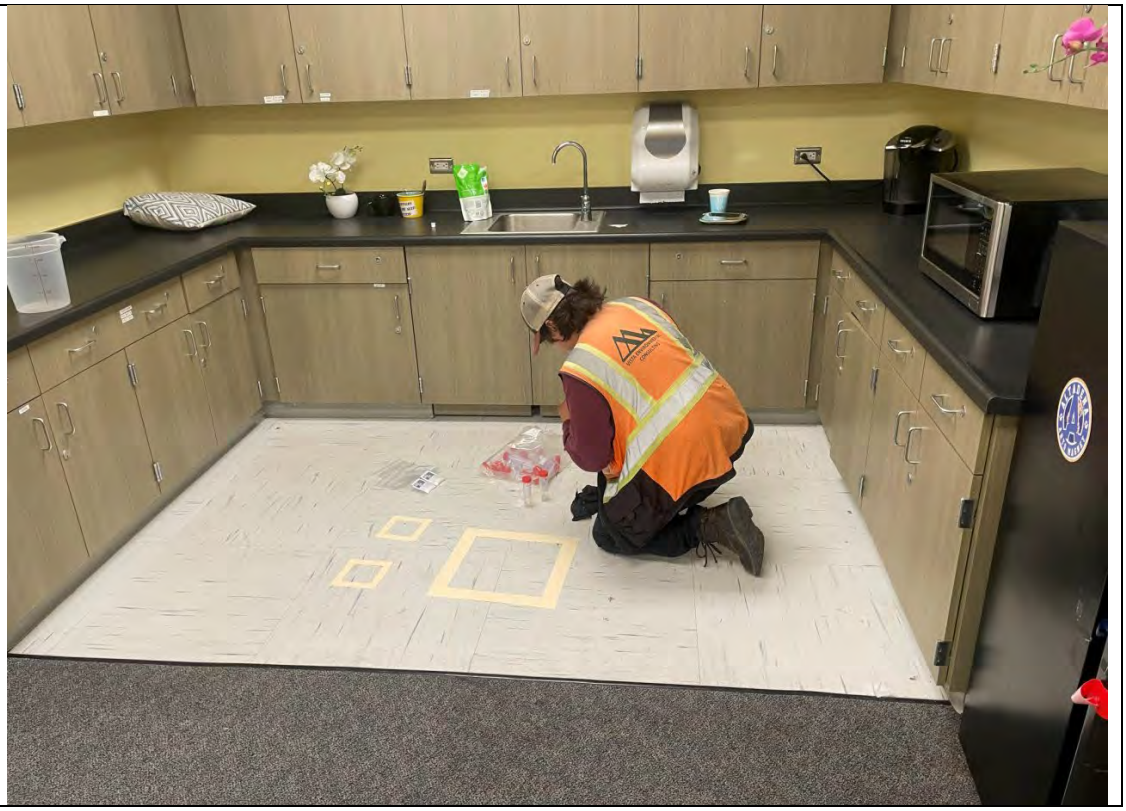
Photo No. 1 **View of Direction of Photo:** N/A **Description**: **Room: A111** Air Sampling near the southern doorway.

Photo No. 2 **View of Direction of Photo:** N/A **Description**: **Room: A112A** Wipe Sampling at the base of the exterior doorway.

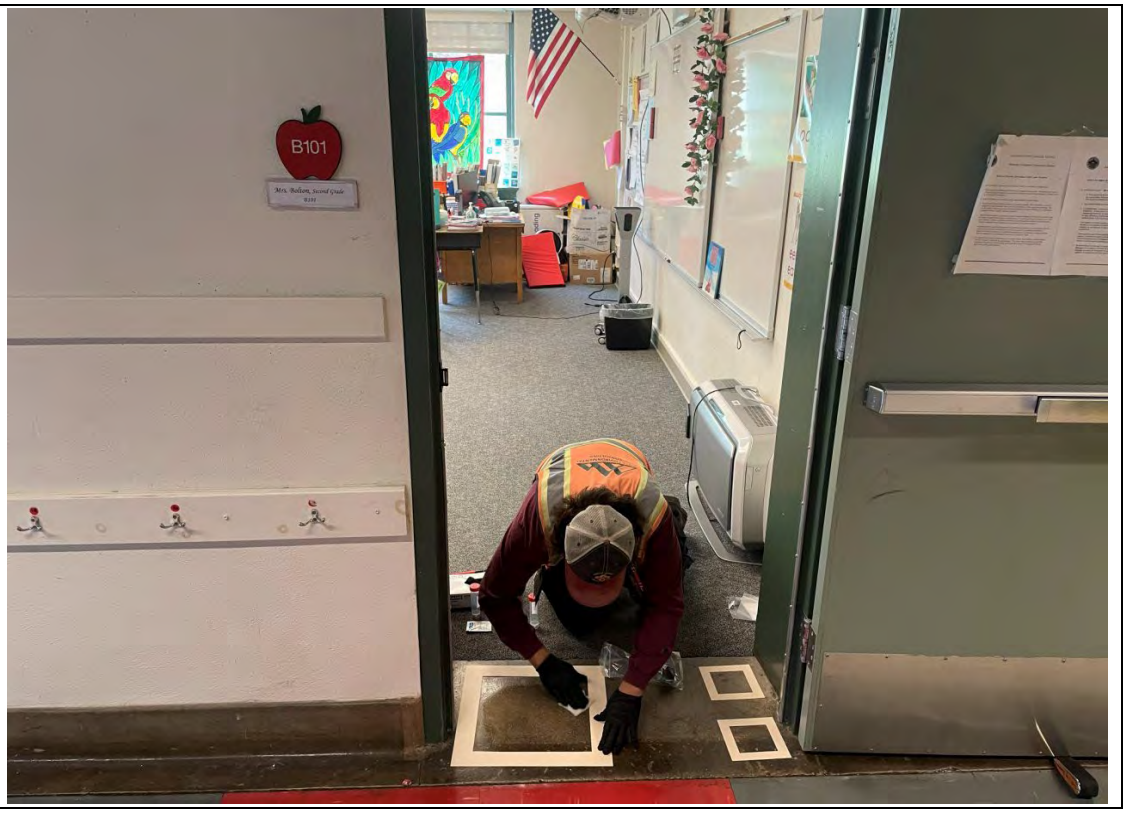
Photo No. 7	
View of Direction of Photo: N/A	
Description: **Room: B101** Wipe Sampling at the base of the doorway.

Photo No. 8	
View of Direction of Photo: N/A	
Description: **Room: A122** (Cafeteria) Air Sampling near the eastern doorway.

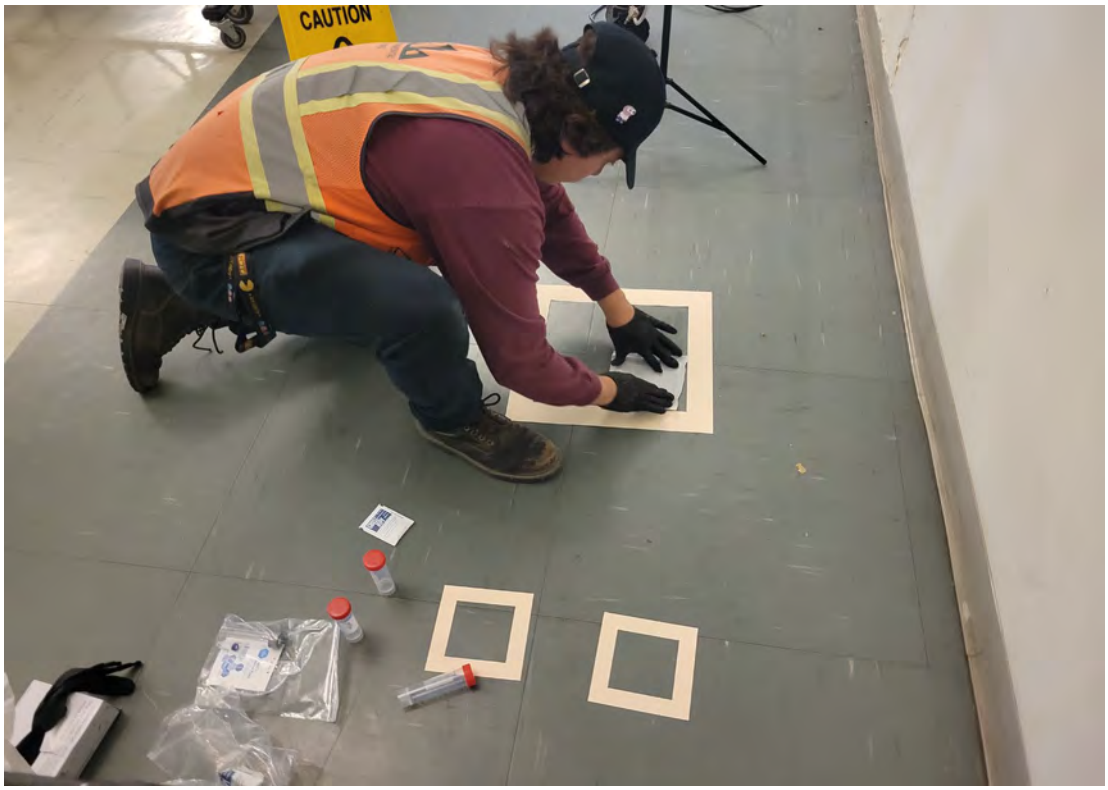
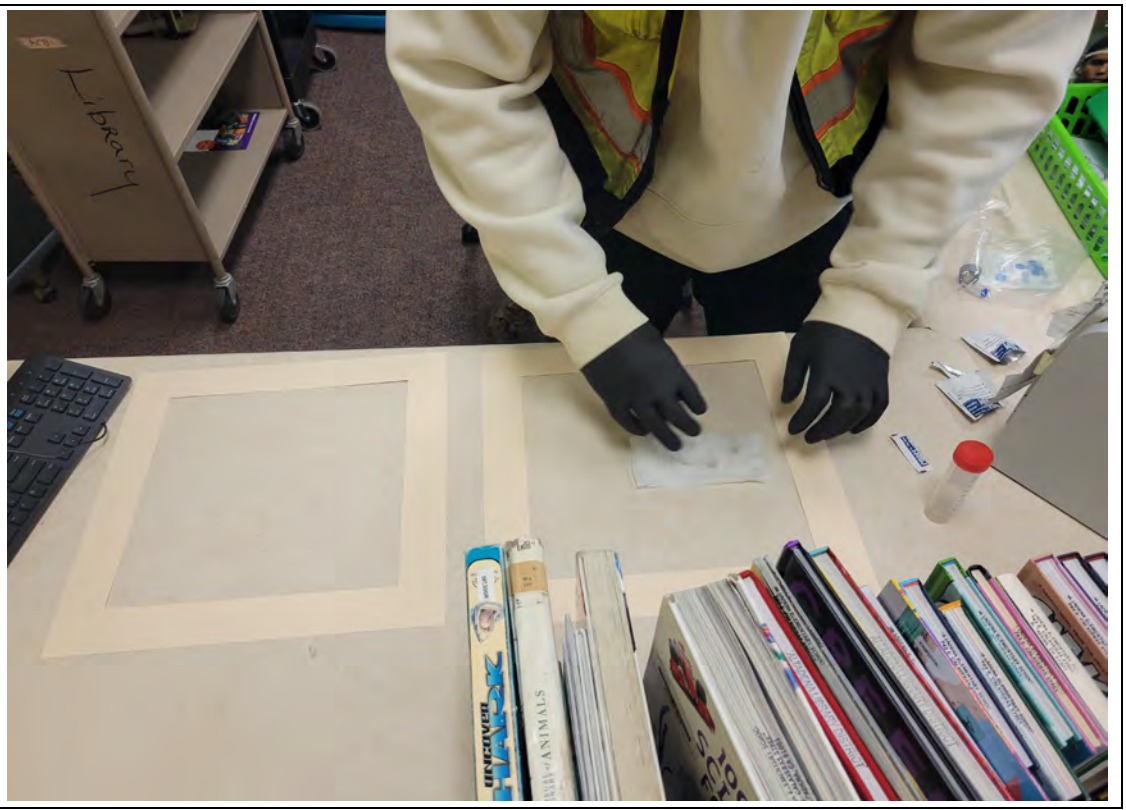
Photo No. 9 **View of Direction of Photo:** N/A **Description**: **Room: A122** (Cafeteria) Wipe Sampling near the eastern doorway.

Photo No. 10 **View of Direction of Photo:** N/A **Description**: **Room: A204** Wipe Sampling on primary desk to the left of the doorway.

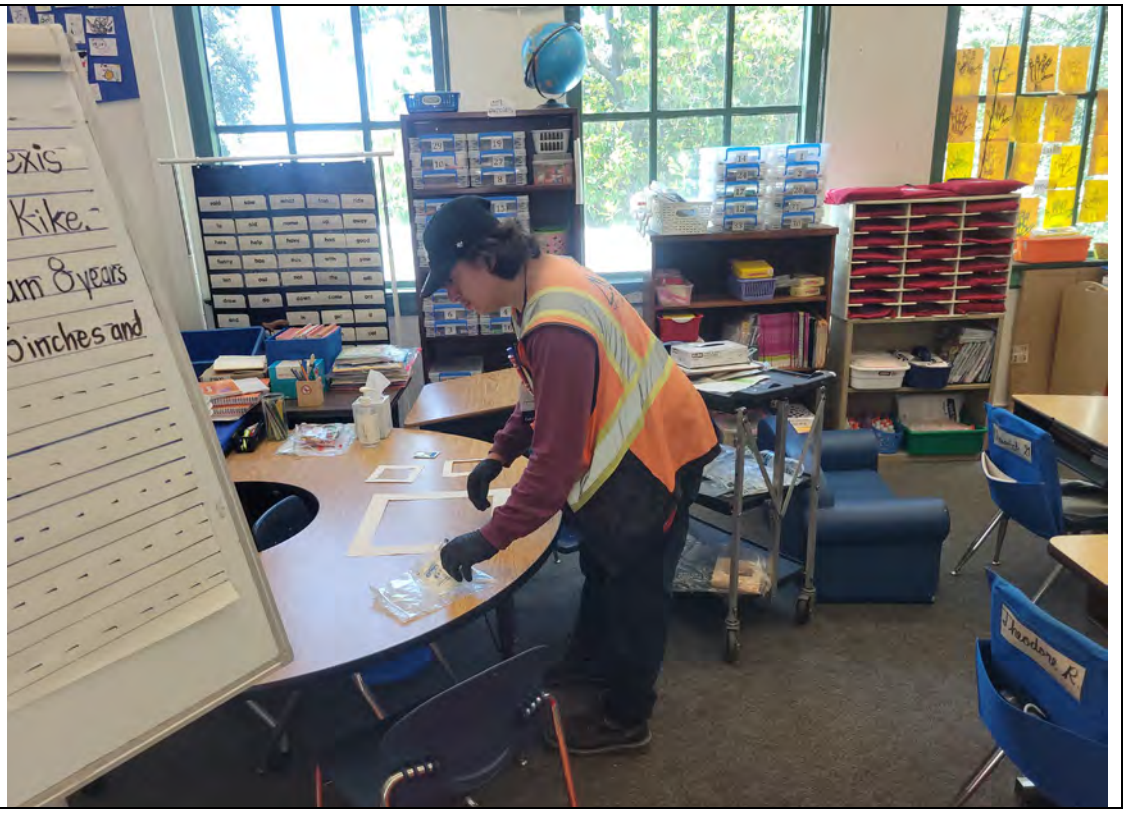
Photo No. 15 **View of Direction of Photo:** N/A **Description**: **Room: B208** Additional Wipe Sampling on desk near back of the classroom.

Photo No. 16 **View of Direction of Photo:** N/A **Description**: **Room: B214** Wipe Sampling at base of the doorway.

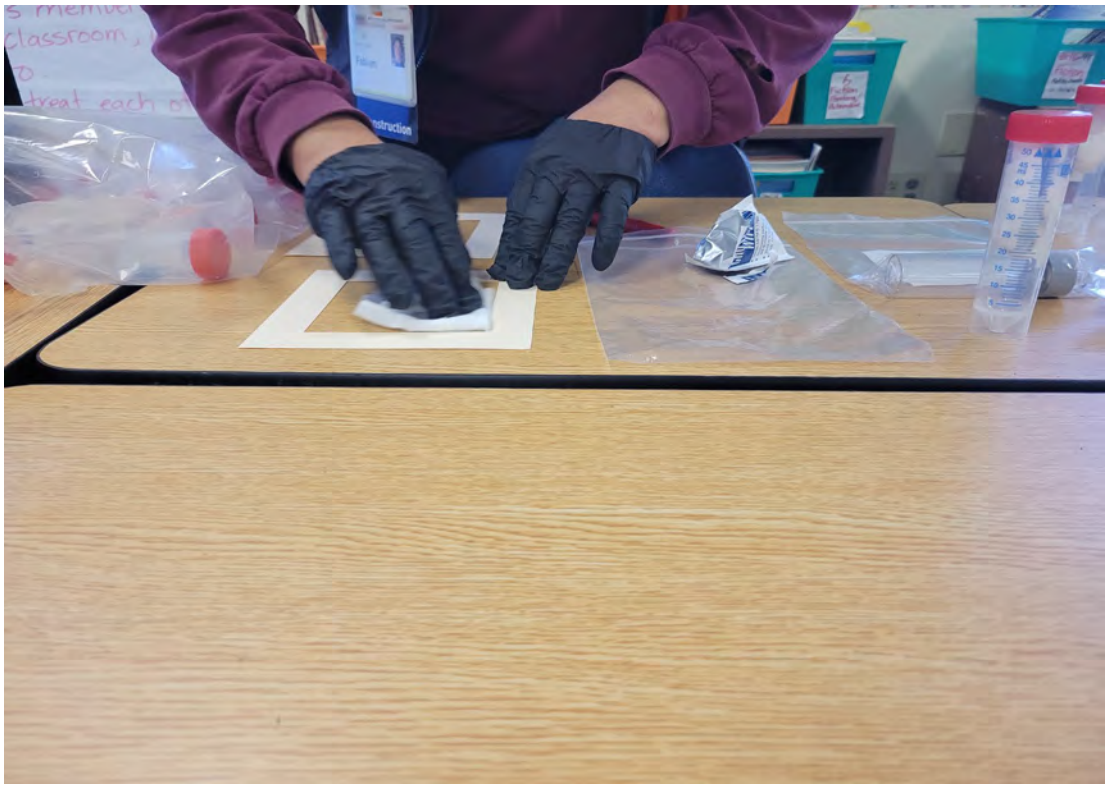
Photo No. 17 **View of Direction of Photo:** N/A **Description**: **Room: Portable 2** Wipe Sampling on the desk near the doorway.

Photo No. 18 **View of Direction of Photo:** N/A **Description**: **Room: Portable 2** Wipe Sampling on the desk near the doorway.
