Williams Lawsuit Settlement Act

2024
"Good Repair" Inspection Report

VENTURA UNIFIED SCHOOL DISTRICT

September 2024

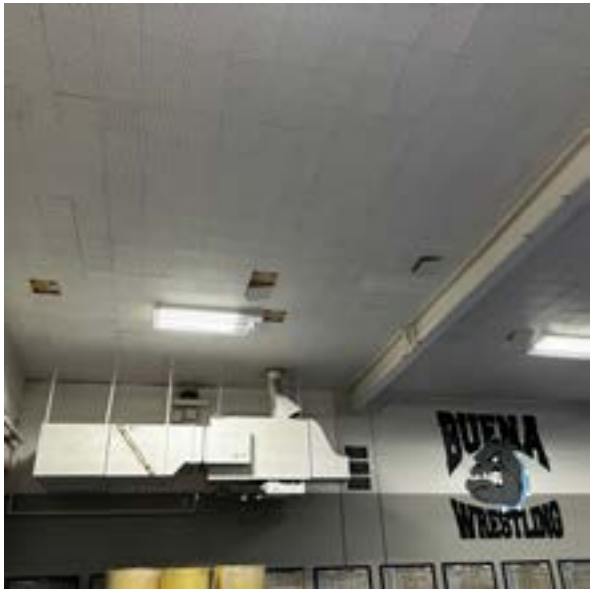
Ceiling tiles falling in rooms 95, 106, 107, 113, 122, 124, 132, 143

Right sink is out of order in Bldg F boys restroom

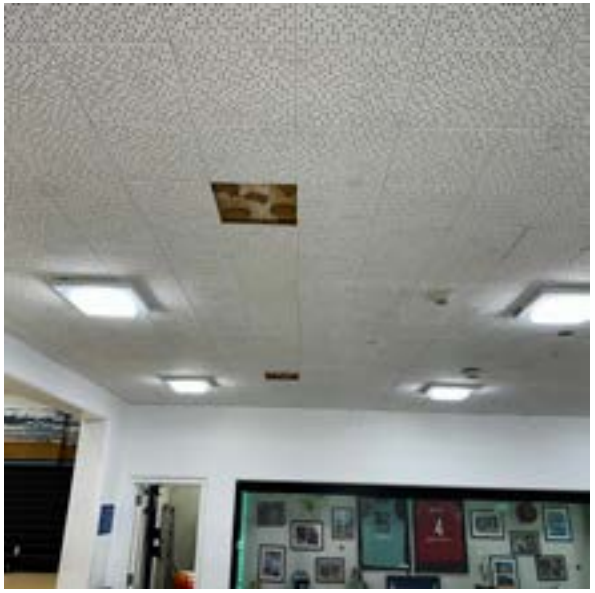
VCT Flooring damaged in rooms 142

Ceiling tiles falling in weight room and wrestling room

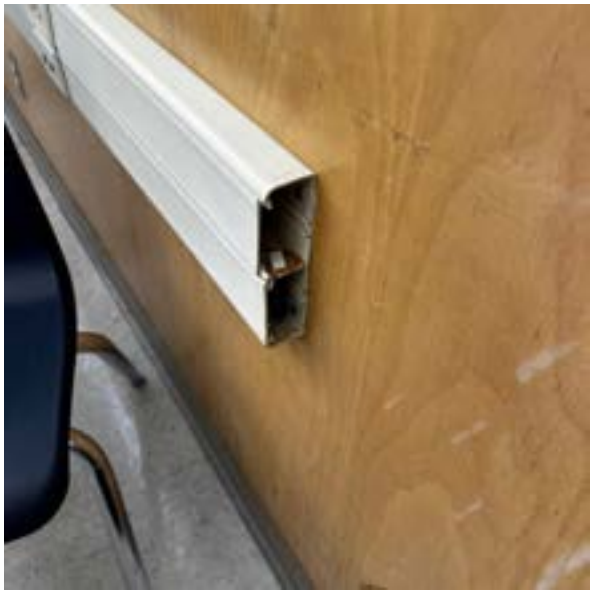
Outlet cover plate damaged in wire mold in room 31

Broken outlet in Room 33 East wall

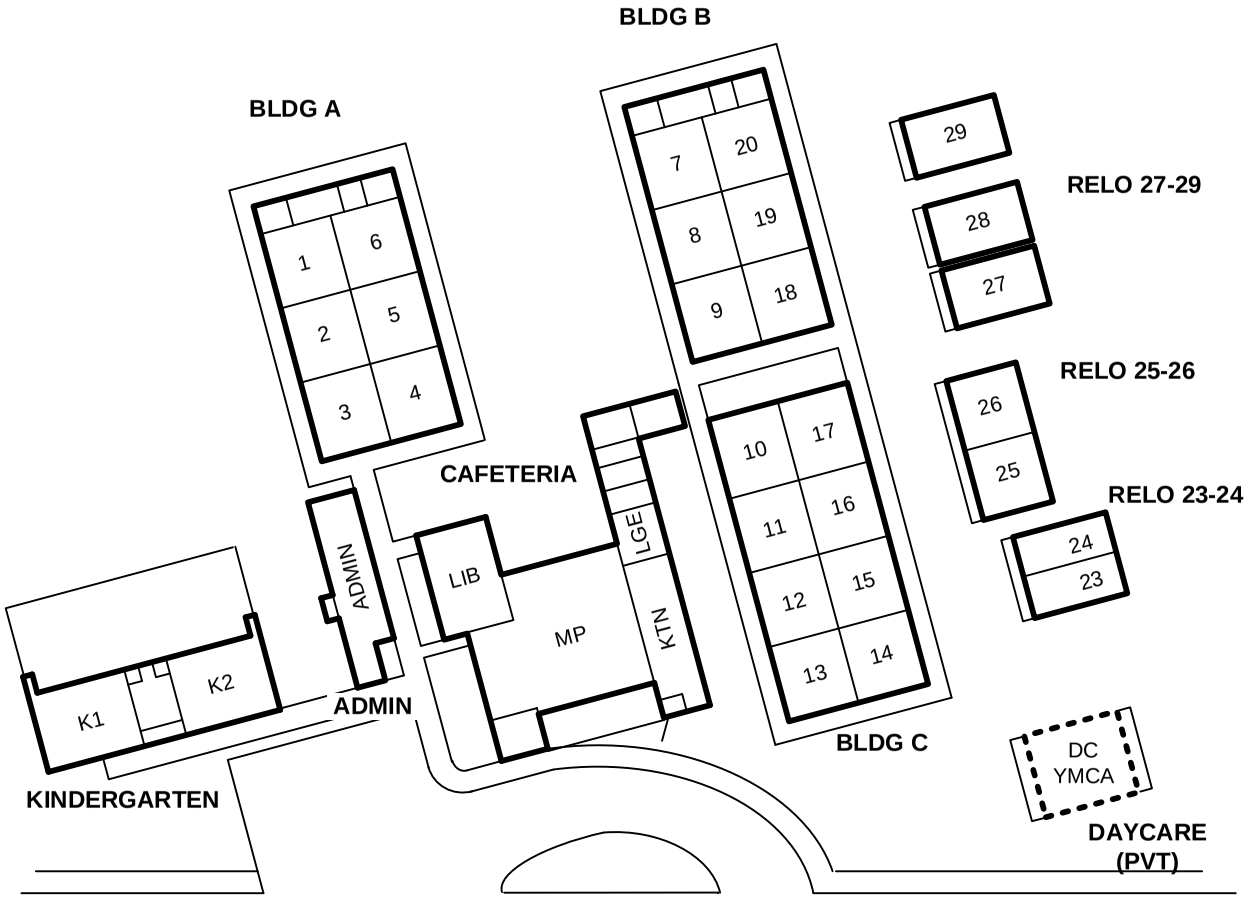
Termite dropping at white board North wall in room 7

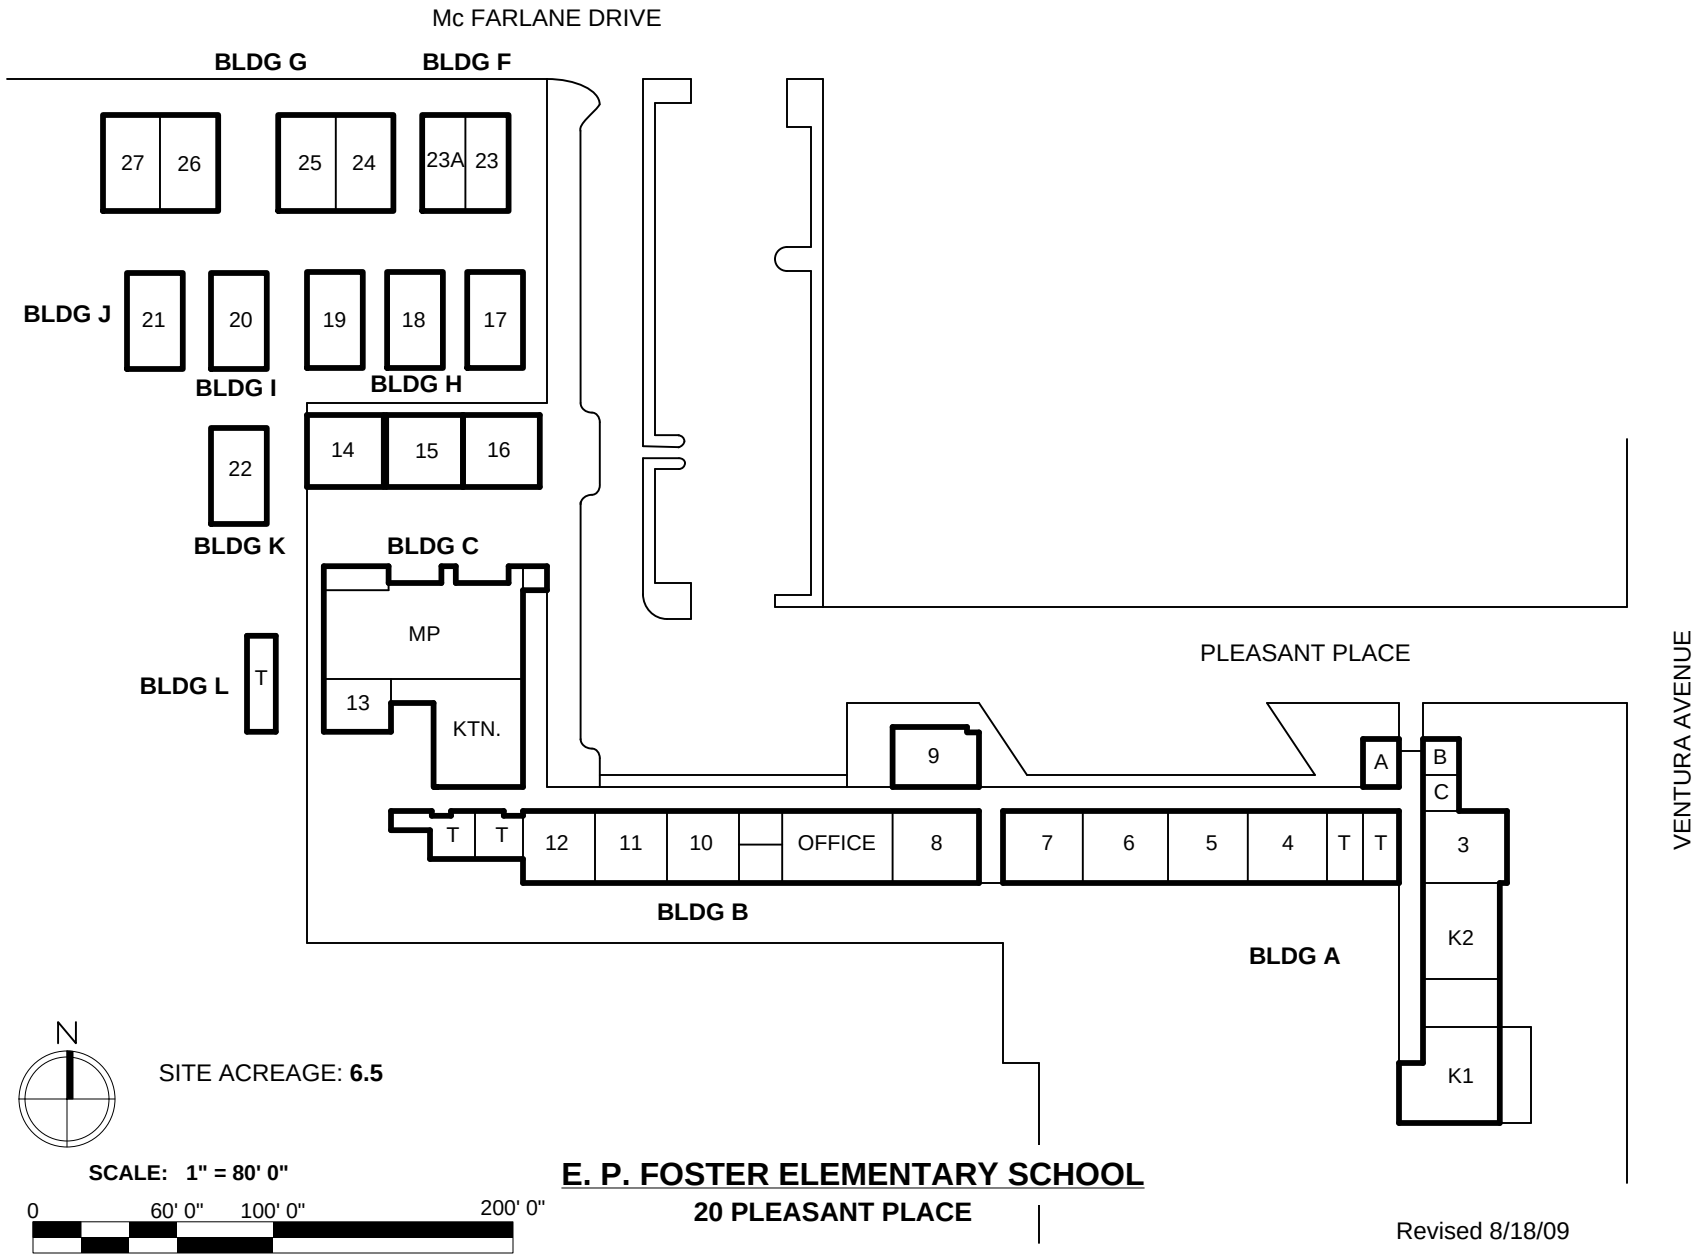
Floor cove base & window trim missing from Classroom 29 East wall

Modular line trim is missing and failing from the West wall in room 23

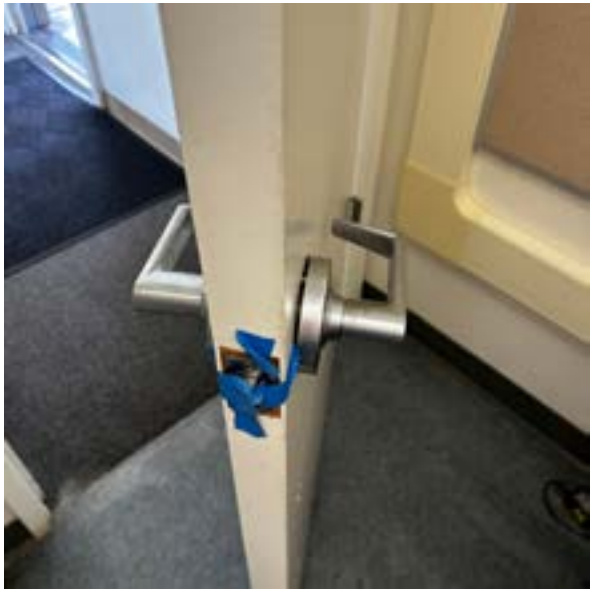
Excessive peeling paint on window mullions in rooms 11, 12, 17 and 19

Independent study exterior door is deteriorated

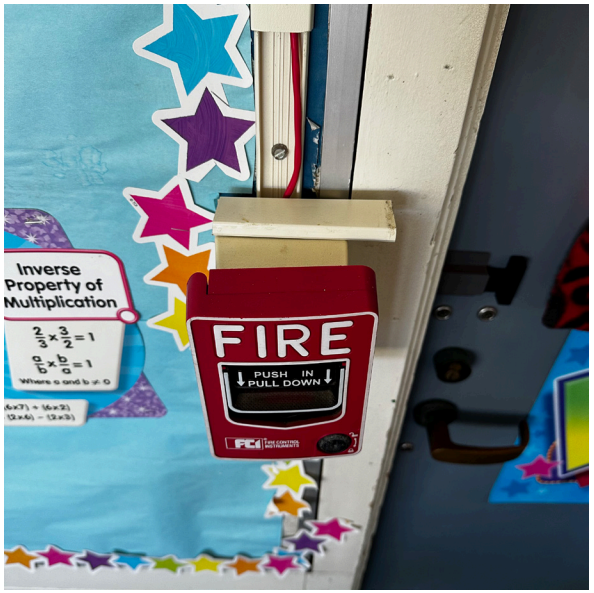
Rotted/Damaged plywood at the Admin arcade South West corner

Building 10 and Library fire alarm is in a trouble state, missing devices

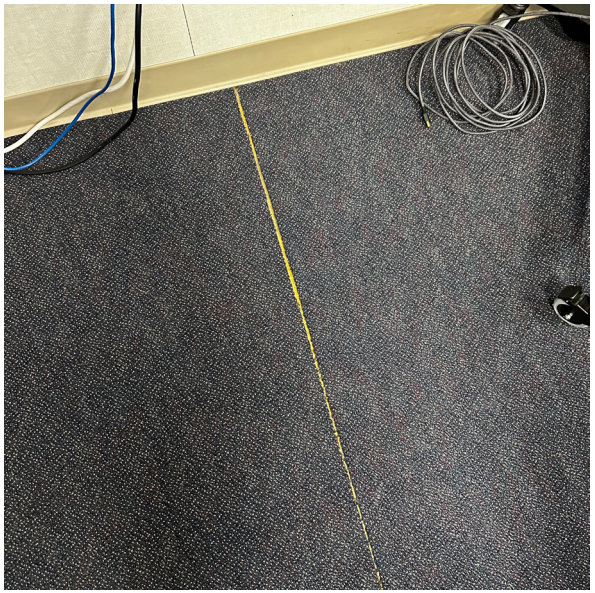
Fire alarm pull station loose in room 5

Carpet seams are peeling in the Library

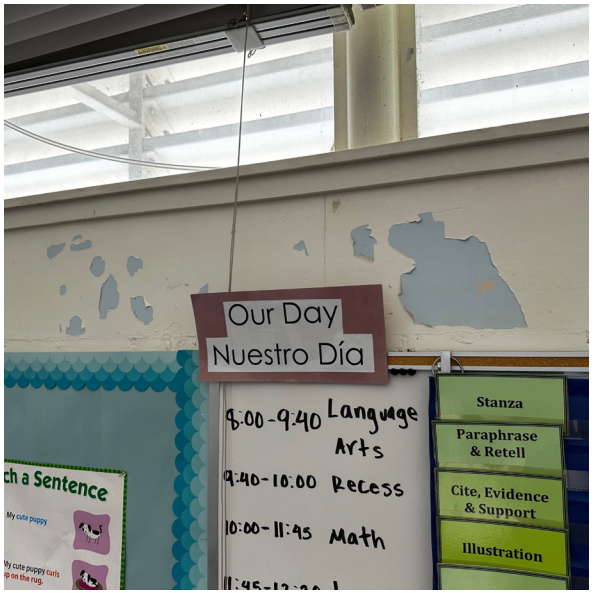
Excessive peeling paint in room 5

Ceiling tiles falling in room 12
