Williams Lawsuit Settlement Act

2021
"Good Repair" Inspection Report

Facilities Services Department

VENTURA UNIFIED SCHOOL DISTRICT

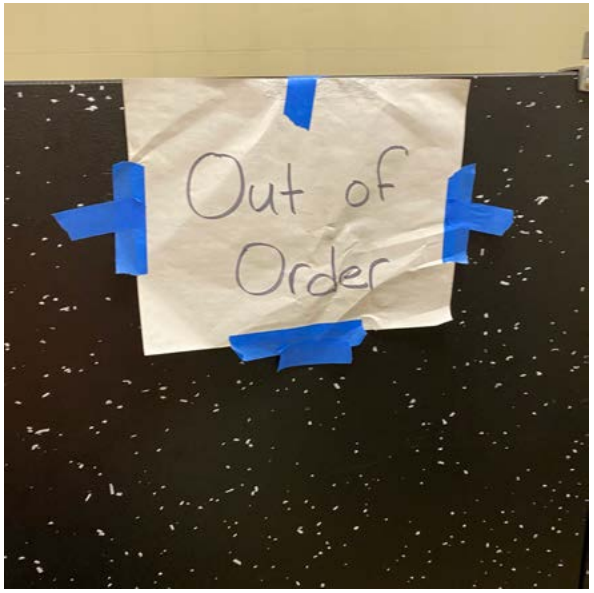
Toilet out of order in Cafeteria Girls re-stroom

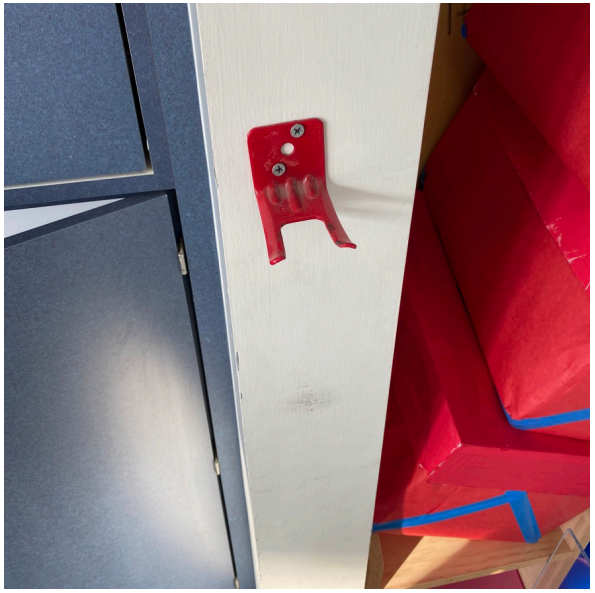
Fire extinguisher is out of service date in Health office

Fire extinguisher missing from room 53

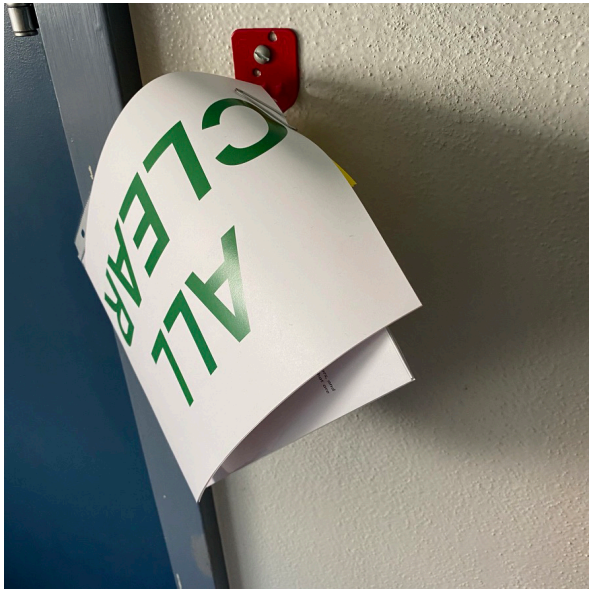
Fire extinguisher missing from room 10

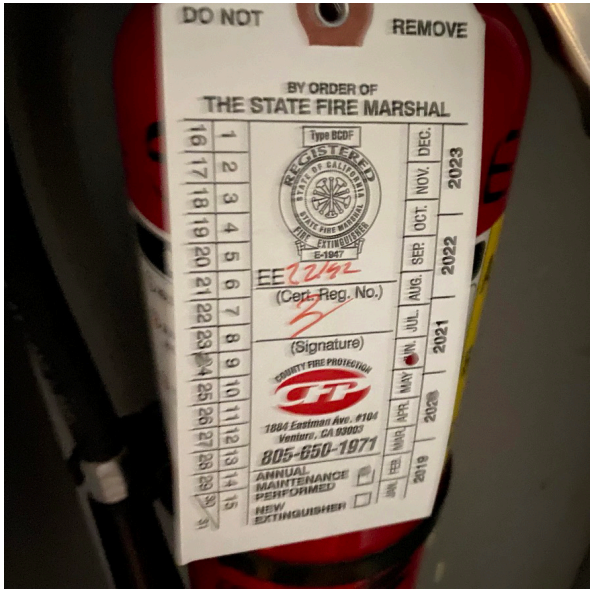
Fire extinguishers missing from Admin teachers lounge and workroom

Cafeteria stage fire extinguisher is out of service date (6/24/2020)

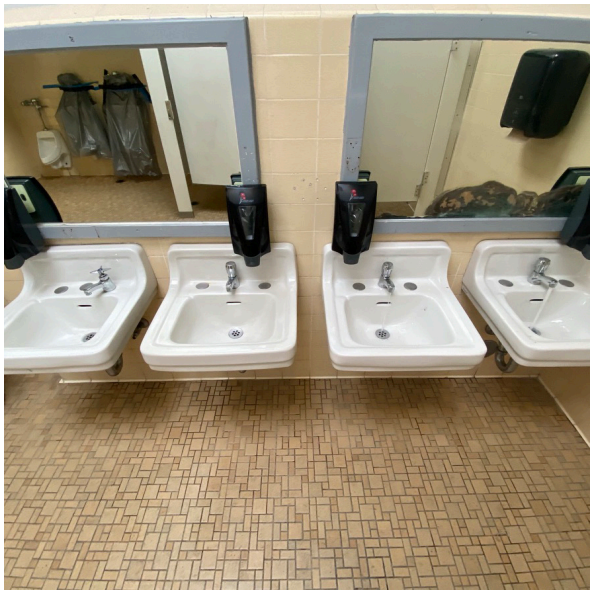
Signs of termite infestation at Classroom 8 North door

Cafeteria exterior door by room 10 is deteriorated and peeling

Two middle sinks out of order in Building B girls restroom

Room 5 sink cabinet doors are deteriorated and falling apart

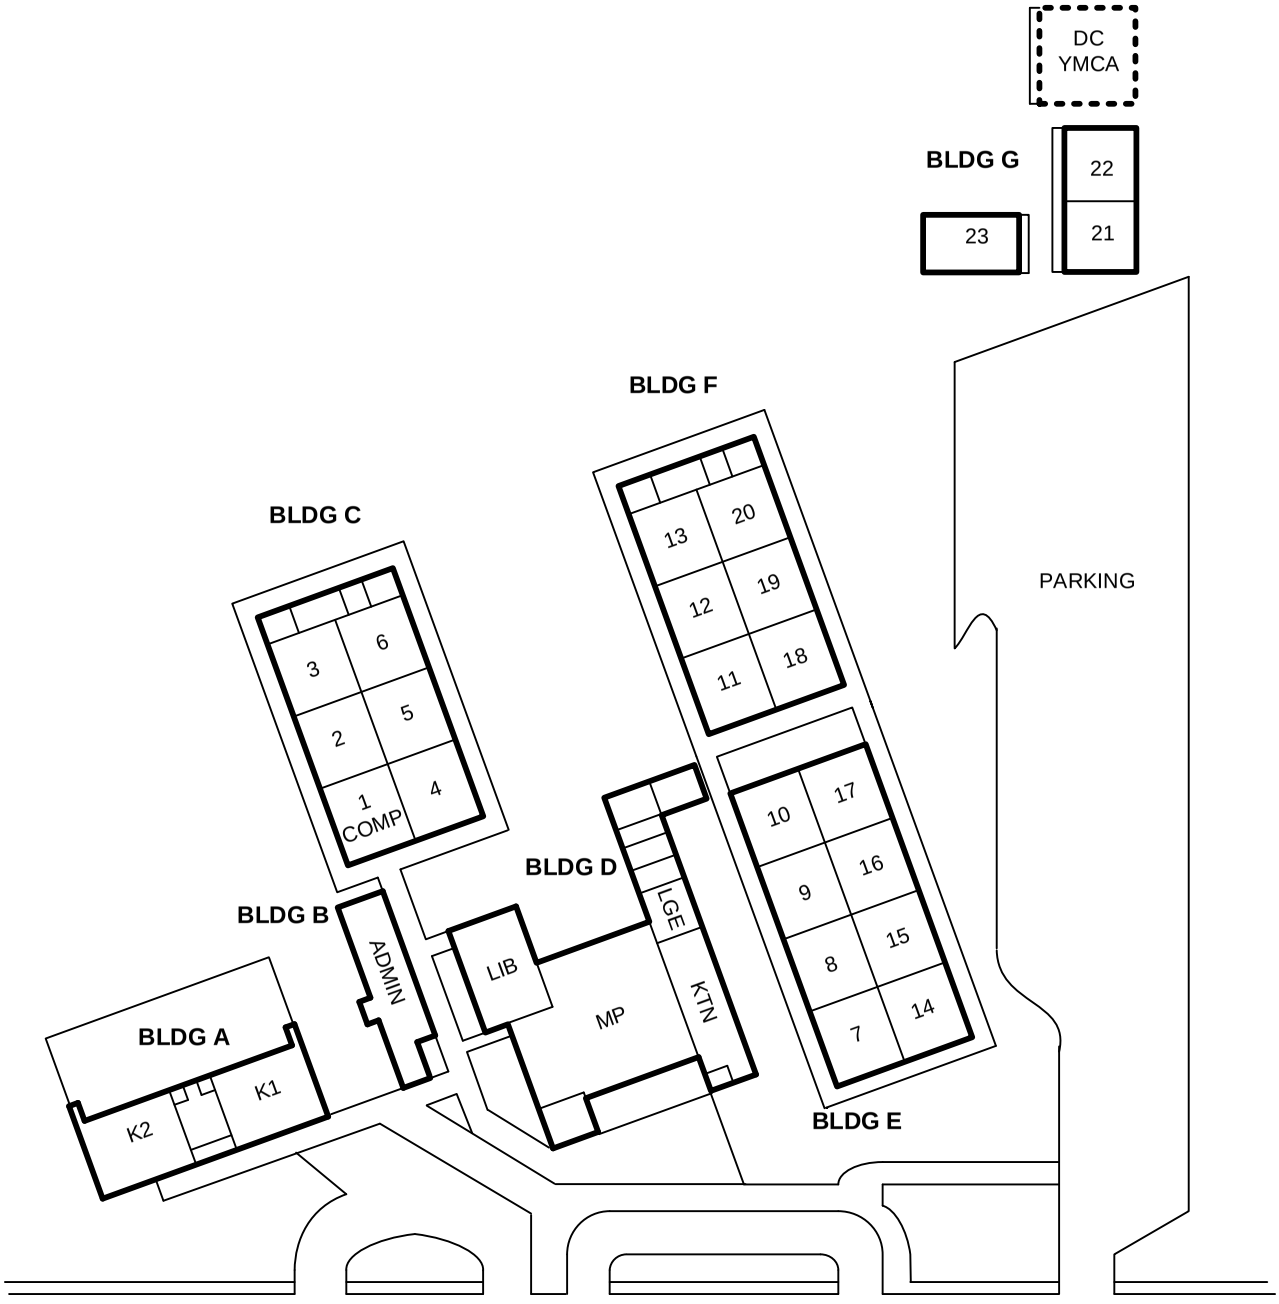
Excessive rust at roof at room 10
exterior West elevation

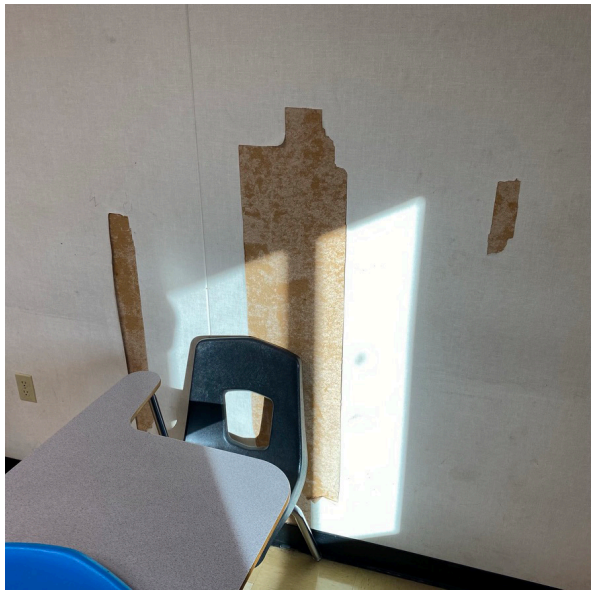
Wall surface is deteriorated at the windows of the little theater

Sink is out of order in room 66 by the South door, Trap and drain removed.

Power strips plugged into power strips in room 120

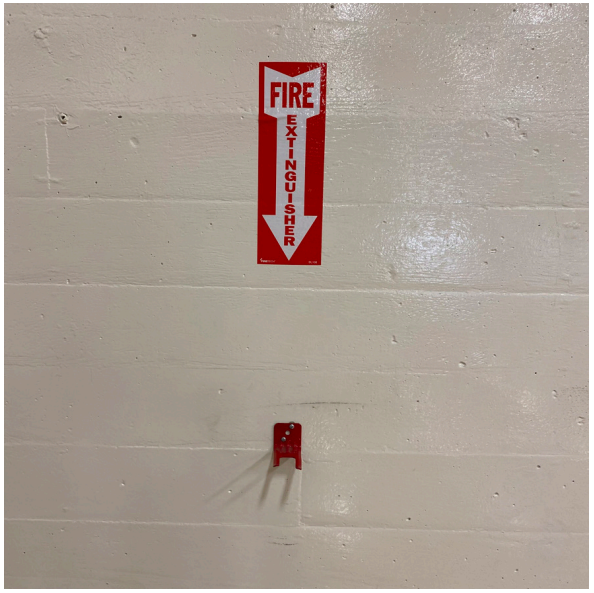
Wall panels peeling in room 133

Fire extinguisher is missing in 312, 312B, 24, Bldg 20 Corridor, Tuttle Gym

Fire extinguisher is missing in Green, dressing costume rooms
