AHERA 6-Month Surveillance Inspection Form

School/Building Name: Kyrene de la Mariposa Science Academy

Kyrene Mariposa Science Academy – 6 Month Surveillance March 11, 2026 & October 15, 2026

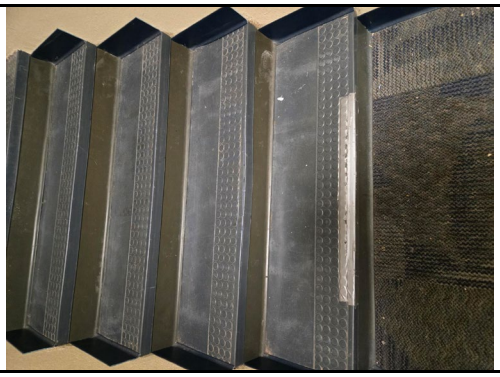
White w/ Gray & White w/ Black 12" x 12" VCT Flooring & Mastic(s)

Blue Stair Tread & Mastic

Black Stiar Tread & Mastic

Tackboard
