AHERA 6-Month Surveillance Inspection Form

School/Building Name: Kyrene del Milenio Elementary School

Date of Surveillance: October 14, 2026

Kyrene Del Milenio Elementary School – 6 Month Surveillance March 10, 2026 & October 14, 2026

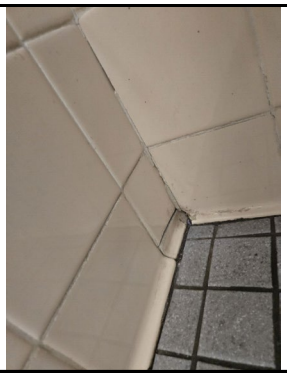
Black Stair Tread

Room/ Area	HM #	Material Description	Friable? (Y/N)	Damage Observed	Action Needed
MPR Back Stage Stairs	26/270	Black Vinyl Stair Tread	No	Broken	Remove/Replace or Enclose/Encapsulate
Restroom (near Media Center & MPR)	40	Beige 4” x 4” Ceramic Cove Base Tile	No	Cracking	Remove/Replace or Encapsulate
Wing C – Boy’s RR Custodial Closet	48	Pipe Insulation with White Wrap	Yes	Tearing/Fraying	Enclose
Wing C Custodial Room	49	White with Gray Specks 12” x 12” VCT & Mastic	No	Broken/Cracking	Remove/Replace or Encapsulate
Girls Restroom (near Room 30)	37	Gray 4” x 4” Ceramic Wall Tile	No	Broken/Cracking	Replace or Encapsulate
Restrooms Throughout	41	Gray w/ White Specs 2” x 2” Ceramic Floor Tile	No	Broken/Cracking	Replace or Encapsulate
Room 22	N/A	Tackboard	No	Torn	Replace or Encapsulate
