Regarding: Electronic Radon Monitor Results
Vernon Elementary School
2044 NE Killingsworth Street
Portland, Oregon
Apex Project 25012092

Radon Inspection Report

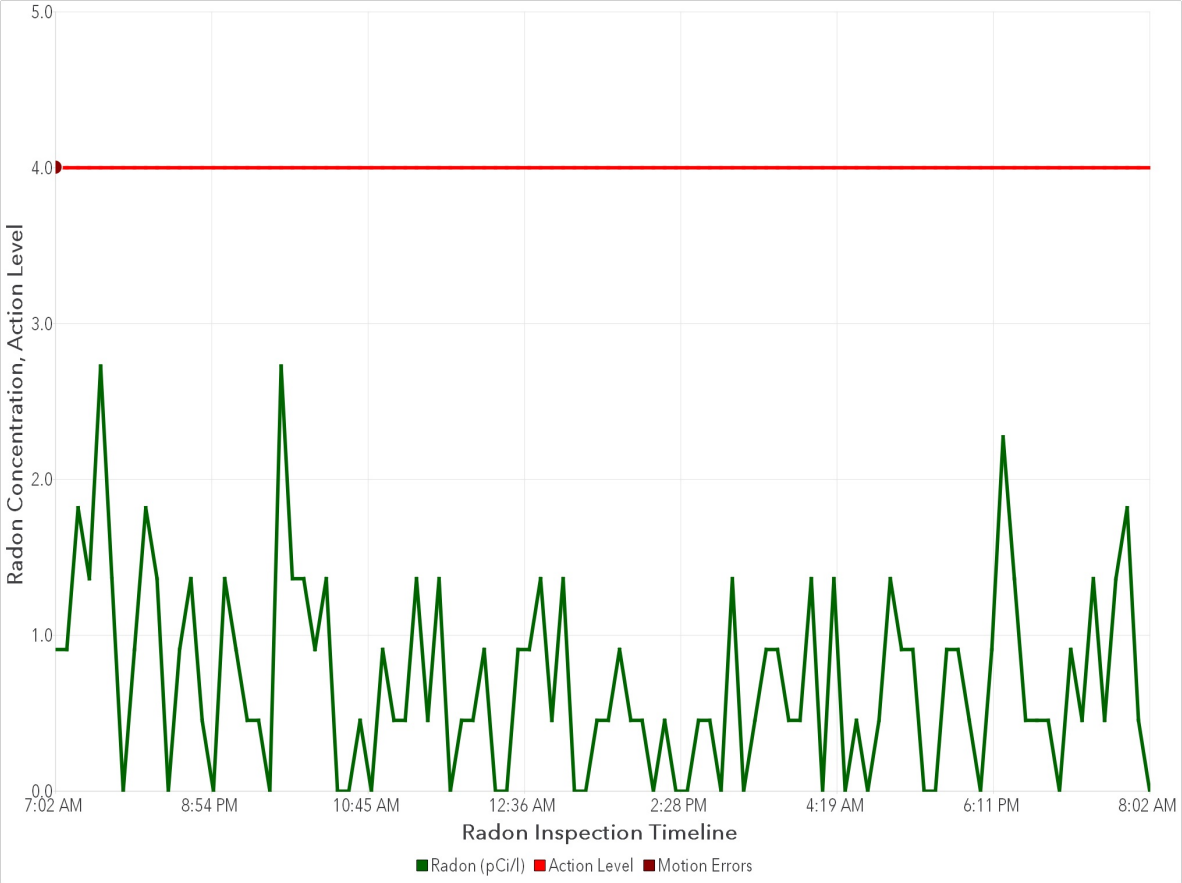
CRM Location:	Start	Stop	Interval	Duration
Room 116	10/26/2026 06:02 AM	10/30/2026 08:02 AM	1 hr	98 hr

Test Result: Pass

Overall Average:
0.7 pCi/l

EPA Average:
0.7 pCi/l

*First 4 hrs of data excluded	Min	Max	Average	Units
Radon Concentration	0.0	2.7	0.7	pCi/l

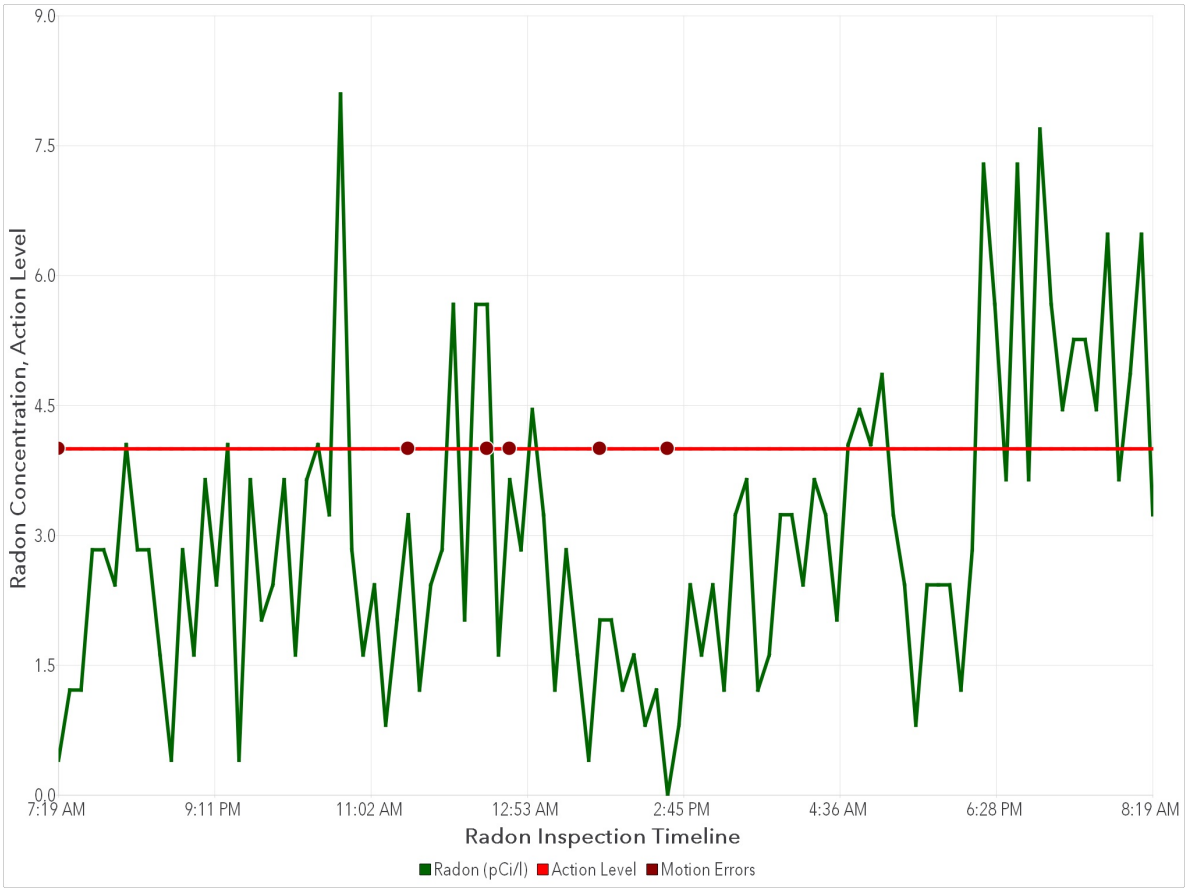
CRM Location:	Start	Stop	Interval	Duration
Basement Staff Room Near Cafeteria	10/26/2026 06:19 AM	10/30/2026 08:19 AM	1 hr	98 hr

Test Result: Pass

Overall Average:
3.0 pCi/l

EPA Average:
3.1 pCi/l

*First 4 hrs of data excluded	Min	Max	Average	Units
Radon Concentration	0.0	8.1	3.1	pCi/l

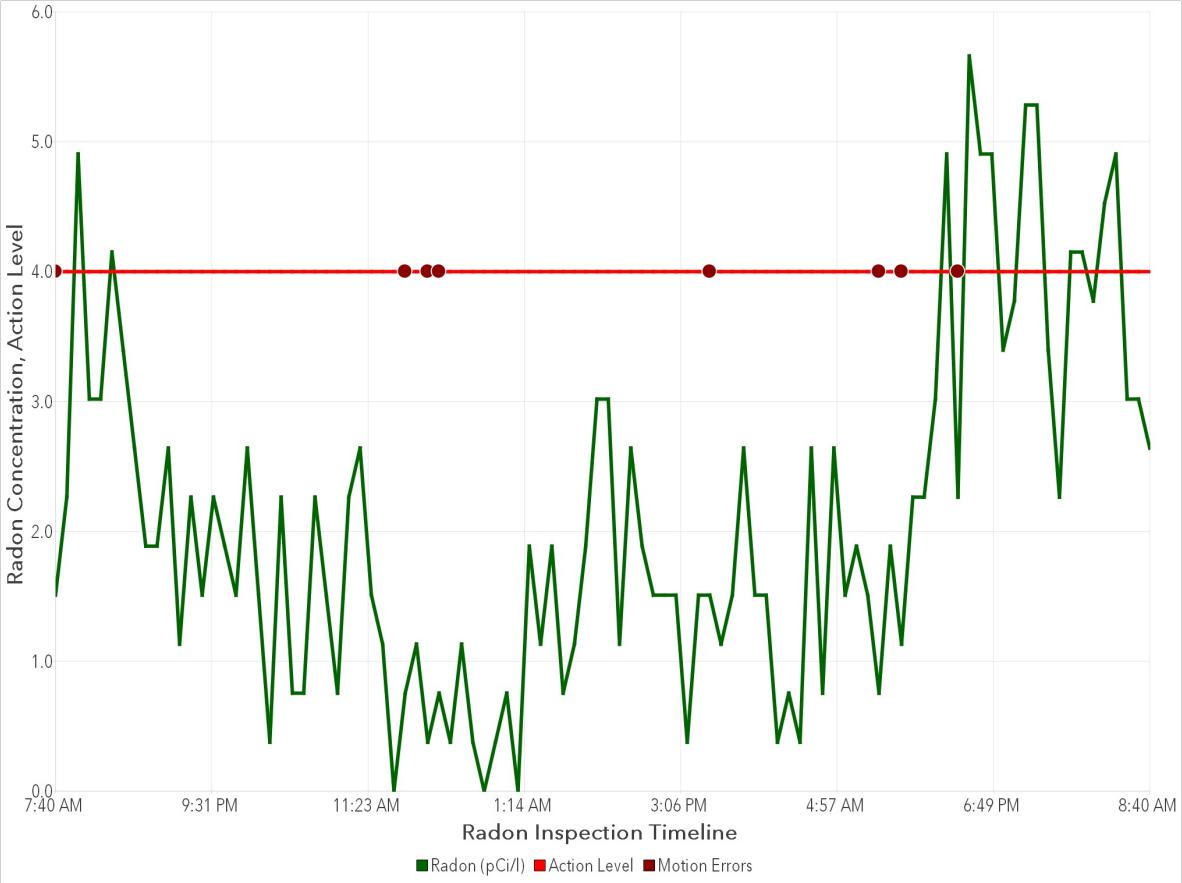
CRM Location:	Start	Stop	Interval	Duration
Multipurpose Room	10/26/2026 06:40 AM	10/30/2026 08:40 AM	1 hr	98 hr

Test Result: Pass

Overall Average:
2.1 pCi/l

EPA Average:
2.1 pCi/l

*First 4 hrs of data excluded	Min	Max	Average	Units
Radon Concentration	0.0	5.7	2.1	pCi/l
