# PROPERTY CONDITION ASSESSMENT

MAINE SCHOOL OF SCIENCE & MATHEMATICS DORMITORY  
77 HIGH STREET  
LIMESTONE, MAINE

ECS PROJECT NO. 50:1008

JANUARY 20, 2019

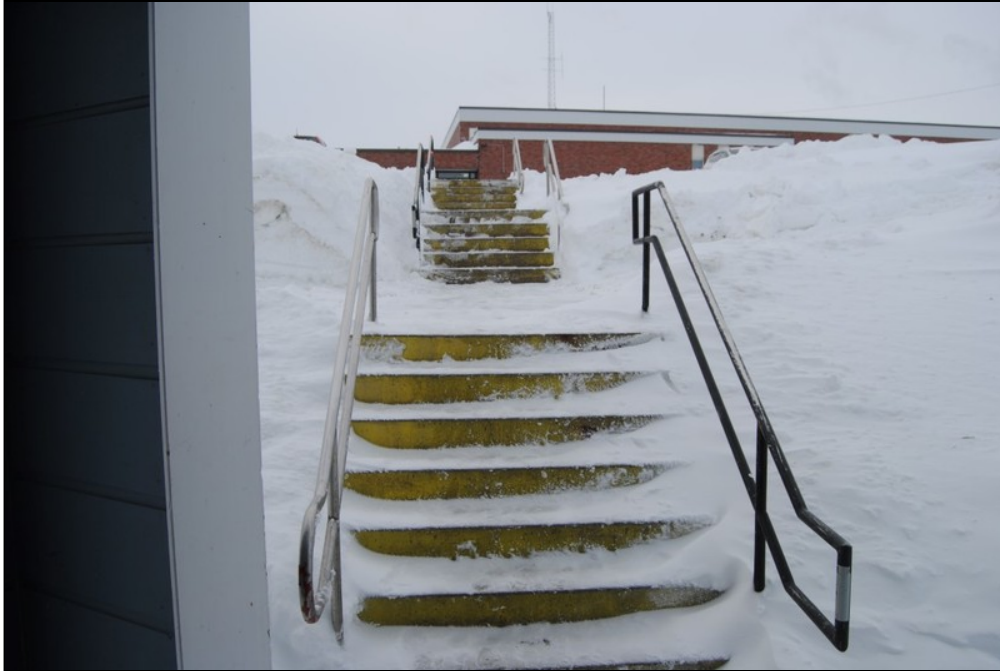
9 - south entrance stairs

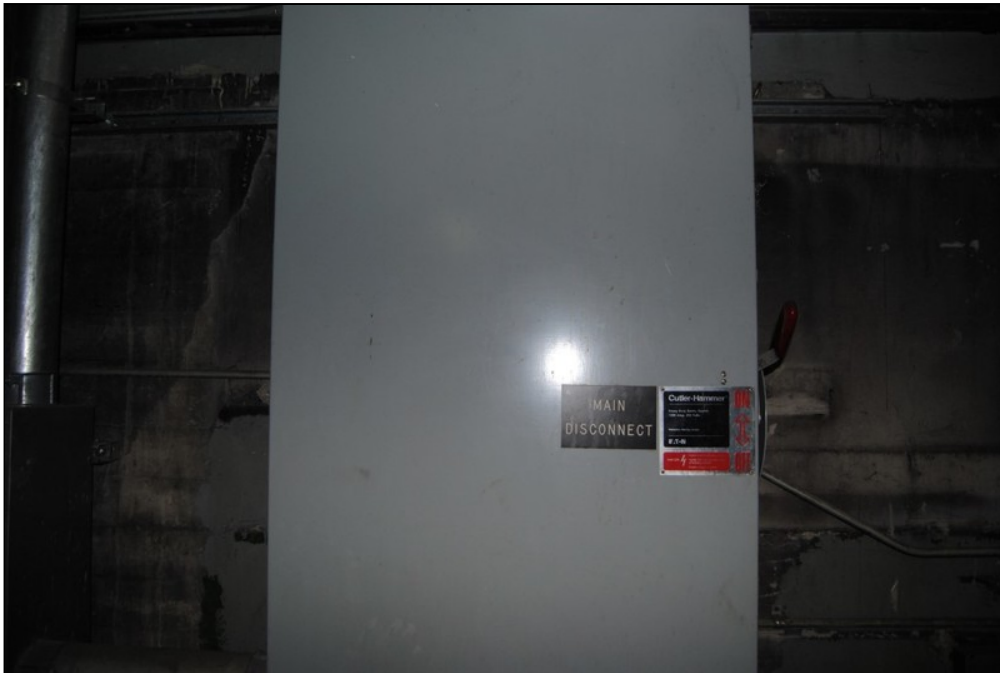
20 - main switch gear

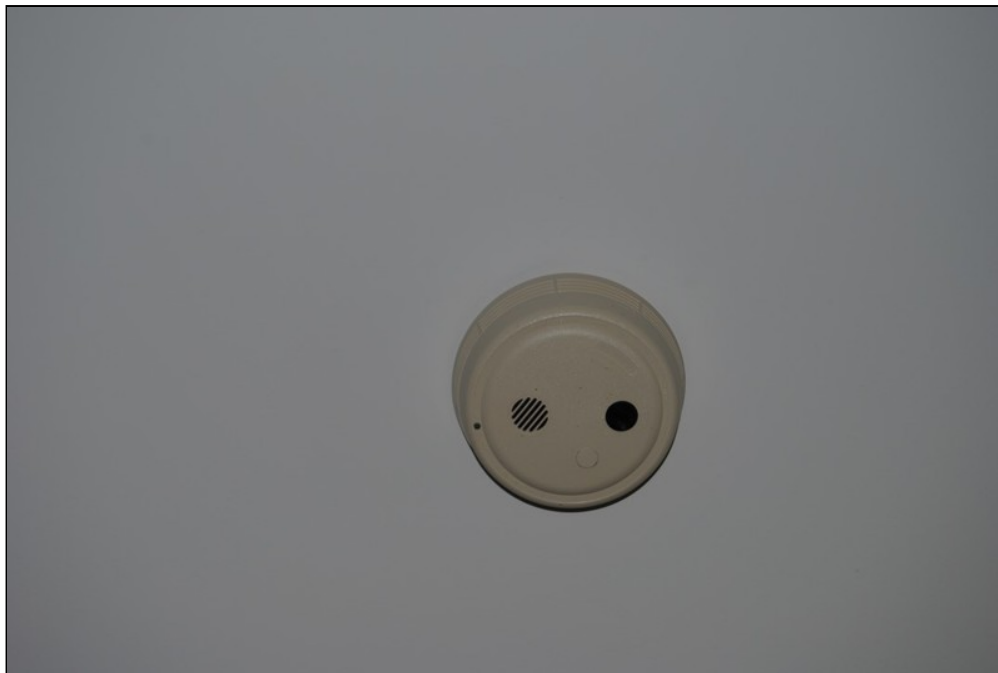
36 - room smoke detector

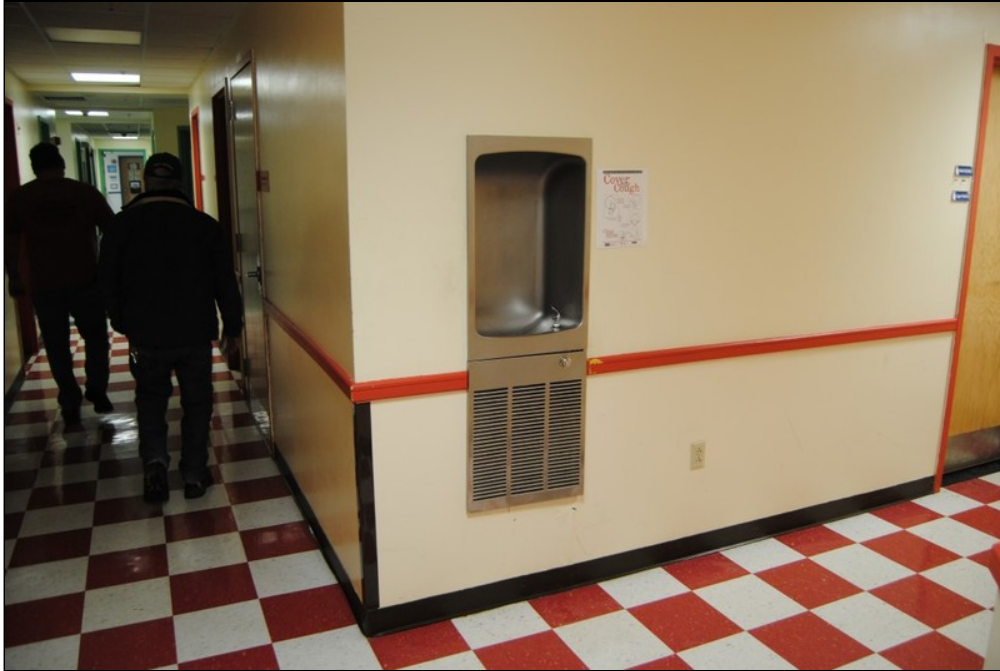
45 - non-ADA water fountain

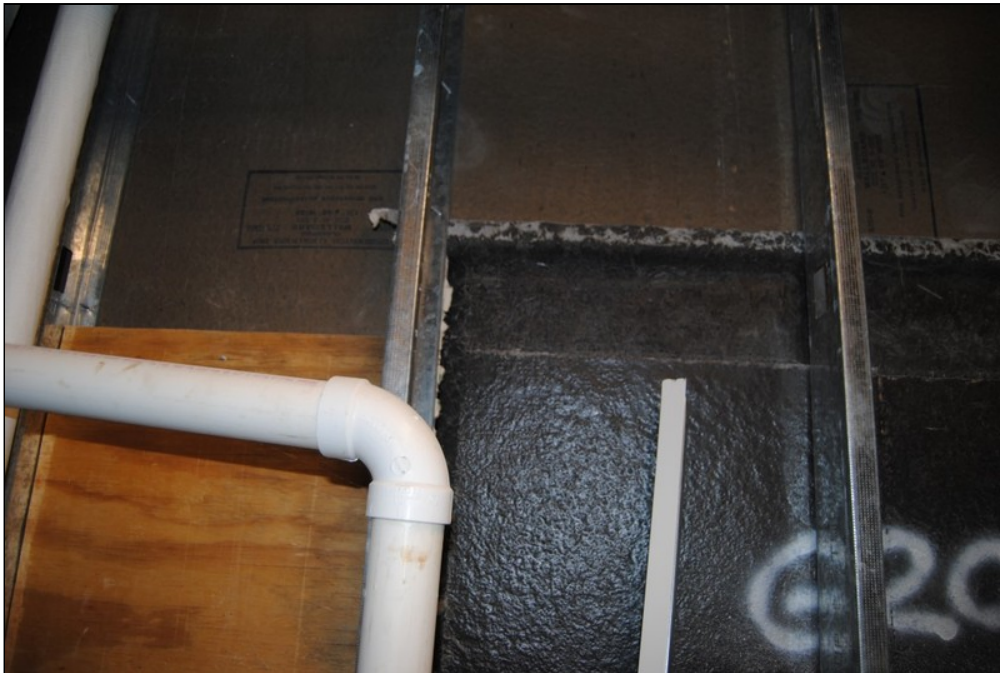
52 - interior wall framing

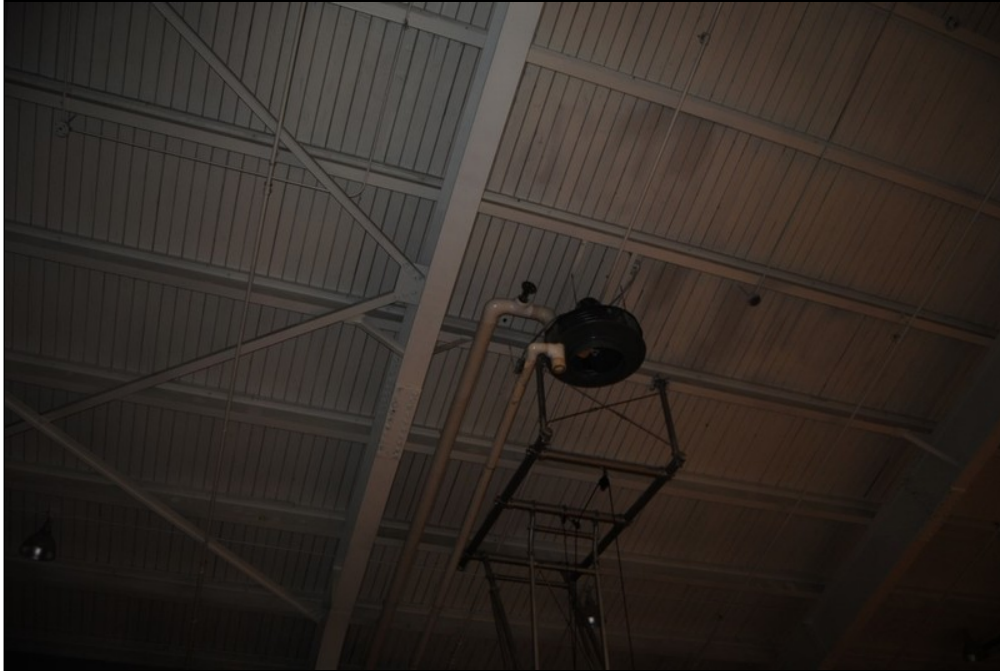
55 - ceiling space heater

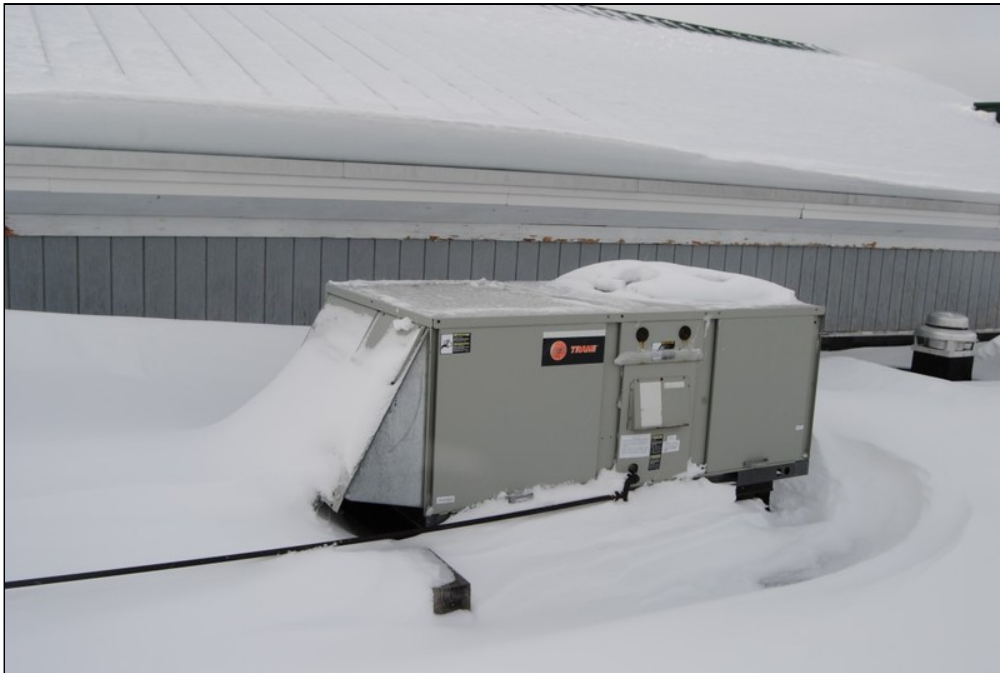
60 - roof top unit

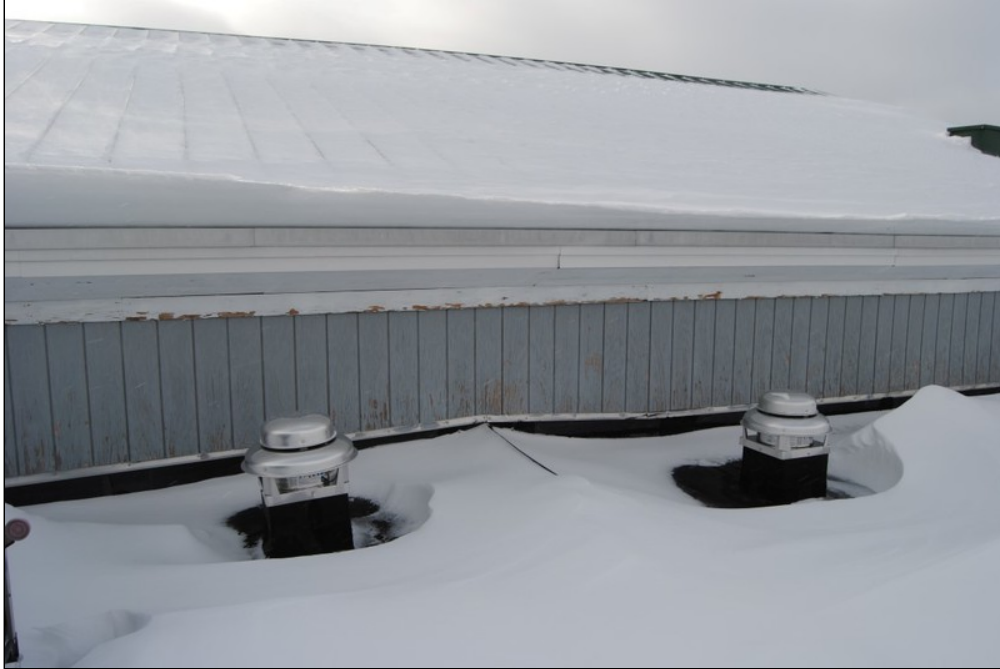
61 - roof top vents
