ELKHART LAKE - GLENBEULAH SCHOOL DISTRICT

DRAFT MASTER PLAN—FACILITIES ASSESSMENT REPORT

PRA Project No. 220066 | February 20, 2023

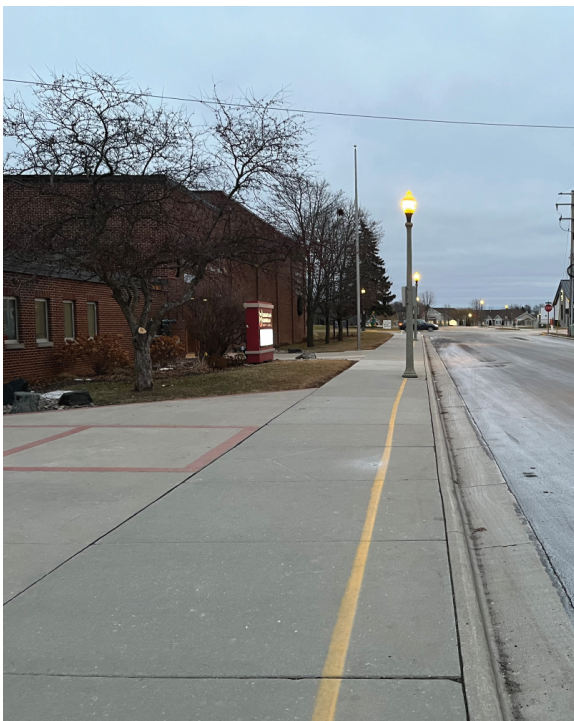
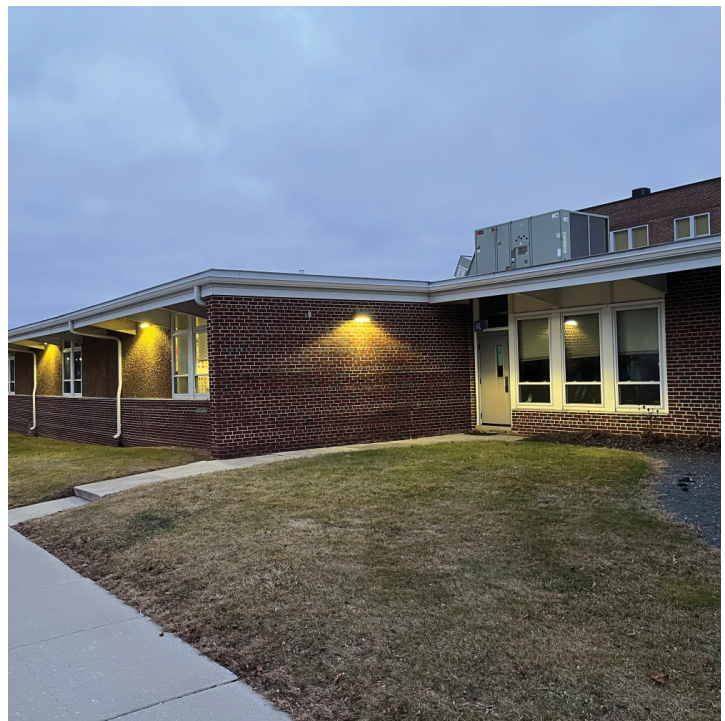
Updates to the exterior of the building have been made in the past when necessary. A few deficiencies are present with sidewalks, asphalt, and landscaping. Areas of the building materials are deteriorating around the perimeter.

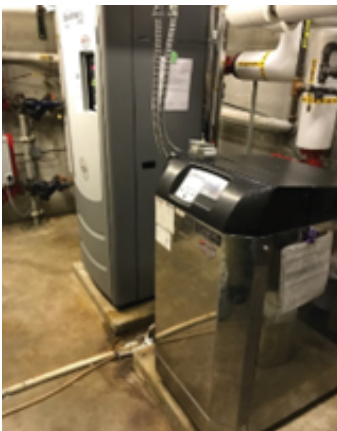
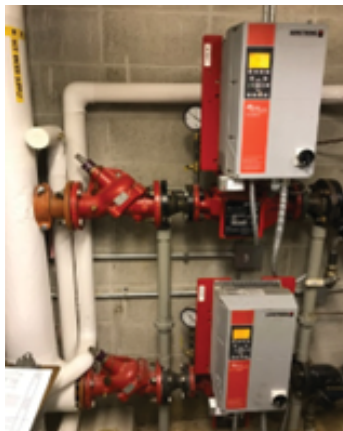
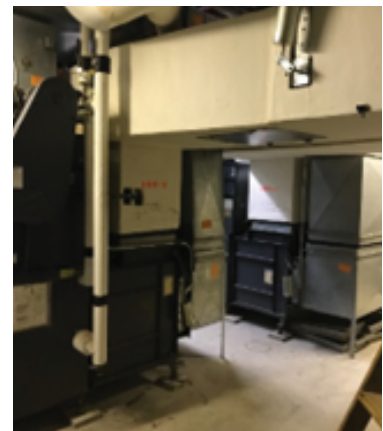
This facility includes multiple areas that are designed and operating as heating and ventilation only systems. Other areas of the building have been upgraded to include air conditioning.

Indoor air handling units No. 1 & 2 were added through the 1989 building addition and renovation project. These units provide heating and ventilation only. All control devices for these units are pneumatic. These units have been well maintained and are in fair operating condition after 30+ years of service.

Air handling unit No.3 provides heating, ventilation and air conditioning to a portion of the 1989 building renovation project. All control devices at this unit are pneumatic. This unit is accessible only through removal of ceiling tile. Facility operating staff indicated that frequent service and repairs are required for this equipment.

The ductwork distribution systems connected to the facility air handling systems are constructed of sheet metal. Ductwork joints, seams and connections are not all sealed properly causing conditioned air leakage into the ceiling cavity.

Remove and replace all pneumatic controls with direct digital control equipment and devices wired into the building automation system.

Remove and replace existing indoor air handling unit No.3 and the connected roof mounted air cooled compressor condensing unit located on roof above as part of any upcoming facility renovation or equipment upgrade project.

Existing HVAC system distribution ductwork should be sealed and insulated to present code requirements during the time of equipment replacement.

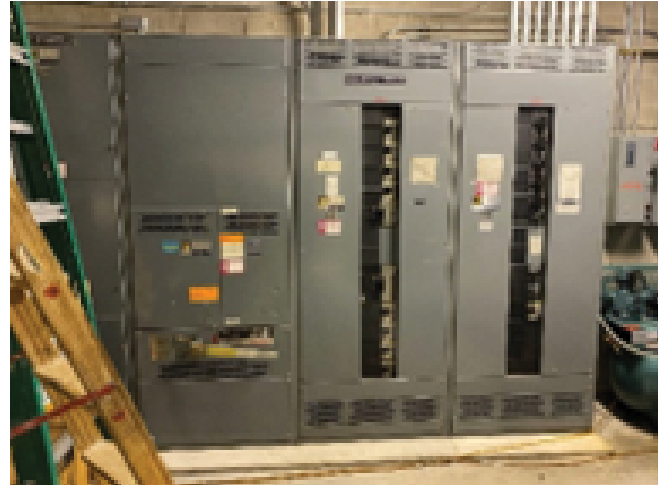
There are numerous age classes of panelboards throughout the facility with the majority of them being Square D NQOD type panelboards. These panelboards date to the 1989 building improvement project. These panels appear to be in fair condition.

There are also Square D NQ type panelboards that were recently installed, in general have room for additional breakers and are in good condition.

The Cutler Hammer Loadcenters and Square D NQOD type panelboards are nearing the end of their useful lives and should be replaced based on their age and condition.

Provide new replacement panelboards in each of these locations.

The Square D NQ type panelboards are in good condition and can remain. Add to the existing panelboards as necessary.

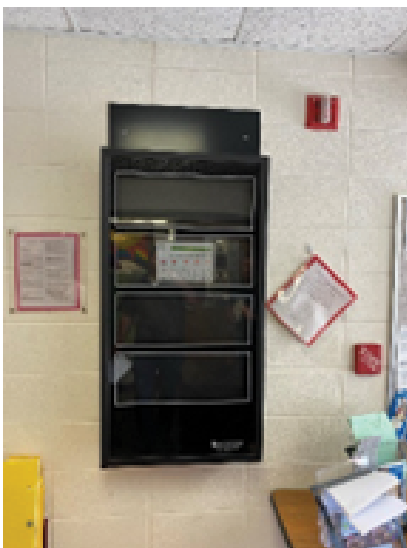
The existing clock system contains numerous, old 24V Franklin clocks throughout the facility. Staff indicated that the existing 24V clock system is failing.

We recommend replacing the existing clock system with a new wireless master clock system with a GPS receiver or an IP based master clock system.

Replace all hard wired synchronized clocks with battery or 120 volt powered GPS clocks.

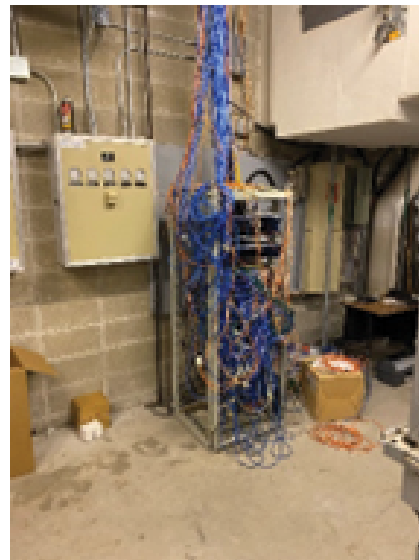
We noted numerous areas where data cabling was not properly supported above the ceilings and was laying on ceiling grid. Provide support for all data cabling above ceilings throughout the facility.

added in future renovation or addition projects, all non-plenum cabling would be required to be replaced with plenum cabling.

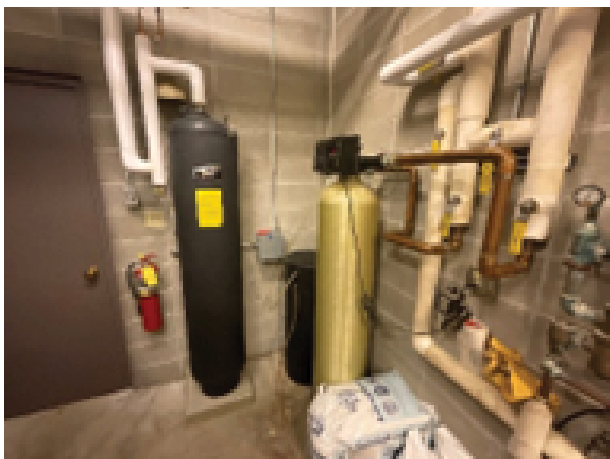
galvanized piping system is near its service life expectancy and PVC is in fair condition.

The building has a grease interceptor that serves the kitchen fixtures and equipment. It is in fair condition.

The building has an acid neutralization basin that serves the science room fixtures. Currently it is being by-passed. It is in fair condition.

The building has a sanitary ejector basin and pump that serves the lower level. It is near its service life expectancy.

Replace the lime stone chips and acid neutralization basin. Provide further investigation for any piping issues upstream of acid neutralization basin.

Provide new sanitary ejector pumps and inspect basin for leaks. Replace basin as if leaks are found.

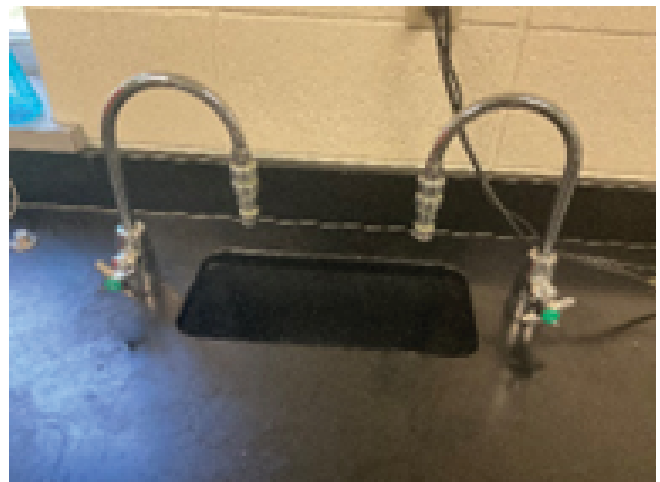
No emergency eyewash was not observed to be in science room.

No emergency shower was not observed to be in science room.

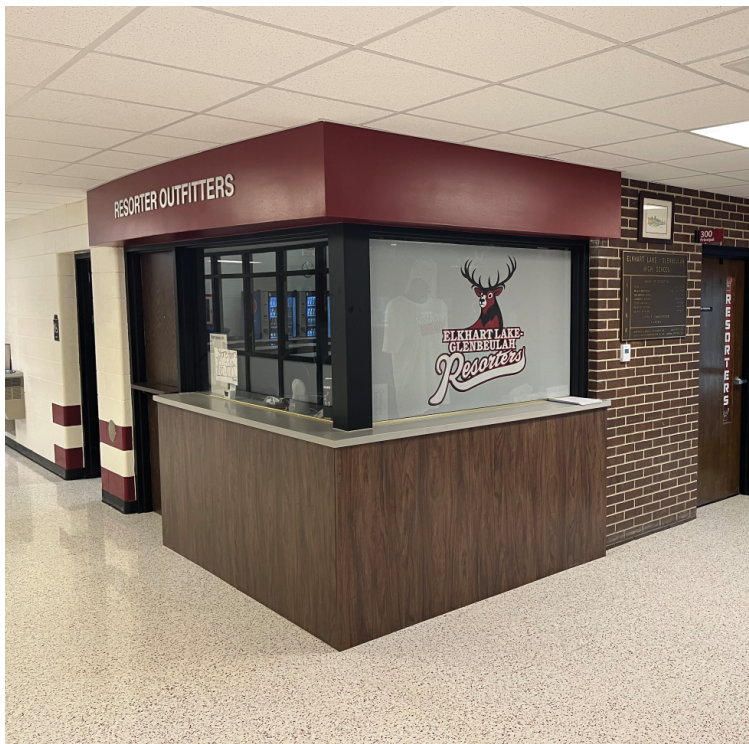
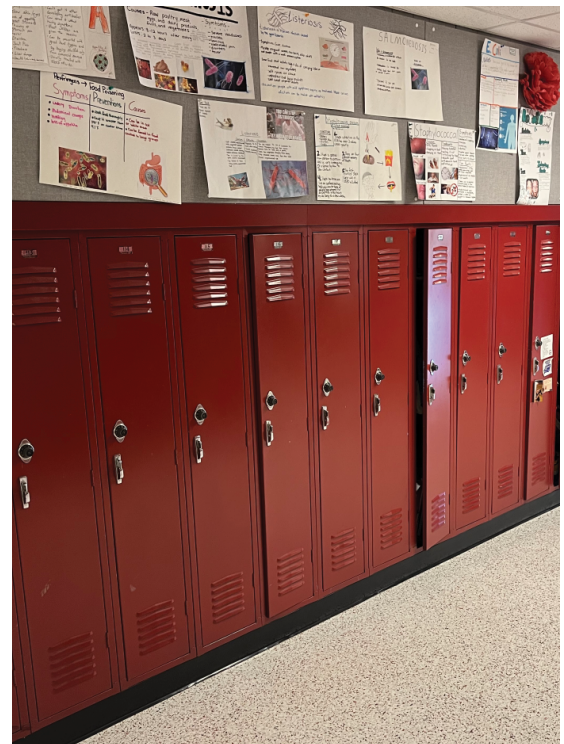
The interior of the building is very well maintained and several material replacements have been completed and have been appreciated by the staff. It would be recommended to complete material replacements. It was reported that the lockers should be replaced. Several components of the building are original and in fair condition. It is recommended for replacement or refinish.

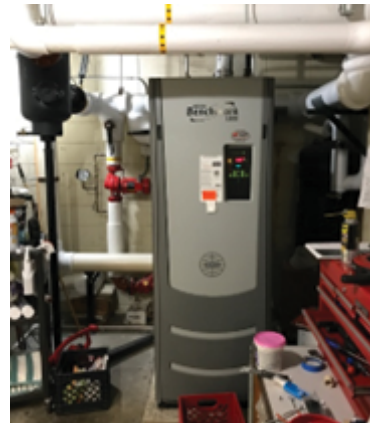
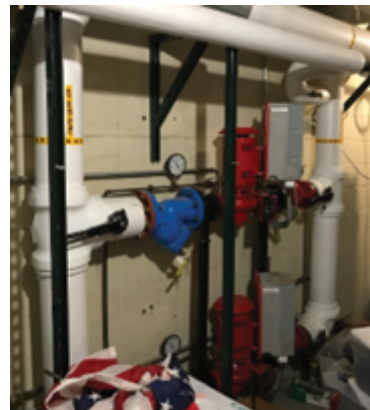
Heating water supply and return piping is in good condition.

Hot water supply and return piping insulation is in good condition.

Existing valves and other hot water specialties installed during the 2015 building upgrade project are in good operating condition.

The existing boilers and pumps are in good operating condition.

The existing boiler plant should operate for several years without excessive service and repair required.

Provide regular testing of the hot water distribution system. Add chemical treatment and corrosion inhibitors as required to maintain recommended water quality standards for: pH, Conductivity, Hardness, chlorides, etc.

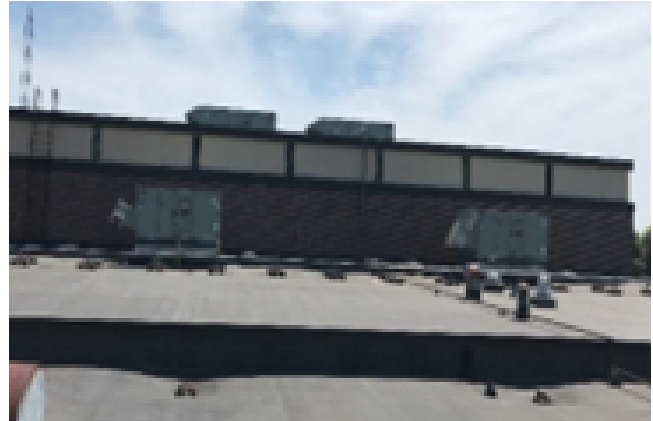
A 2015 building renovation and equipment upgrade project removed (6) existing packaged rooftop heating, ventilation and air conditioning systems and replaced them with Variable Air Volume (VAV) packaged rooftop units.

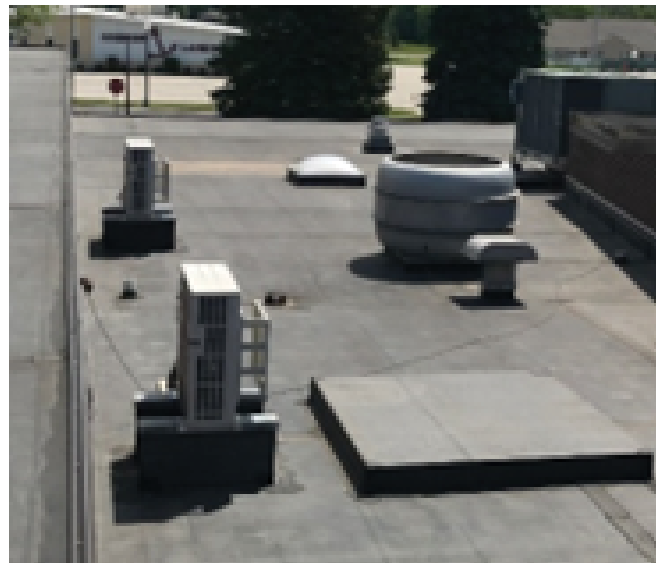
The Kitchen area received (2) Mitsubishi Electric ductless split system air conditioning units as part of the 2015 project. Controls for the kitchen area cooling units are standalone electronic and not included on the building temperature controls system. These systems utilize refrigerant type: R-410A.

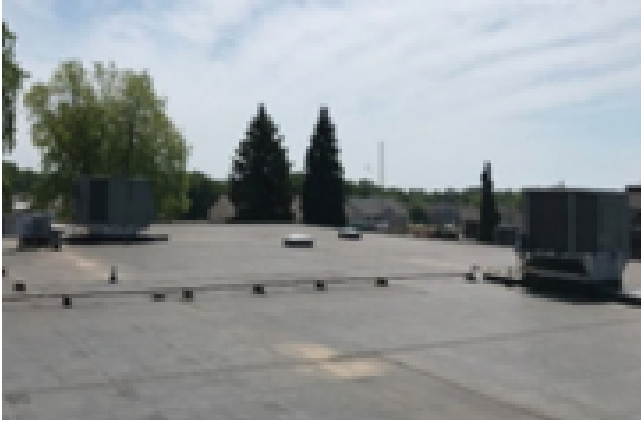
A 2019 building renovation and equipment upgrade project removed the facilities remaining (5) existing packaged rooftop

heating, ventilation and air conditioning systems that were not upgraded in 2015.

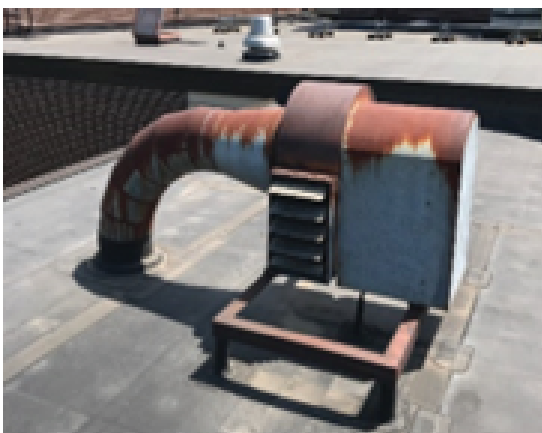
Welding booths and welding exhaust fans are present. The exhaust fan and make-up air system for technical education welding are in average / poor operating condition. These systems have exceeded their anticipated service life.

Any future expansion or renovation to the technical education welding program should include equipment upgrades to the exhaust and natural gas fired make-up air systems.

System replacement is suggested as a low

priority item when funding is available, when frequent service and maintenance become necessary or at the time of equipment failure.

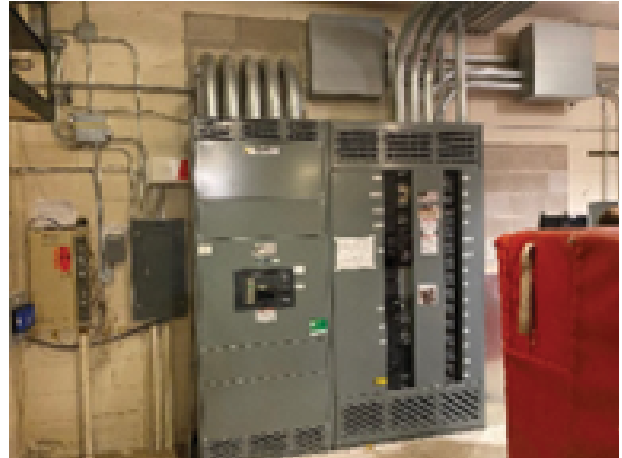
No surge protective device was found for this service.

Both existing main electrical services to the facility buildings appear to be in good condition, have room for additional breakers and can remain. Add to the existing services as necessary.

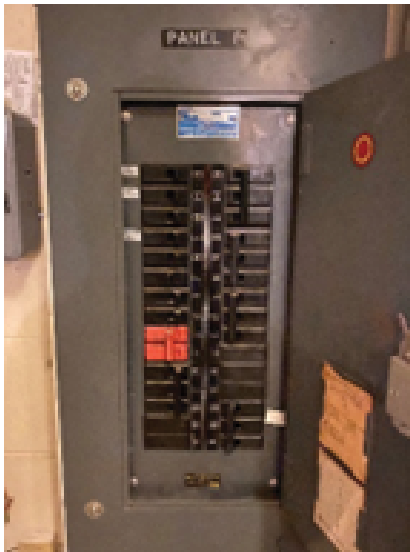
There are numerous age classes of panelboards throughout the facility with many of them being very old. The oldest panelboards in the building are ITE type panelboards as well as Square D QO Loadcenters. These panels are over 30 years

old and are at the end of their useful life. Additionally, there are numerous Square D NQ type panelboards that were recently installed, in general have room for additional breakers and appear to be in good working condition.

The panels older than 30 years are at the end of their useful life and should be replaced based on their age and condition. Provide new replacement panelboards and new feeders in existing conduit in each of these locations.

The Square D NQ type panelboards are in good condition and can remain. Add to the existing panelboards as necessary.

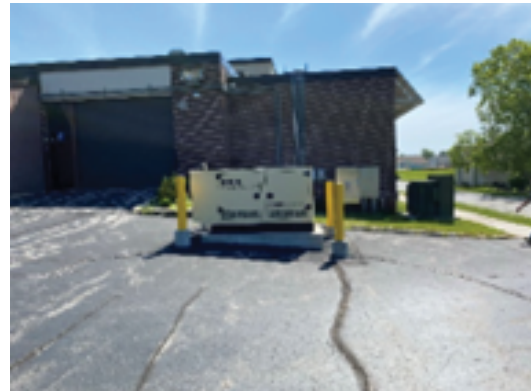
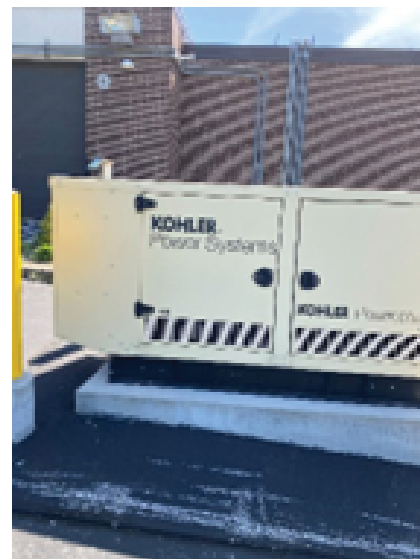
The generator is located outside on the west side of the building. The generator was installed in 2014 and appears to be in good condition.

The generator feeds two Kohler transfer switches. The two transfer switches separate life-safety from non-life-safety loads.

The life-safety transfer switch feeds a 70A 120/208V panelboard. The non-life-safety transfer switch feeds a 225A 120/208V panelboard. Both emergency panelboards contain a Mersen surge protective device.

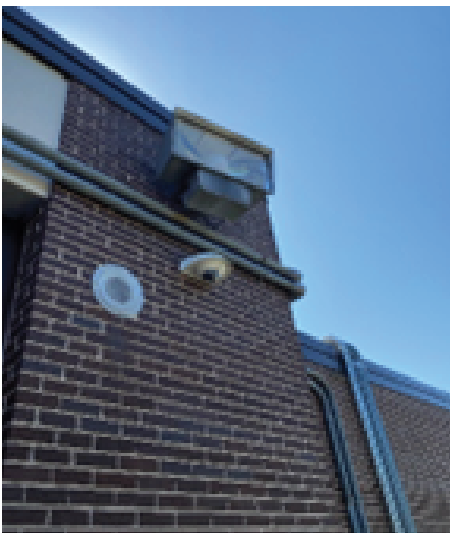
A few very old T12 fluorescent type and incandescent type fixtures remain in some janitorial and maintenance spaces.

The majority of the exterior fixtures are LED type fixtures. Numerous, old wall mounted HID type fixtures remain on the exterior of the building, but do not appear to be operational.

A possible upgrade to all LED interior lighting should be considered with all new occupancy controls and 0-10v dimming.

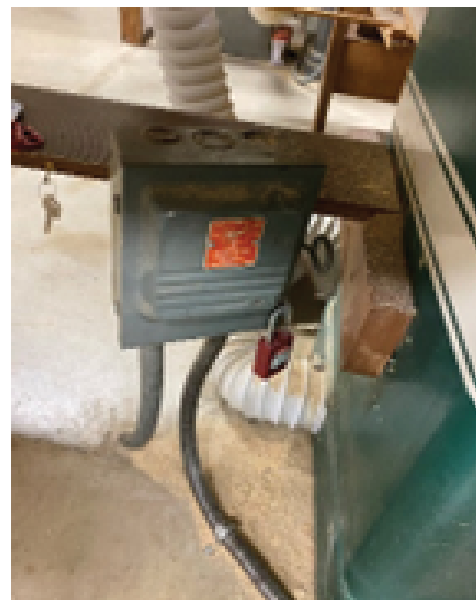
The Floor fed devices and bus duct located in the shop areas are outdated. Consider replacing with cord drops to provide power to the shop equipment.

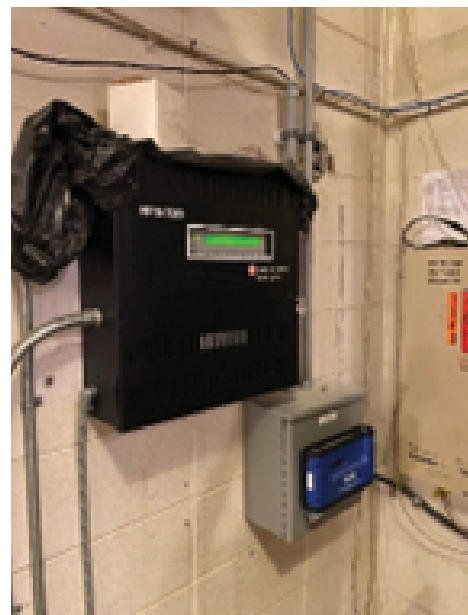
The fire alarm is a Honeywell Notifier addressable system in the facility that dates back to 2014. The head end control panel is located in the lower level boiler room and appears to be in good operating condition.

Ensure that the existing fire alarm devices are properly supported and operational. Repair or replace damaged devices.

Many code updates have been adopted since the time of installation of the existing fire alarm system. A plan for the replacement of the existing fire alarm system in the next 10 years could be considered. The new system would provide a new, code approved voice addressable fire alarm system throughout the entire facility.

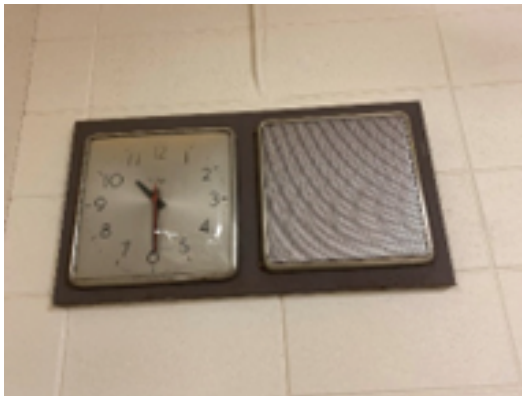
The existing clock system contains numerous, old 120V Simplex and American Time clocks. The clocks are fed off of a Simplex master clock located in the high school office.

Consider replacing the old 120V clocks and head end with a new GPS clock system with all new clocks throughout the facility.

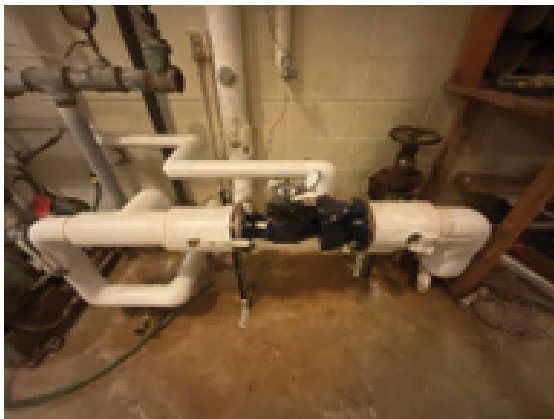
Water Service consists of a 4" Ductile piping supplied by the local municipal water utility with a 3" water meter with bypass piping and valves. It serves the entire domestic water system.

The piping system material is a mix of copper and galvanized steel. The valve types are gate and ball. The copper piping system is in fair condition. The galvanized steel piping system has exceeded its expected service life.

All existing galvanized piping shall be replaced with new insulated copper piping with accessible isolation valves.
