Madison Schools –Comprehensive Assessment Study

Architectural Assessment October 6, 2015

TOWN CAMPUS EARLY LEARNING CENTER

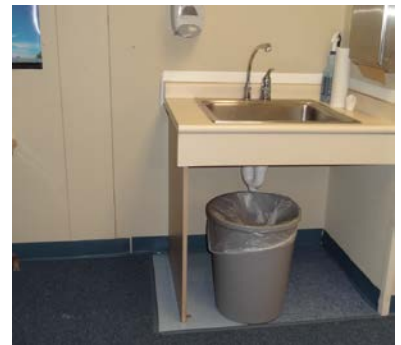
Sink Fixtures - Fixtures on the sinks in the classrooms are not ADA code compliant. Fixtures are required to be no more than 11 inches from the front edge of counter.

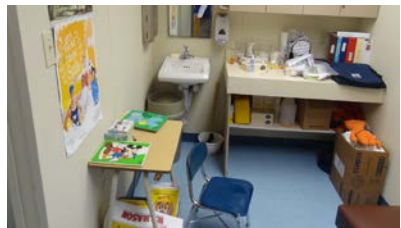
Sink Clearances - Nurses office sink has furniture and trash bin in front of the sink which prohibits access.

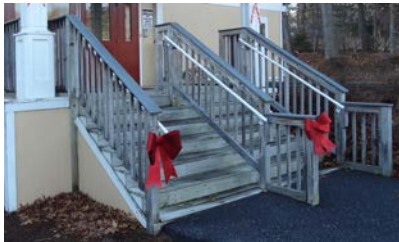
Exterior Stairs and Ramps - Do Not meet current ADA requirements.

- Main Entry stairs and the stairs on the North side of the building exiting Room #1 do not have extensions on the handrails at the top or bottom as required per code.
- Rear Entry on South side and the East side entry near the play yard have a ramp with non compliant handrails. Per code ramps are required to have handrails with extensions at top and bottom of ramp.
- Main Entry ramp does not have handrails. Ramps with a slope great than 1:20 are required by code to have handrails. Verify slope and install handrails if slope is greater than 1:20.

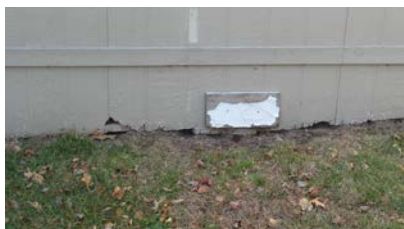
Portable Classroom Modular- The painted wood paneling and trim are in good condition but the wood skirt around modular's is rotting and or stained in multiple areas at grade level. Stairs and ramps to portable classrooms are in good condition but the stairs need a few code upgrades. (See ADA/ Accessibility Section)

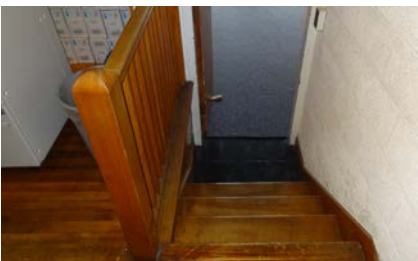
Stage or Platform Stairs - Platform which shares space with the Cafeteria has 4 risers up to the stage. There are no extensions at the top or bottom of stairs as required per current codes.

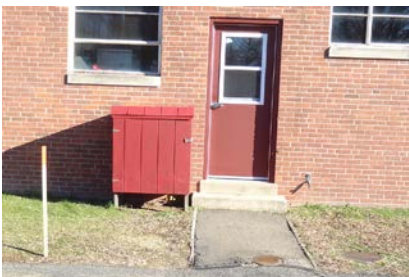
Exterior Doors - Multiple exterior doors exit to a step down area and not a platform or ramp.

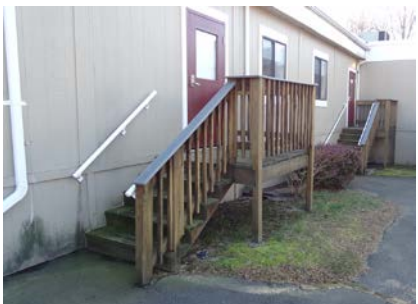
Exterior Stairs - Do not meet current ADA requirements. Rear Entry stair from modular classrooms do not have code compliant hand or guardrails with extensions top or bottom and stairs from Gymnasium do not have any handrails.

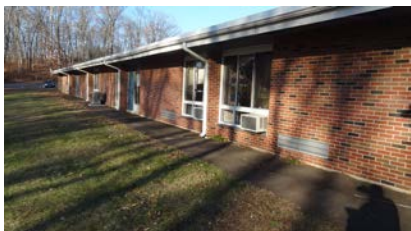
Exterior Walls - The exterior walls of the 1957,63 and 88 structure consist of brick masonry with concrete masonry unit backup. The exterior masonry walls appear to be in good condition showing no significant need of remedial work with the exception of some staining and minor cracks. Again, these can be treated, cleaned and patched to provide a more aesthetically pleasing appearance.

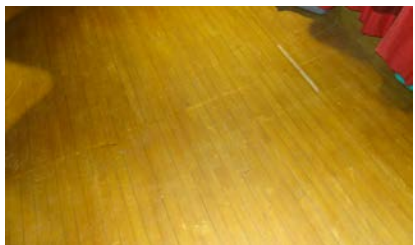
Flooring -Majority of the flooring is carpet and is located throughout the building. These are in fair to good condition. Platform or Stage flooring is a stained wood and is in need of refinishing. A few areas have VCT flooring and are noted in the Hazardous section.

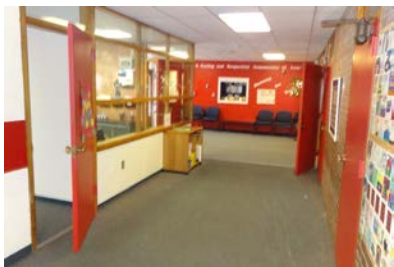
Door Knobs - Multiple doors throughout building have knobs on doors and are not code compliant. Knobs should be removed and replaced with lever type hardware.

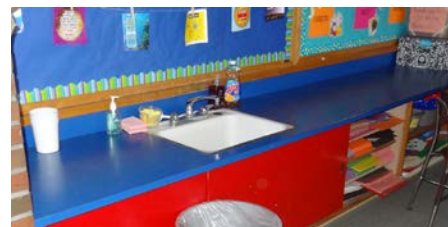
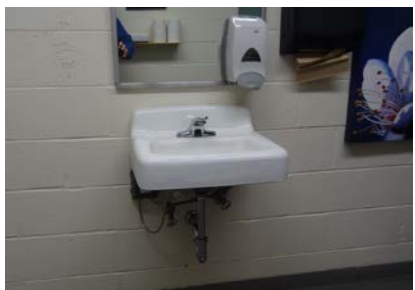
Pipe Insulation - pipe insulation miss below ADA sinks in restrooms and classrooms.

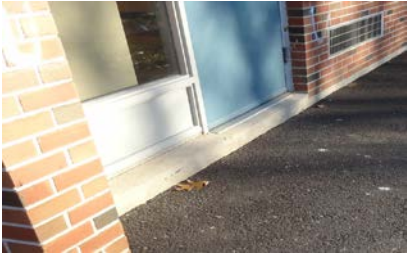
Exterior Doors - Multiple exterior doors, around entire building, exit to a step down area and not a platform or ramp.

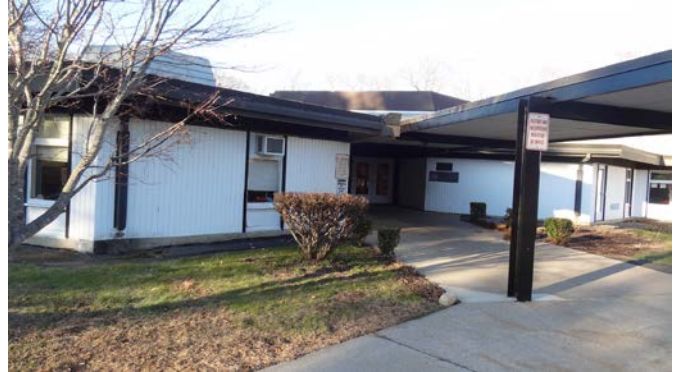
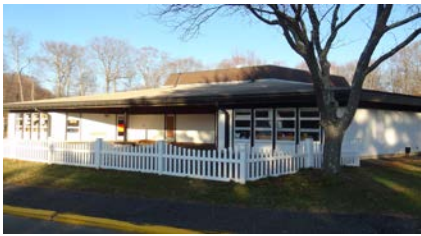
Exterior Walls - Exterior walls are painted block and are in fair to good condition. A few areas around structure are in need of attention. Paint chipping or peeling and need repaired at base of panels below down spouts.

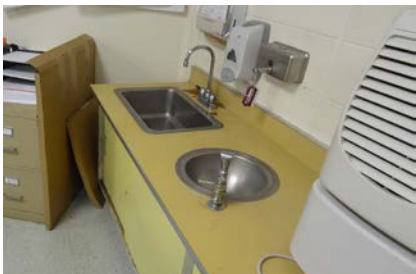
Laminated Casework - The laminate on the casework in almost all classrooms and offices are old and showing signs of age and are chipping or peeling.

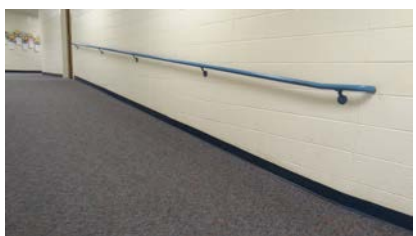
Ramp - Ramps in corridors are steeper than 1:12 which exceeds the maximum slope for means of egress ramps.

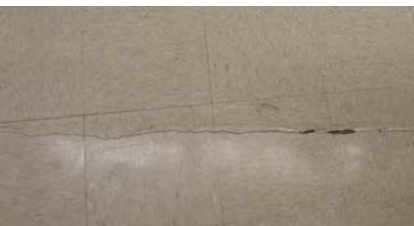
Flooring - VCT flooring in corridors, Classroom and Kitchen are warping, chipping and failing at the edges of the tile. Carpet in classrooms are in good condition.

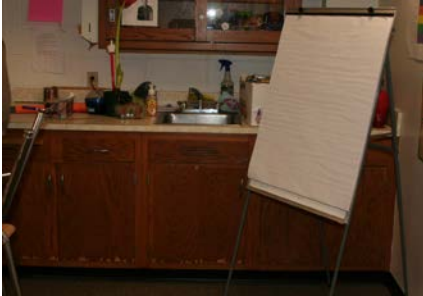
Casework - The casework in almost all classrooms and offices are old and showing signs of age and are chipping.

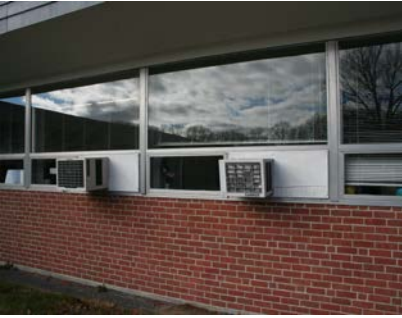
Windows - Existing window units are aluminum framed, single glazed windows and are original. Window AC units also appear to be in poor condition. Painted peeling around wood frame and plywood panel and metal exterior casing is dented or damaged. Glass block windows around Auxiliary Gym are broken and mismatched.

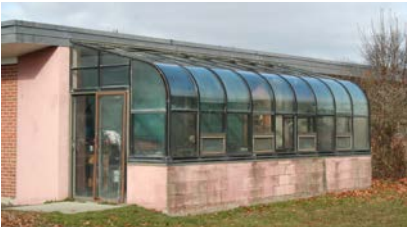
Green House - Painted concrete block at the base of the green house is stained. Sliding screen door on green house is ripped and rusted. Recommend replacing sliding glass door with a more secure door.

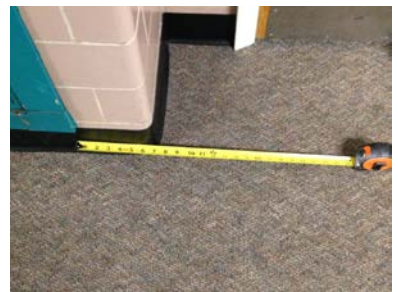
Pull side Door Clearance - Pull side of door on multiple classrooms and misc. closets and restrooms throughout the building do not meet the required clearance of 18" clear. Approximately 25 classrooms and 10 miscellaneous spaces do not meet code.

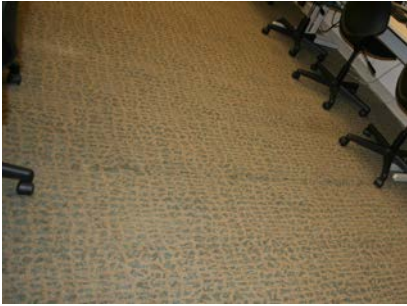
Flooring - Carpet flooring in Classrooms, Media Center, Computer Rooms and Offices areas. Tile flooring in all other spaces with the exception of the shop areas which have polished concrete floors. We were informed that the carpet flooring has been coming apart at seams and has been an ongoing problem. Carpet coming apart at the seams was very apparent in the Media Center and the Computer Room. All other flooring appears to be in good condition.
