# ARCHITECTURAL REVIEW

## Existing Conditions Assessment

# STRUCTURAL REVIEW

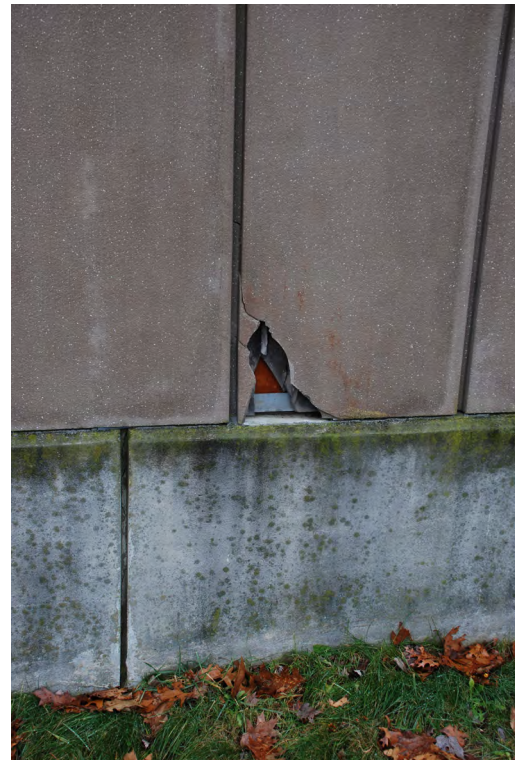
freeze-thaw cycling that has exposed steel reinforcing in some locations, evidence of water staining throughout the building, likely a result of moisture run-off from the adjacent window metals, and organic matter (moss or algae) growing on surface areas of the building where continuous contact with moisture and the surface does not dry frequently (ie. North facing elevations adjacent to trees and vines). Refer to the structural evaluation for additional information.

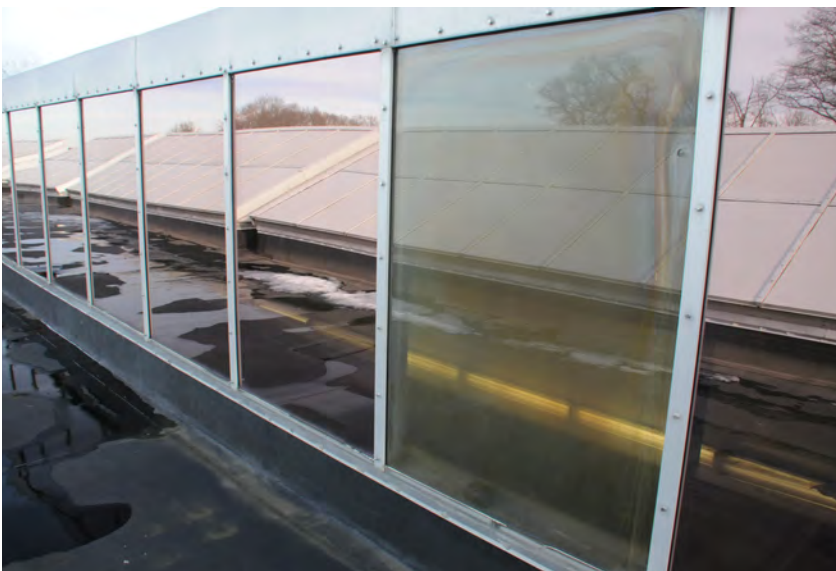
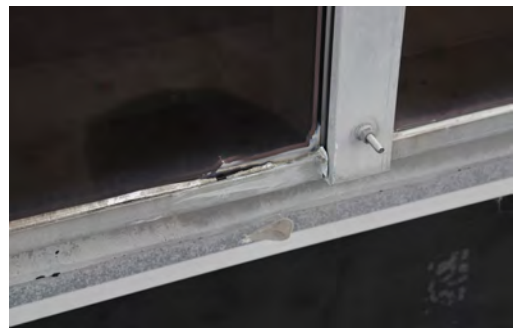
It is evident that the thermal seal of the insulated glass panel has failed in numerous locations and, as a result, the panel has become fogged or condensation has collected over time. As the condensation dries many times over, mineral deposits remain on the interior surface of the glass (between the two layers of glass), resulting in a window that appears constantly dirty, as can be seen in the photo.
