SHAWNEE MISSION HORIZONS HIGH SCHOOL

# **FACILITY EVALUATION**

# SUMMARY

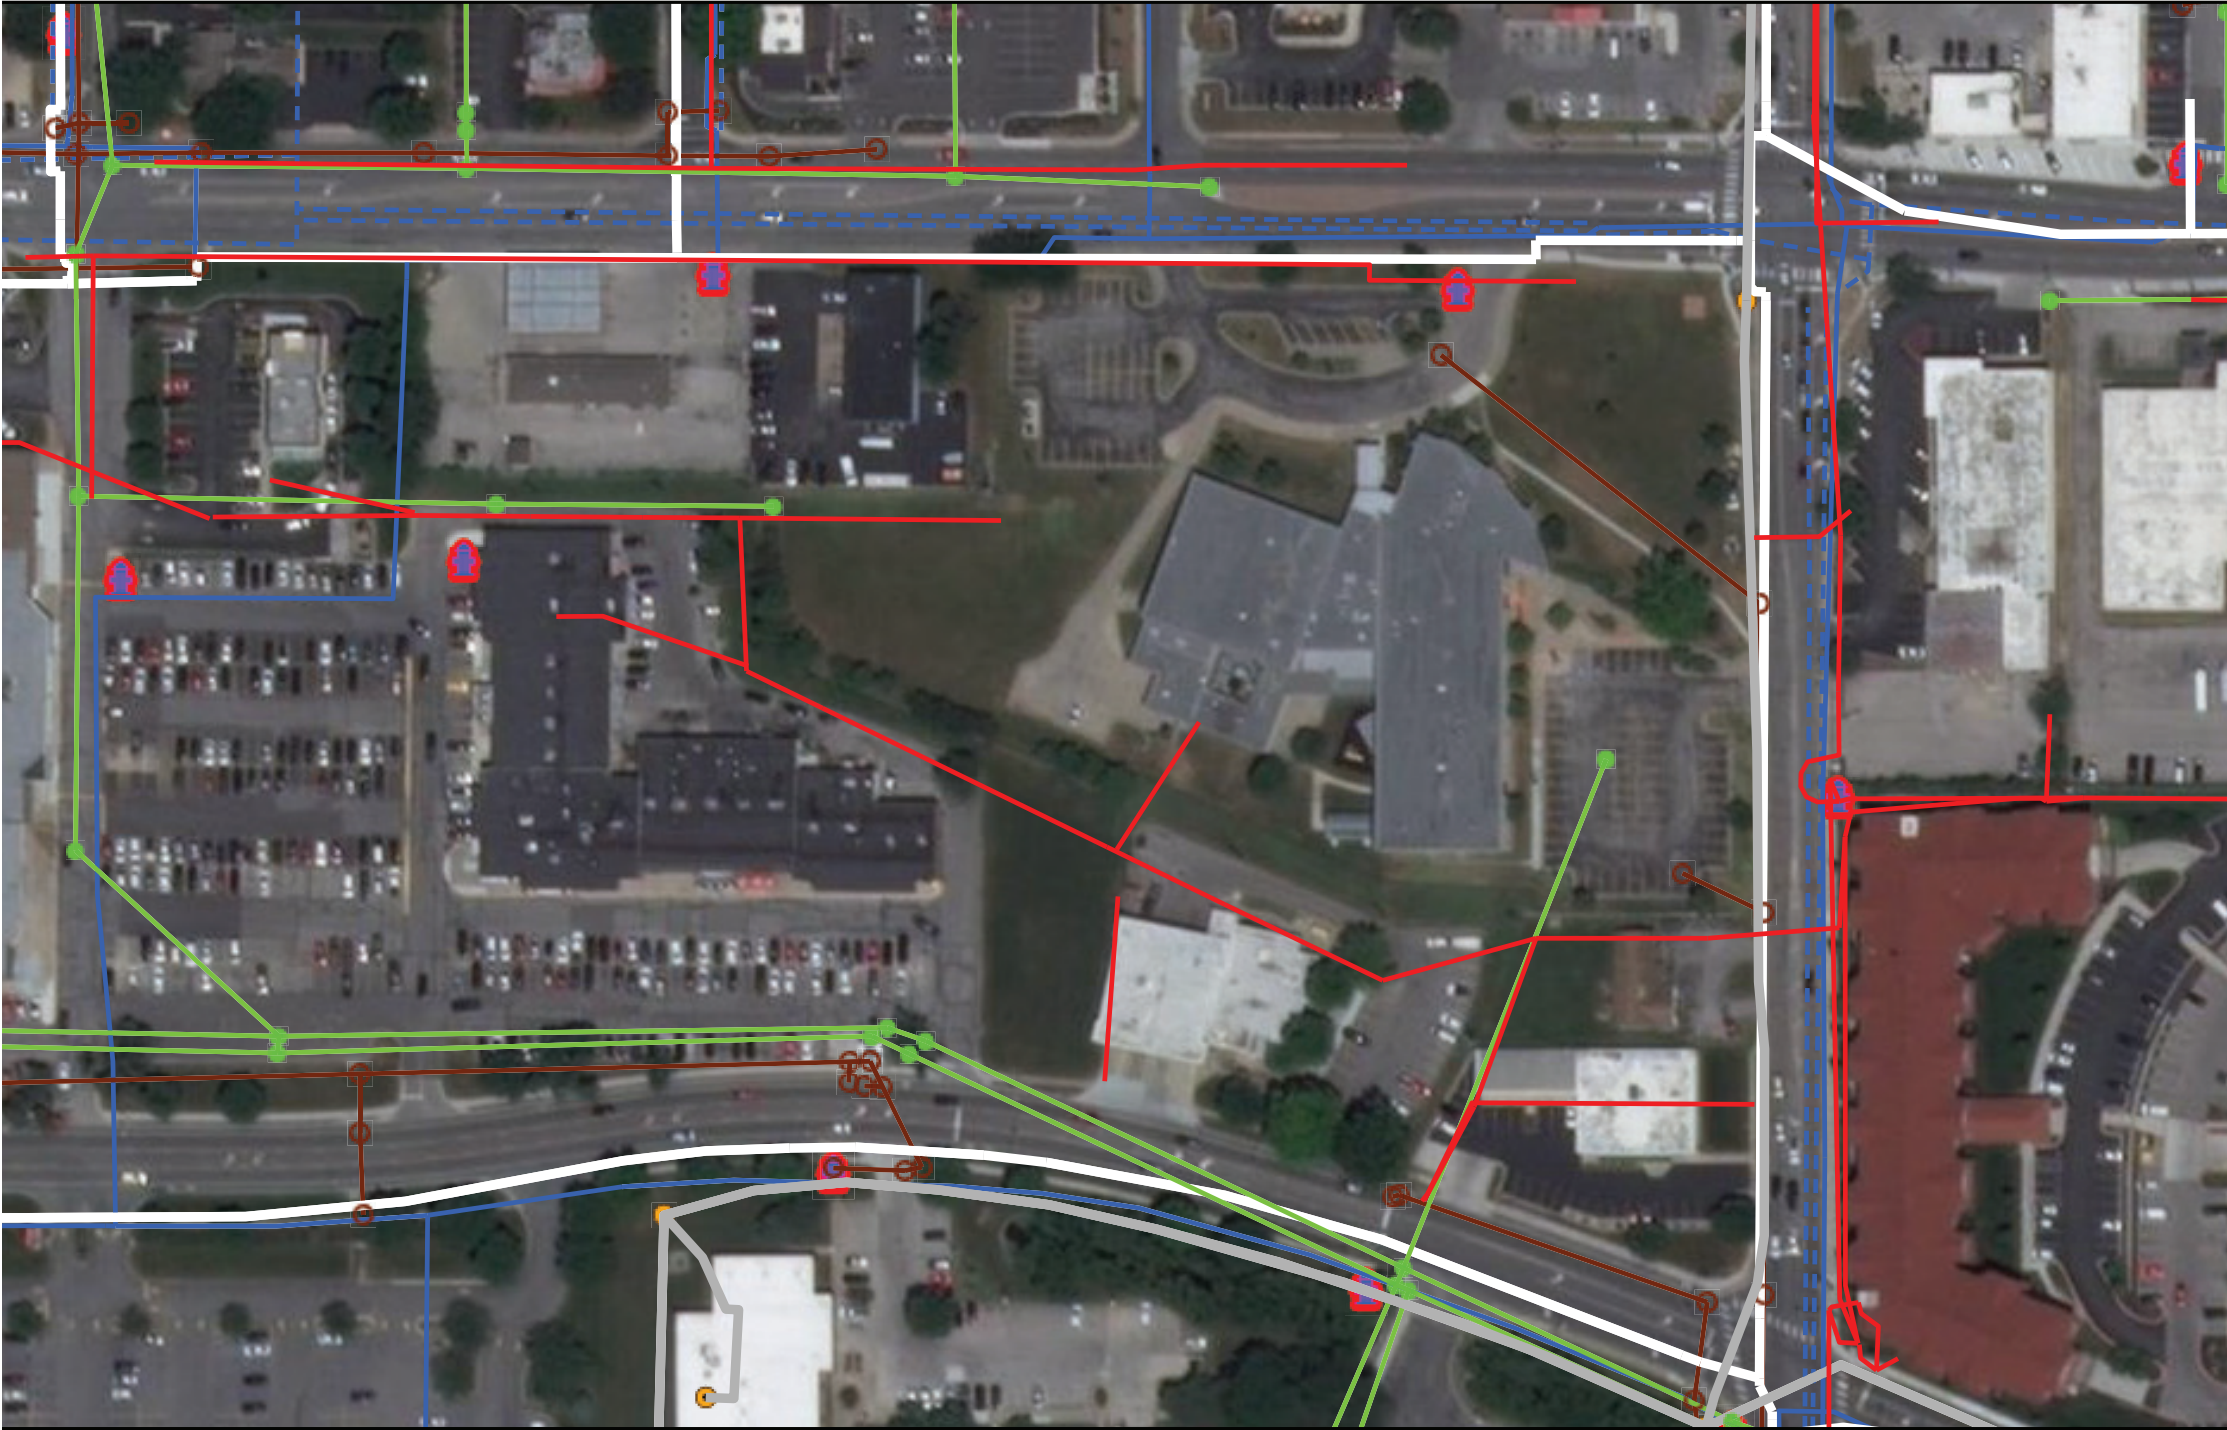
ROOF ASSESSMENT

- Roof Areas**
- Canopy Roof H  
SBS Mod. Bit. Membrane  
2011-2013 (Missing)
  - Roofs A,B,C,D,E  
Tamko 103FR / 394 sq.  
April 2001 (20 year) 2021
  - Roofs G  
Tamko 103FR  
2011-2013 (Missing)
  - Roofs F  
Standing Seam Metal Roof  
2001 (20 year) 2021
