516 FACILITY CONDITION ASSESSMENT ACT EDUCATION CENTER

FACILITY CONDITION ASSESSMENT

17960 Monterey Rd. Morgan Hill, Ca 95037 | adultschool.mhusd.org

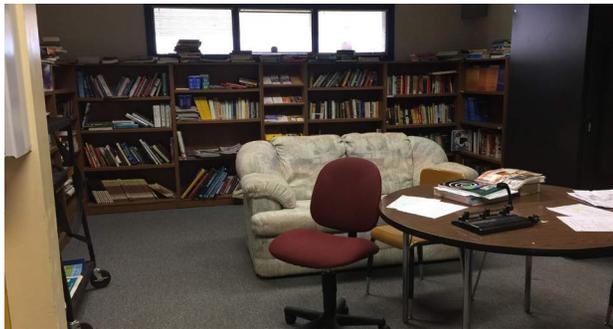
Typical Classroom

- Flooring in classrooms are damaged.
- There is an unknown odor in a couple of the classrooms.
- The ceilings in Central building are damaged.
